Preliminary Advice

Vehicle No	: SJJ702L	Accident Date	: 25/02/2018
Make	: AUDI A6	Policy No.	: 2100095224-09
Assignment Date	: 01/03/2018	Excess	: S\$0.00
Date of Inspection	: 01/03/2018	Est. Duration of Repair	: 0.00
Inspection At	: PREMIUM AUTOMOBILES PTE LTD (UBI) 55 UBI ROAD 1 SINGAPORE 408699

VEHICLE DAMAGE INSPECTION REPORT

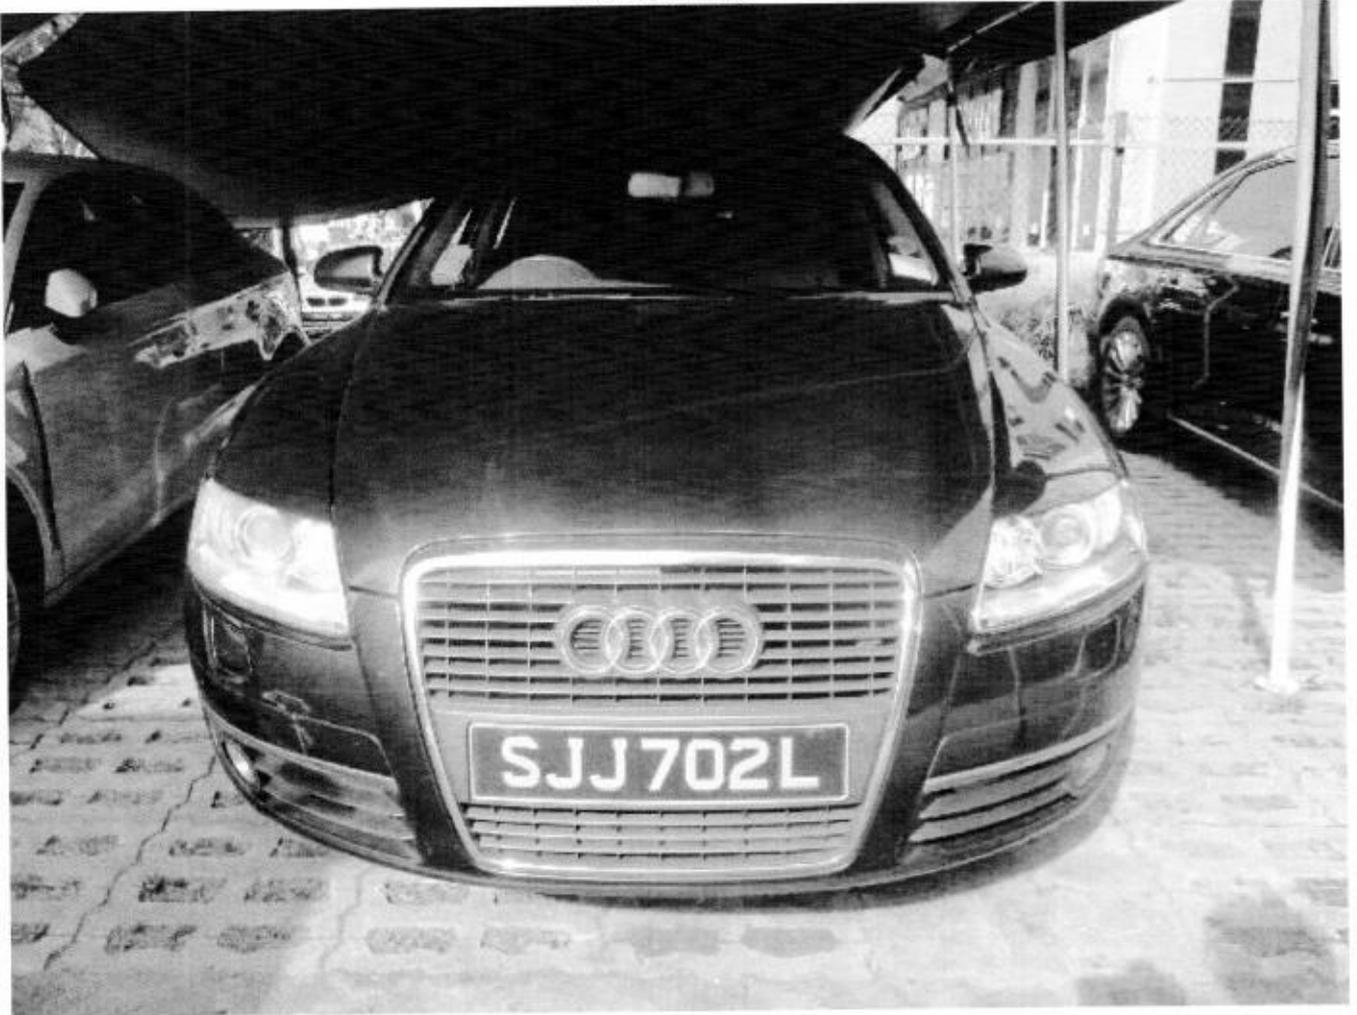
Accident Photo

The vehicle sustained impact / damages o/s portion, undercarriage and parts claimed are consistent to the accident.

Parked on 54 Riverina Crescent
and damaged by SKV 181P

The driver of the other vehicle was waiting beside my car for someone to wake up as the accident happened at around 630 am in the morning.
He hit my mirror and left his number and with me. His car was also damaged and he claimed that it had to be towed away.

The accident has caused intensive damages including unconfirmed items. The damages incur onto the frontal rhs and rhs undercarriage which estimated to be \$9,900. We estimated labour cost to be \$8,032 before any supplementary.

In view of the above, the vehicle is uneconomical to be repaired, you are advised to invite tender for the wreck.
