BMW 523i

PRELIMINARY ADVICE OF VEHICLE NO. SGN 9239M

THE VEHICLE SUSTAINED DAMAGES AT THE FRONT O/S PORTION. DAMAGES SEE DETAILS.

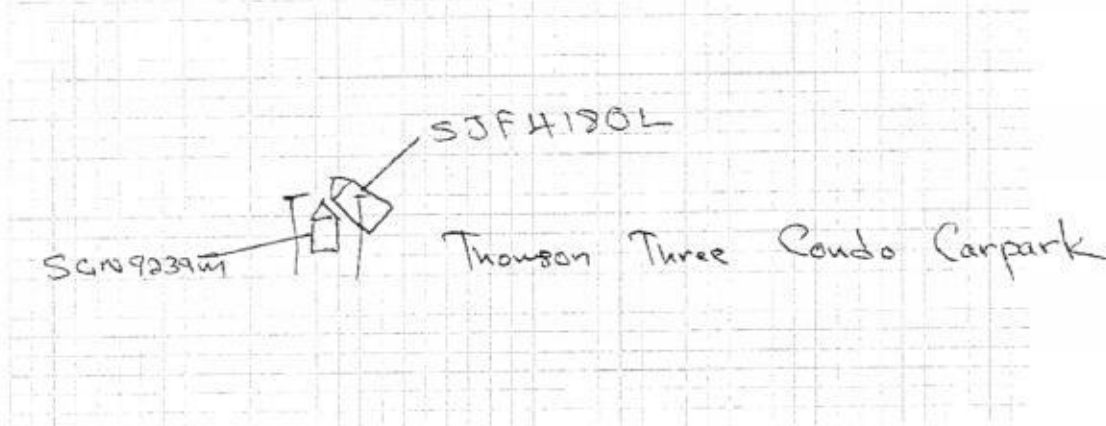
SKETCH PLAN

On 18 Feb Monday around 9am, I received a call from Mr Takaguchi Aoshima via the Management Office of Thomson Three Condominiums.

Mr Aoshima informed me that he had hit my front bumper while moving his car out of his parking lot next to my car. My car was parked and there was no passenger in the car.
