Preliminary Advice

Insured Vehicle No : SLL53S
TP Vehicle No : SLU4864U
Make : SUBARU XV
Date of Inspection : 09/03/2018
Inspection At : MOTOR IMAGE ENTERPRISES PTE LTD (HQ)
19 LORONG 8 TOA PAYOH
SINGAPORE 319255
Accident Date : 08/02/2018
Assignment Date : 05/03/2018
Est. Duration of Repair : 3.00

VEHICLE DAMAGE INSPECTION REPORT

Our File No: CS/MSG18004205/GRD3N2

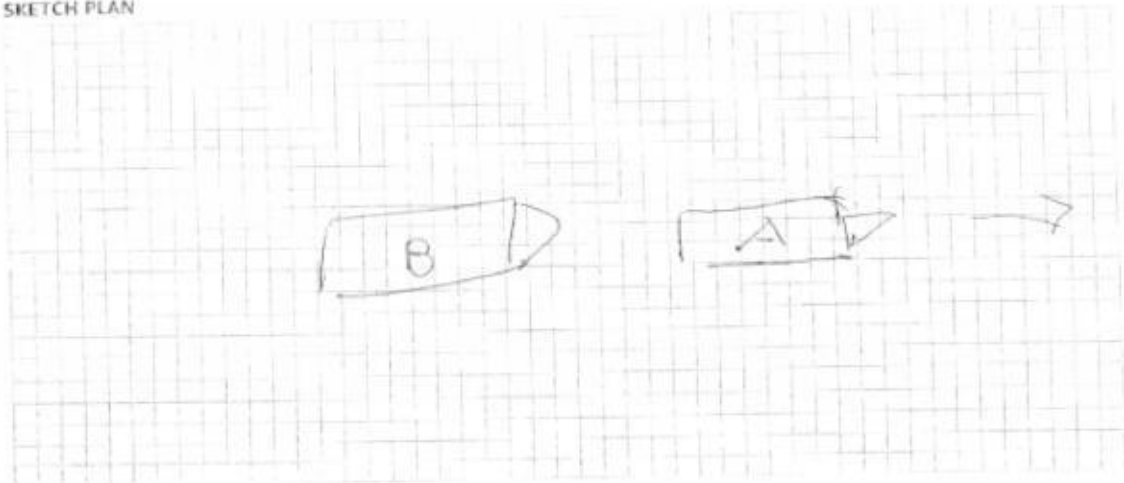
SKETCH PLAN

DESCRIBE CIRCUMSTANCES OF THE ACCIDENT

WAS TRAVELLING AYE TOWARDS TUAS BEFORE NORMANTON.

CAR A (MYSELF) MANAGE TO STOP IN TIME WHEN THE CAR IN FRONT

CAME TO A COMPLETE STOP.

WHEREBY CAR B DID NOT STOP IN TIME AND HAD BUMP

INTO CAR A.
