Affiliated to Federation Internationale Des Experts En Automobile				
MSIG INSURANCE (SINGAPORE) PTE LTD		Ref : CS/MSG18003913/T1vb-1		
16 RAFFLES QUAY #24-01 HONG LEONG BLDG SINGAPORE 048581		Date : 07-03-2018	 	
		Code : MSG		
<b>1. Policy Particulars :- OWN DAMAGE</b>				
Insured Veh.	Veh. Inspected		SKN 2595H	
Policy No. A80430752AVW	Coverage (\$)		0.00	
Claim No. 550704	Excess (\$)		500.00	
Assign From MERIMEN (JOSLIN LIM)	Assign Date		07/03/2018	
<b>2. Vehicle Particulars &amp; Condition</b>				
Make & Model	c.c		0	
Engine No. HIDDEN	Year of Reg.			
Chassis No.	Colour			
Odometer -	Steering			
Brakes	Modification			
General				
<b>3. Conditions of Tyres</b>				
	Size	Make	Balance	
R/H Front Tyre			mm	
L/H Front Tyre			mm	
R/H Rear Tyre			mm	
L/H Rear Tyre			mm	
<b>4. Description of Damages</b>				
<b>5. General Information</b>				
Accident Date 25/02/2018	Inspection Date		08/03/2018	
Survey held at	VIN'S MOTOR PTE LTD 160 SIN MING DRIVE #03-03 SIN MING AUTO CITY SINGAPORE 575722

To: MSIG Insurance (Singapore) Pte. Ltd. 4 Shenton Way #21-01 SGX Centre 2 Singapore 068807	From: LKK Auto Consultants Pte Ltd 51 Ubi Ave 1 #01-25 Paya Ubi Industrial Park Singapore 408933
Attn: Josl

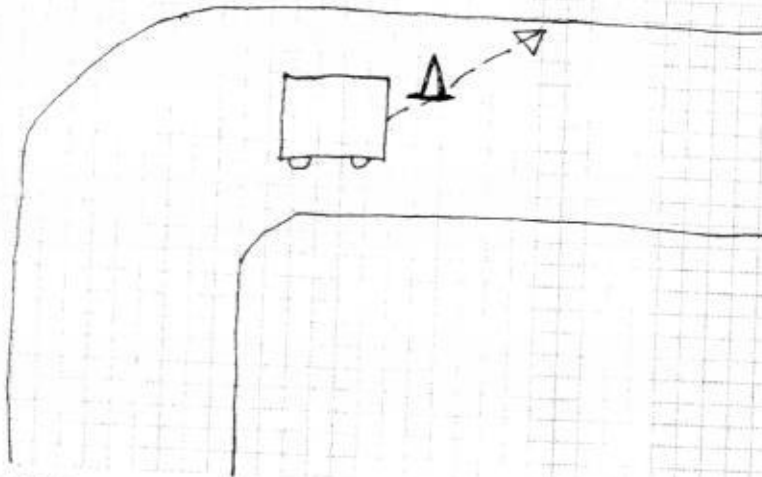
SKETCH PLAN

DESCRIBE CIRCUMSTANCES OF THE ACCIDENT

As I was exiting the basement carpark of Shenwood Condominium on Sunday, 25 Feb, at 6:15pm, I saw a pylon in the middle of the driveway. The pylon had not been there before. ~~I was~~ In order to avoid the pylon, I swerved and I hit the wall of the driveway. (Please refer to in-car camera footage for the details.) The weather at that time was fair and visibility was clear.
