VEHICLE APPRAISAL REPORT

Regn. No : FBG 3393K
Make : HARLEY DAVIDSON
Model : SPORTSTER XL1200X
Year : 2012 (COE.Exp : Jun 2022)

VEHICLE DAMAGE INSPECTION REPORT

Handling Insurer:	MSIG Insurance (Singapore) Pte. Ltd.	Policy No:	MSD/VPCP/17-001233-00
Claimant Vehicle No :	FBG3393K	Insured Vehicle No :	SLD8362P
Date of Loss:	28/01/2018	Nature of Claim:	TP
		Claim No:	MSC/V/18-000186

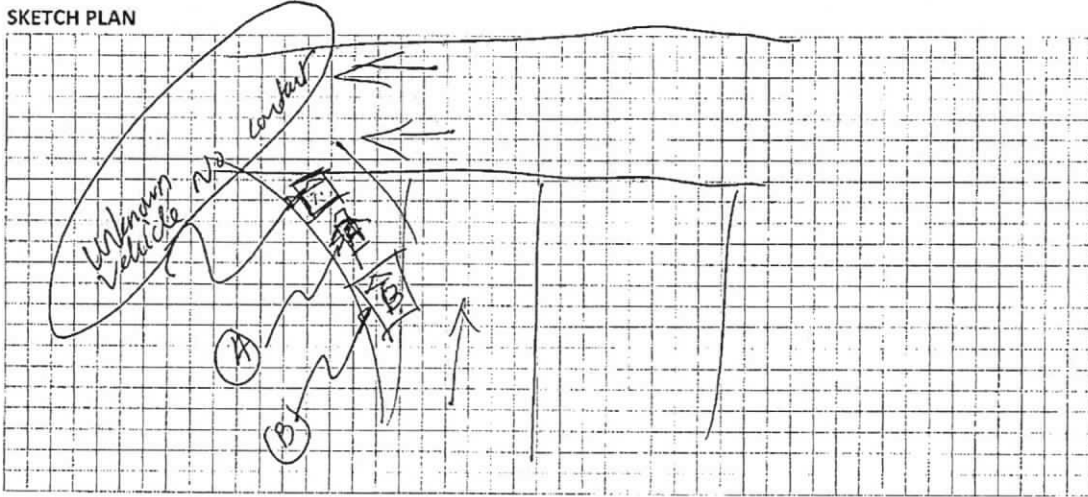
SKETCH PLAN

I am vehicle A in the sketch. Vehicle A was not able to move off after ~~the~~ oncoming traffic has cleared 3 times. I anticipated vehicle A to move off and accelerated. Upon realising vehicle A failed to move off, I applied my brakes. Vehicle B could not react in time and collided into me.
