## VEHICLE DAMAGE INSPECTION REPORT

Handling Insurer:	China Taiping Insurance (Singapore) Pte. Ltd.	Policy No:	DMPCSN7042621710
Claimant Vehicle No :	SHD3614T	Insured Vehicle No :	SGJ9566P
Date of Loss:	05/03/2018	Nature of Claim:	TP
		Claim No:	SNM18D01178C02

Reg No:	SHD3614T	Engine No:	2ZRR923660
Make & Model:	TOYOTA PRIUS, 1.8 HYBRID CVT (A)	Chassis No:	JTDKB3FU703530401
Reg. Date:	14/09/2016 (Man. Year: 2016)	Odometer:	0 km
Colour:	Blue		
Engine Capacity:	1798 cc		
Market Value/New Car Price:	N/A		
Sum Insured (\$\$):	Market Value/New Car Price

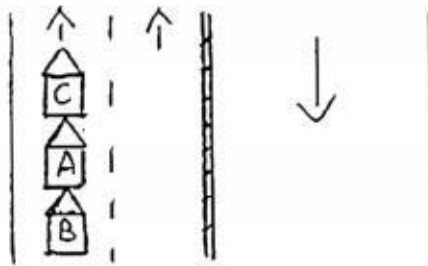
**SKETCH PLAN**

A-SHD 3614T

B-SGJ 9566P (Private Car)

C-SLN 7472J (Private Car)

Along B.Panjang Ring Rd Twds Petir Rd In Frt Of Greenridge Sec School
