1. Policy Particulars :- THIRD PARTY CLAIM

4. Description of Damages

4. Description of Damages			
THE VEHICLE SUSTAINED DAMAGES AT THE REAR PORTION. DAMAGES SEE DETAILS.			
5. General Information			
Accident Date	09/03/2018	Inspection Date	12/03/2018
Survey held at	SMRT AUTOMOTIVE SERVICES PTE LTD 60 WOODLANDS INDUSTRIAL PARK E4 SINGAPORE 757705		
5a. Remarks			
A)THE INSPECTION WAS CONDUCTED ON A"WITHOUT PREJUDICE" BASIS. B)IN ACCORDANCE TO YOUR INSTRUCTIONS, WE HAVE NOT AUTHORISED REPAIRS.			
5b. Estimate Days of Repair			
ESTIMATED NORMAL PERIOD FOR REPAIR:		5 Working Days

ADJUSTMENT ON REPAIR COST FOR VEHICLE NO. SHC 4075Y

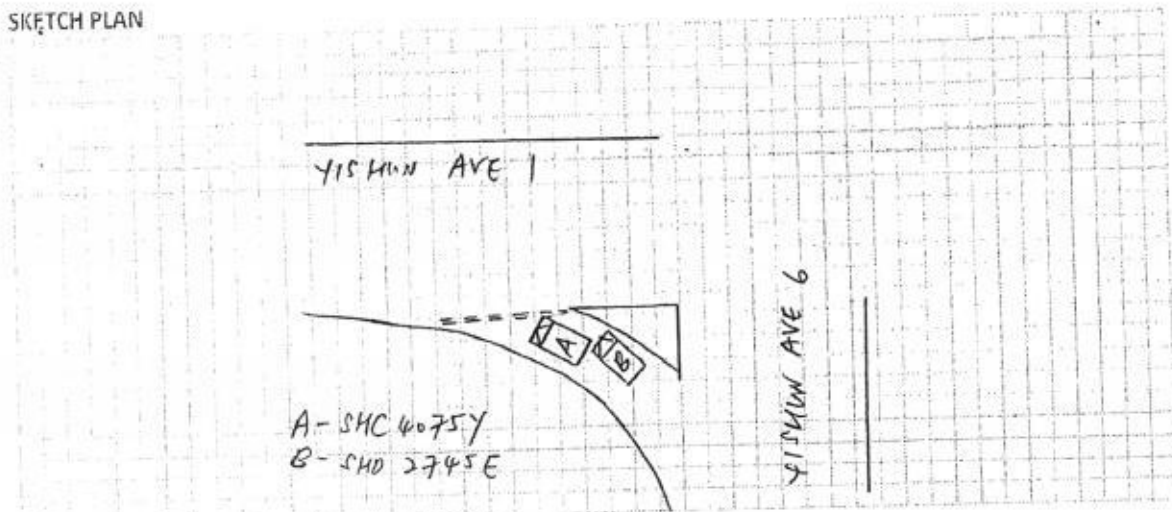
SKETCH PLAN

I WAS STATIONARY ALONG THE SLIP ROAD OF YISHUN AVE 6 WITH A PASSENGER ON BOARD TO LOOK OUT FOR THE ONCOMING TRAFFIC ON YISHUN AVE 1 WHEN THE PRIME TAXI SHD2745E FROM BEHIND COLLIDED ONTO THE REAR PORTION OF MY TAXI.
