# LKK Auto Consultants Pte Ltd

### 1. Policy Particulars :- THIRD PARTY CLAIM

### 2. Vehicle Particulars & Condition

**ACCIDENT INVOLVING OUR TAXI SH 6678M YOUR INSURED SKS7887G**  
**AND OTHER \_\_\_\_\_ ON 14.03.18**

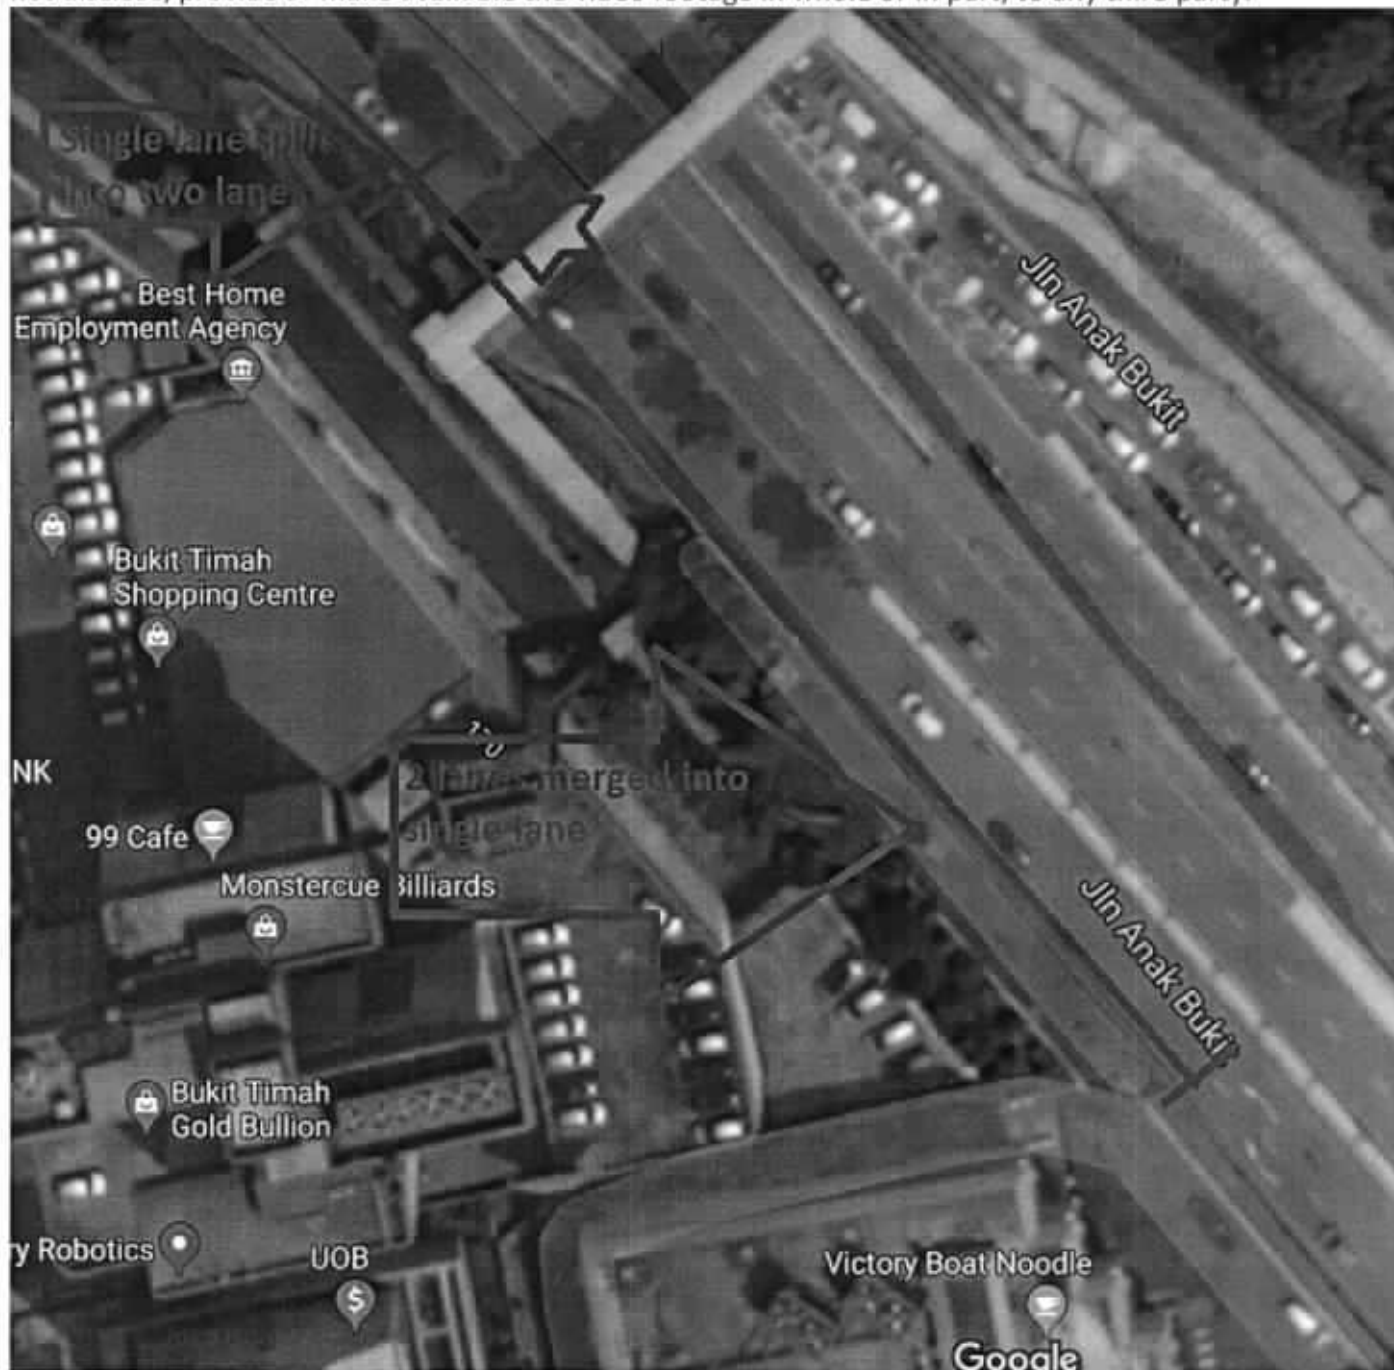
Your 50% offer is rejected. Accident happened at the single lane, before it splits into two lanes. Video footage clearly shows that taxi was travelling ahead and it was your insured who squeezed through the

lane that caused the accident. We attached herewith the longer VC. Please note that the video footage is solely for investigation and shall not be reproduced. You undertake to preserve its confidentiality and will not disclose, provide or make available the video footage in whole or in part, to any third party.
