Ref : CS/SMO18005103/Urd3

PRELIMINARY ADVICE OF VEHICLE NO. SLL 9934R .

THE VEHICLE SUSTAINED DAMAGES AT THE FRONT O/S PORTION. DAMAGES SEE DETAILS.

ADJUSTMENT ON REPAIR COST FOR VEHICLE NO. SLL 9934R

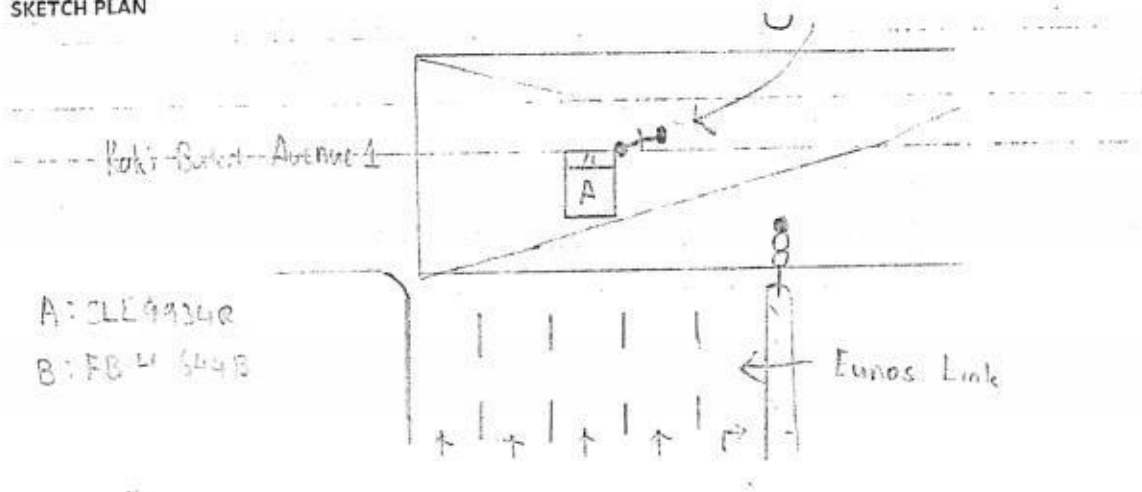
SKETCH PLAN

On 05.03.2018 at about 1340 hours, I was driving my vehicle (A: SLL9934R) along 3rd lane of Eunos Link. Upon reaching the junction of Eunos Link and Kaki Bukit Avenue 1, traffic was green in my favor, so I continue straight on my journey. Suddenly, a motorcycle (B: FBH644B) from the opposite direction make a right turn into Kaki Bukit Avenue 1 and hit onto the front right portion of my vehicle. On the spot, my passenger Steven Teo (HP Num: 9760 1138) willing to be my witness. Vehicle A: 1 passenger onboard Motorcycle B: no passenger onboard
