MOTOR SURVEY ASSIGNMENT

1. Policy Particulars :- THIRD PARTY CLAIM			
Insured Veh.	SH 7570H	Veh. Inspected	SHC 8811M
Policy No.		Coverage (\$)	0.00
Claim No.	D18002204MFSH	Excess (\$)	0.00
Assign From	CWS (MAY CHUA)	Assign Date	20/03/2018

4. Description of Damages			
THE VEHICLE SUSTAINED DAMAGES AT THE FRONT & REAR PORTION. DAMAGES SEE DETAILS.			
5. General Information			
Accident Date	16/03/2018	Inspection Date	20/03/2018
Survey held at	CHUNNI MOTOR REPAIRS PTE LTD BLK 10 ANG MO KIO INDUSTRIAL PARK 2A AMK AUTOPOINT #03-19 SINGAPORE 568047		
5a. Remarks			
A)DAMAGES CONSISTENT TO ACCIDENT REPORT. B)THE INSPECTION WAS CONDUCTED ON A"WITHOUT PREJUDICE" BASIS. C)IN ACCORDANCE TO YOUR INSTRUCTIONS, WE HAVE NOT AUTHORISED REPAIRS.			
5b. Estimate Days of Repair			
ESTIMATED NORMAL PERIOD FOR REPAIR:		7 Working Days

ADJUSTMENT ON REPAIR COST FOR VEHICLE NO. SHC 8811M

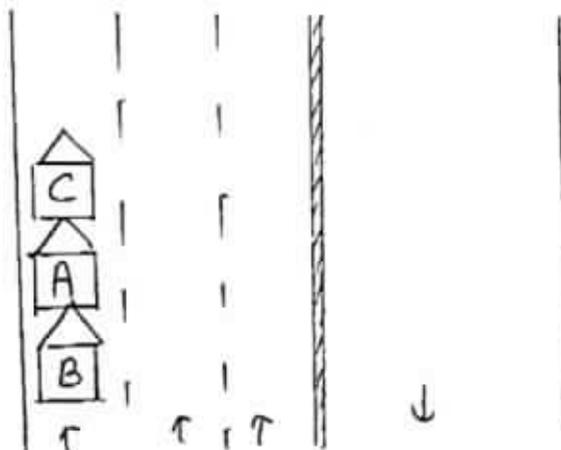
SKETCH PLAN

A - SHC 8811M.
 B - SH 7570H. (CTPL)
 C - SKH 6417U.

Along Tampines Ave 5 B4 Tampines Central 2 Junction.

On 16/03/2018 @ about 12:10 hrs,my taxi (A) (SHC 8811M) was travelling along Tampines Ave 5 before Tampines Central 2 junction with no passenger on board.
I saw infront of my vehicles slowing down and stopped ,So I follow too.
Out of sudden,there was a loud impact coming from the rear portion and caused my taxi (A),to lose control and surge forward,and colliding onto veh (C) (SKH 6417U) rear portion.My taxi (A) front and rear portion were damaged.
I assessed the damages to my taxi (A) and come to know that there were 3 vehicles involved in the chain accident.
No one was conveyed by the ambulance.
The parties involved in the accident are:
A - SHC 8811M.
B - SH 7570H (CTPL). Female driver.
C - SKH 6417U. Mr. Mohamed Naseer Bin Tam Abdul Aziz. NRIC : S 8040631B. Hp : 9781 8503.
No injury in this accident.
