Preliminary Advice

TP Vehicle No : SHA3157L

Make : HYUNDAI I40

VEHICLE DAMAGE INSPECTION REPORT

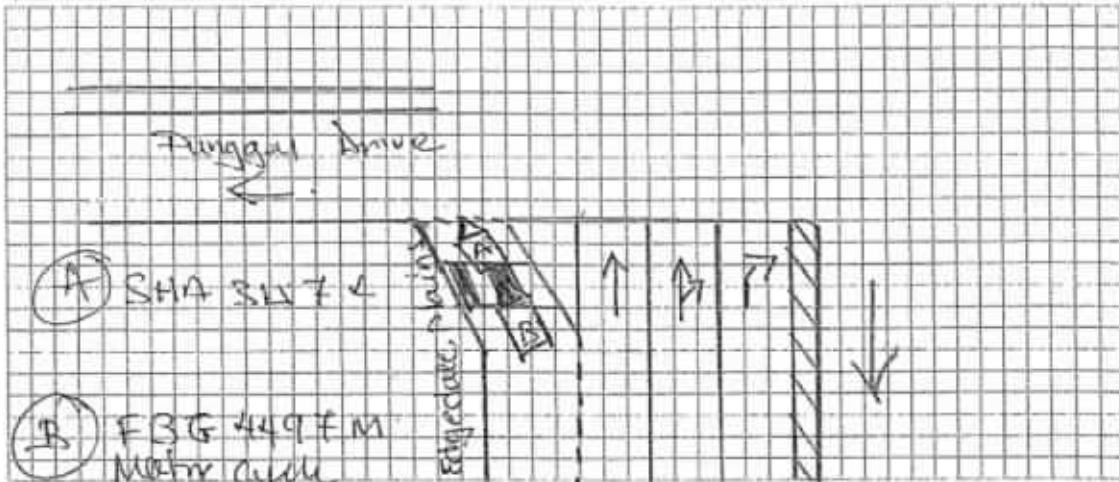
SKETCH PLAN

ON 17 March 2018 @ 2:00 pm I

veh-A was along Edgeclate plain x

turning of Punggol drive. I veh A

turn left to Punggol drive. I veh A

Slow down and stop. Suddenly veh-B

from Rear hit veh-A. at the point of

accident veh-A no passenger.
