VEHICLE DAMAGE INSPECTION REPORT

Our File No: CS/CTI18005295/URBN2

Handling Insurer:	China Taiping Insurance (Singapore) Pte. Ltd.	Policy No:	DMCVSN1528011702
Claimant Vehicle No :	GBG8037G	Insured Vehicle No :	GBC7300Z
Date of Loss:	13/03/2018	Nature of Claim:	TP
		Claim No:	SNM18D01361C02

Reg No:	GBG8037G	Engine No:	1KD2749526
Make & Model:	TOYOTA DYNA 150, 3.0 D (M)	Chassis No:	JTFAT35Y00K209116
Reg. Date:	30/10/2017 (Man. Year: 2017)	Odometer:	22348 km
Colour:	White		
Engine Capacity:	2982 cc		
Market Value/New Car Price:	N/A		
Sum Insured (\$\$):	Market Value/New Car Price

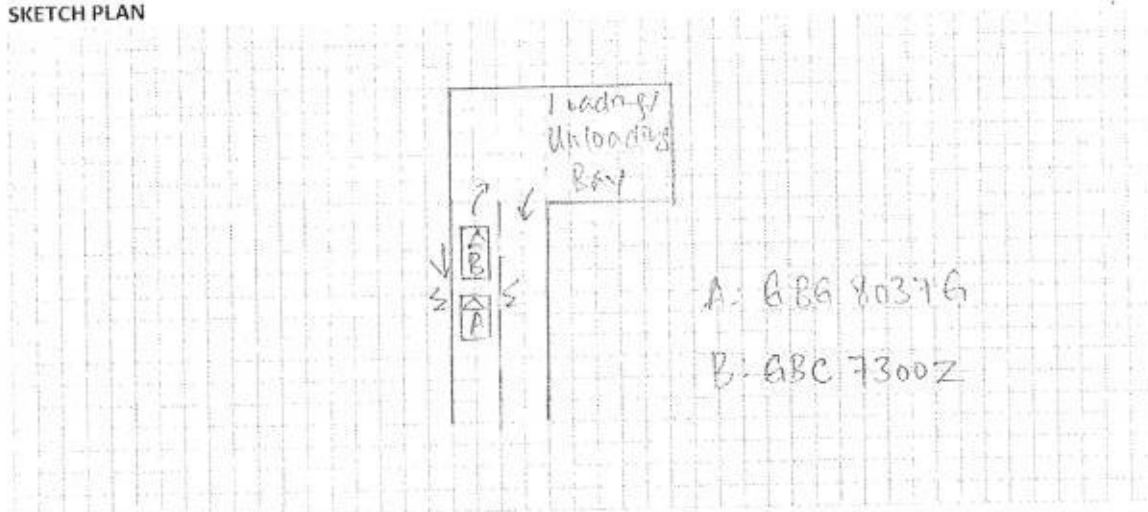
SKETCH PLAN

I was stationary due to a jam. As I pulled my hand brake and check the invoices, Vehicle B in front suddenly hit me at the front. Nobody was injured.
