VEHICLE DAMAGE INSPECTION REPORT

Our File No: CS/CTI18005363/DVD3N2

Handling Insurer:	China Taiping Insurance (Singapore) Pte. Ltd.	Policy No:	DMPCSN3059131601
Claimant Vehicle No :	SHA4139H	Insured Vehicle No :	SJE4595D
Date of Loss:	16/03/2018	Nature of Claim:	TP
		Claim No:	SNM18D01422C02

Reg No:	SHA4139H	Engine No:	D4FDGU693168
Make & Model:	HYUNDAI I40, 1.7 D CRDI F/L ABS AIRBAG 4DR (A)	Chassis No:	KMHLB41UMHU097081
Reg. Date:	15/12/2016 (Man. Year: 2016)	Odometer:	186687 km
Colour:	Blue		
Engine Capacity:	1685 cc		
Market Value/New Car Price:	N/A		
Sum Insured (\$\$):	Market Value/New Car Price

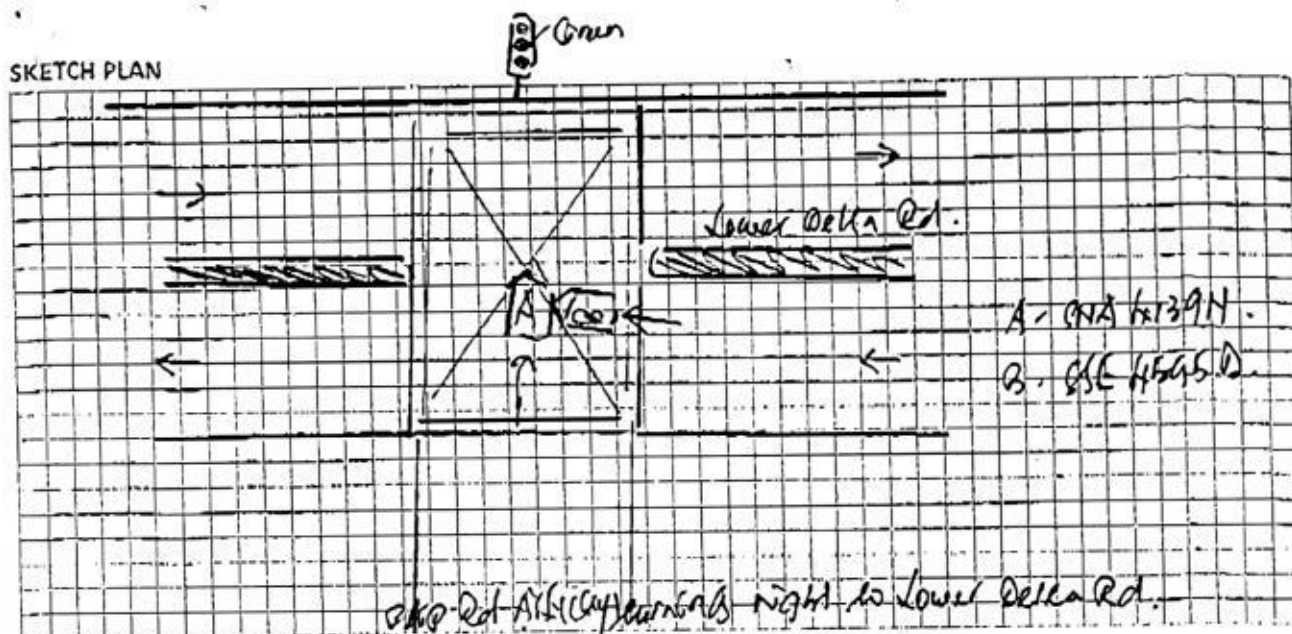
SKETCH PLAN

on 16/3/2018 @ 10:35hrs. my taxi (A) (CHA 4139H) was travelling along AYE (Lany) to Lower Delta Rd. with 1 female passenger on board. my female pax name Ms Eugene Tan Chin Hong, ID 79094060. HP no: 97901460.

I was stop at the traffic junction, I saw the traffic turn green so I proceed to turning to Lower Delta Rd. suddenly, vehicle (B) (SEE 4545D) on my right side, dashed out and collided onto my taxi (A) right portion. my taxi (A) right portion was damaged.
