**Preliminary Advice**

Insured Vehicle No	: SLE1921S	Accident Date	: 18/03/2018
TP Vehicle No	: SHD1355D	Assignment Date	: 22/03/2018
Make	: HYUNDAI I30 GDH	Est. Duration of Repair	: 4.00
Date of Inspection	: 26/03/2018		
Inspection At	KOMOCO MOTORS - (ALEXANDRA) (HQ) 253 ALEXANDRA ROAD SINGAPORE 159936

## ESTIMATE REPAIR BILL FOR HYUNDAI I30(A) WAGON REGN NO: SHD 1355 D

## VEHICLE DAMAGE INSPECTION REPORT

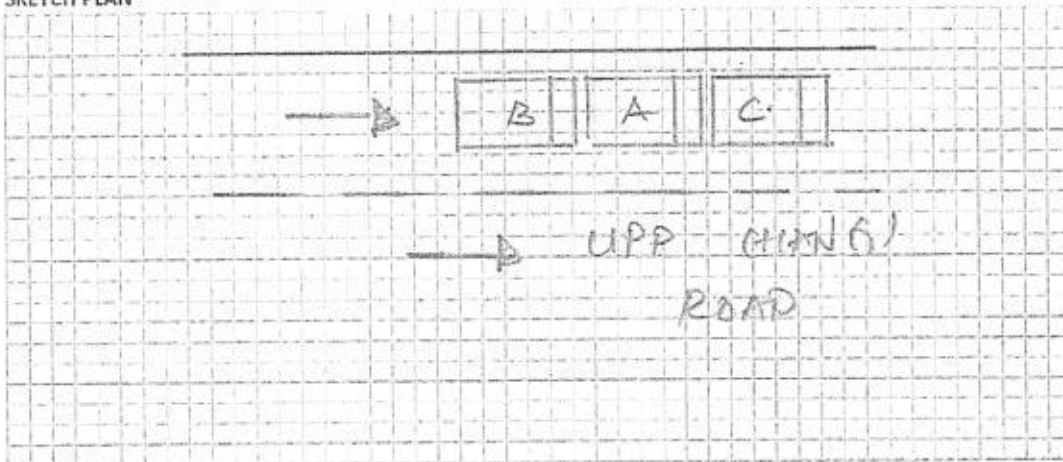
### SKETCH PLAN

DUE TO THE IMPACT, MY TAXI HAD DAMAGES ON THE REAR PORTION AND THE  
FRONT PORTION.

VEHICLE B HAD DAMAGES ON THE FRONT AND NO DAMAGES TO VEHICLE C.
