Preliminary Advice

Insured Vehicle No	: FY3960G	Accident Date	: 21/03/2018
TP Vehicle No	: SKD9846R	Assignment Date	: 26/03/2018
Make	: BMW X3 XDRIVE20I	Est. Duration of Repair	: 5.00
Date of Inspection	: 26/03/2018		
Inspection At	: HO BENG TRADING (HQ) BLK 3020A #01-33, UBI ROAD 1 SINGAPORE 408714

Estimated repair cost for vehicle no: SKD9846R BMW X3 '12

VEHICLE DAMAGE INSPECTION REPORT

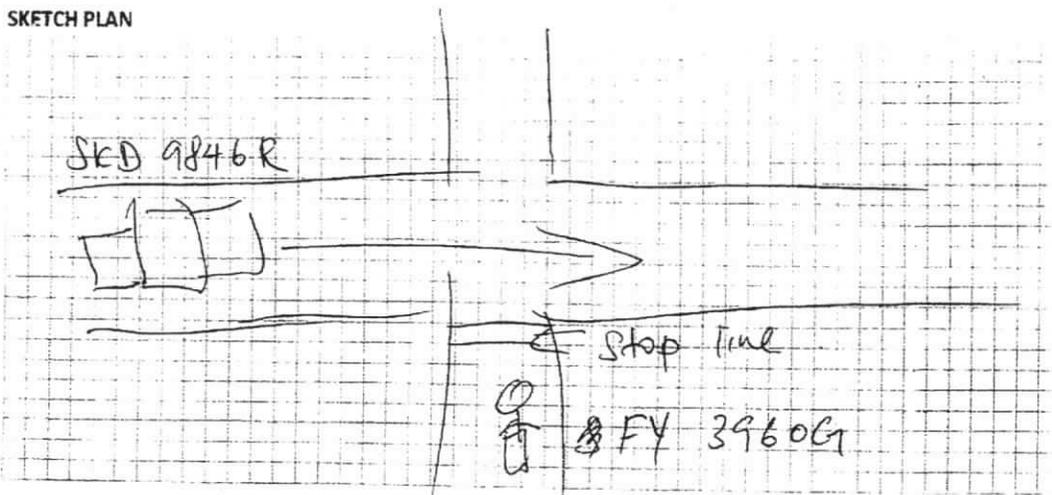
SKETCH PLAN

On 21st Mar 2018, about 745am, I, owner of SKD 9846R was travelling straight on Jalan Lapang.

The motorist, FY 3960G suddenly came out from Jln Senang and banged into my driver's side door all the way to the passenger ~~to~~ (behind) door. My car is badly dented by the collision. The motorist failed to stop at stop line before ~~making~~ going straight or perhaps making a right turn.
