1. Policy Particulars :- THIRD PARTY CLAIM				
Insured Veh.	SLH 216K	Veh. Inspected	SH 7204R	
Policy No.	DMPCSN3094911700	Coverage (\$)	0.00	
Claim No.	SNM18D01600C02	Excess (\$)	0.00	
Assign From		Assign Date	28/03/2018

HYUNDAI SONATA 2.0 (A)

ADJUSTMENT ON REPAIR COST FOR VEHICLE NO. SH 7204R

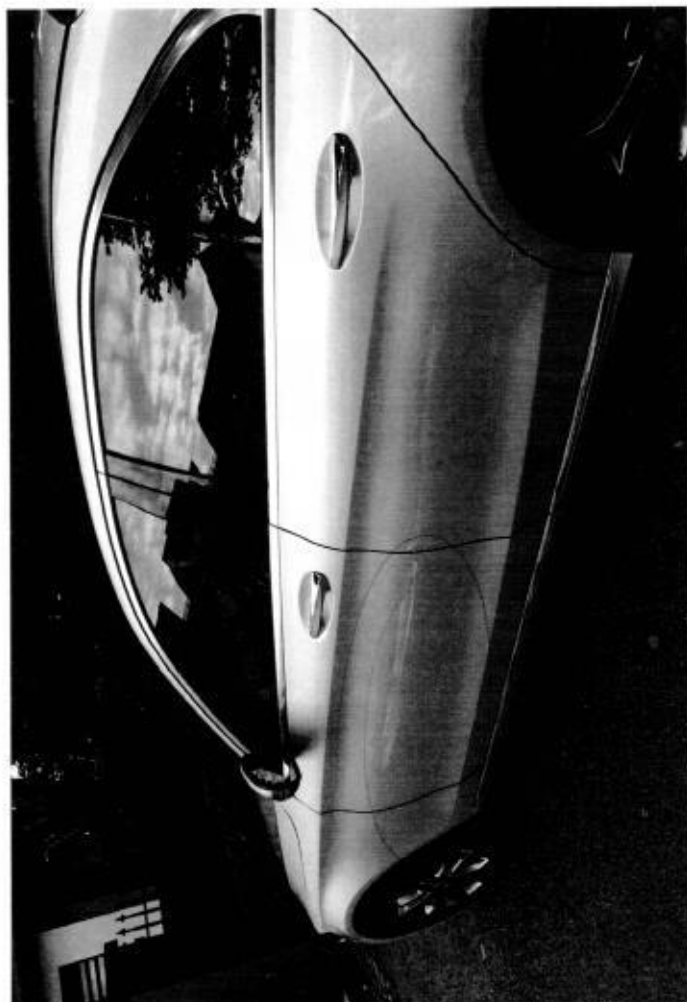
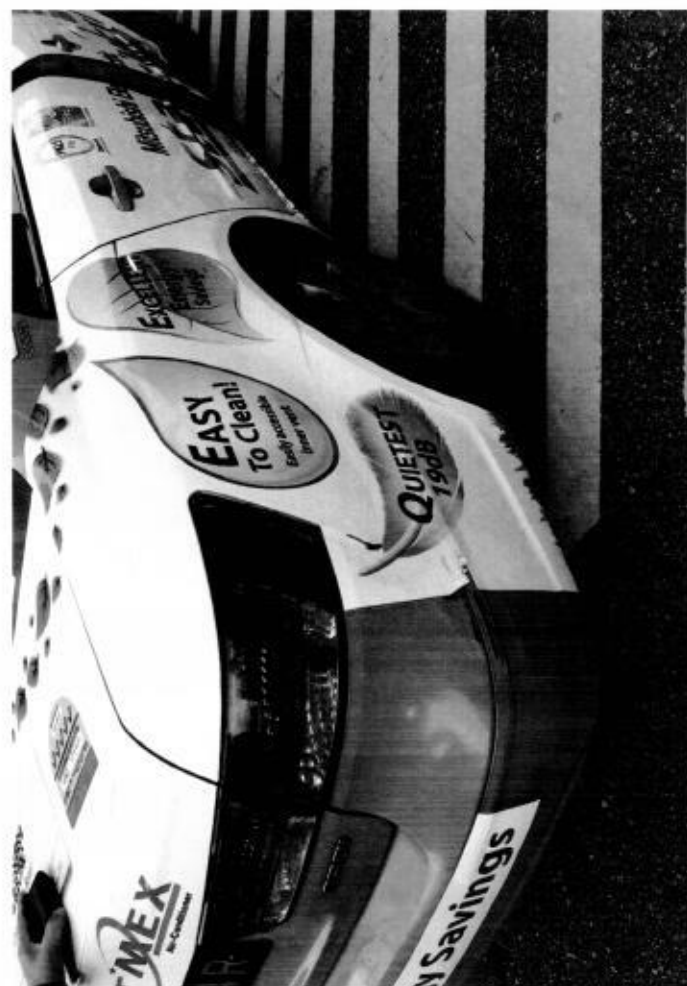
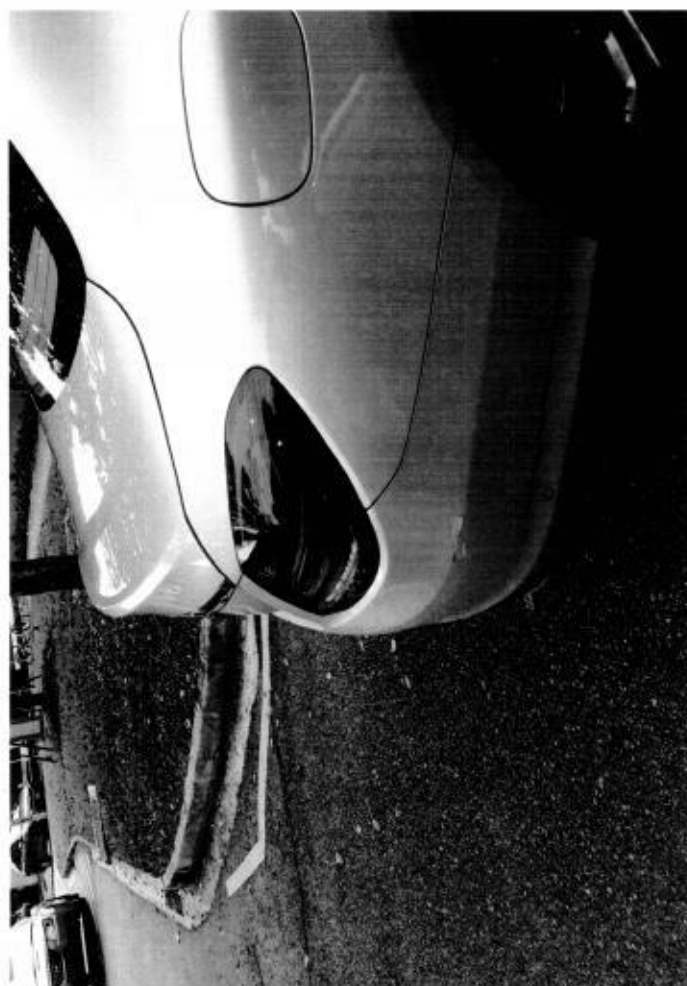
- YOU HAVE MENTIONED IN YOUR REPORT THAT DUE TO A CHASE TO ANOTHER VEHICLE, YOUR VEHICLE KNOCKED AT RIGHT SIDE BUMPER OF TAXI. THE IMPACT CAUSED THE BUMPER DEFORMED WHICH WARRANTS A REPLACEMENT TOGETHER WITH BUMPER PROTECTOR WHICH WAS SCRATCHED. IN ADDITION RIGHT FENDER IS ALSO AFFECTED.

Attached herewith is the damaged photos of third party taken by our surveyor for your record purposes. Based on the photo, the damages observed to the third party vehicle were consistent to the damages observed by our surveyor at the time of inspection.

THE VEHICLE SUSTAINED DAMAGES AT THE REAR PORTION. DAMAGES SEE DETAILS.
--

Qty	Description of Parts	Condition	Estimate By Workshop (\$)	Our Adjusted (\$)
<u>REPLACEMENT OF PARTS</u>				
1	REAR BUMPER	DEFORMED	578.40	578.40
1	REAR BUMPER PROTECTOR (RH)	SCRATCHED	38.00	38.00
	LESS 20% DISCOUNT		-123.28	-123.28
			493.12	493.12
<u>SPECIAL NETT ITEMS</u>				
1	REAR BUMPER ADVERTISEMENT LOGO (SN)	NECESSARY	50.00	50.00
2	REAR FENDER ADVERTISEMENT LOGO (LH/RH) @\$100.00 (SN)	NECESSARY	200.00	200.00
			250.00	250.00
<u>LABOUR</u>				
	PANEL BEATING.		250.00	200.00
	SPRAY PAINTING CHARGE.		250.00	180.00
	WIRING CHARGE.	NOT NECESSARY	50.00	-
	REMOVE/REFIX REVERSE SENSOR.		120.00	60.00
			670.00	440.00
GRAND TOTAL			1,413.12	1,183.12
RECOMMENDED COST OF LUMP SUM REPAIRS (TO ITS PRE-ACCIDENT CONDITION)				950.00
