To Inspect Vehicle No: SHA 1312T Insured: SJZ 8558A

## 1. Policy Particulars :- THIRD PARTY CLAIM

Date Of Report	23/03/2018 16:41
Date Of Accident	23/03/2018 01:45
Exact Location Of Accident	GRANGE RD TWDS PATTERSON RD JUNCTION
Country/State of Loss	SINGAPORE

## VEHICLE DAMAGE INSPECTION REPORT

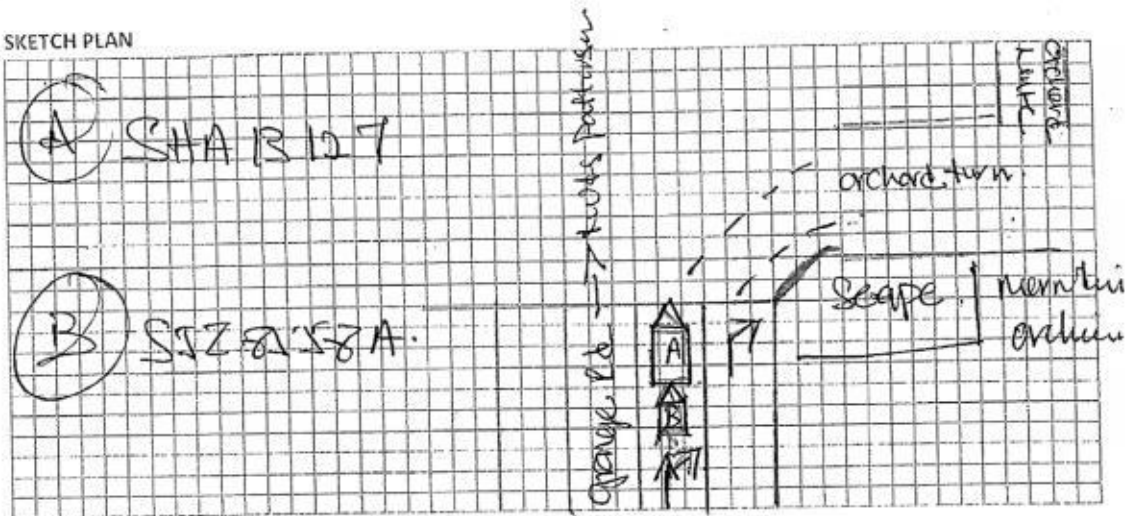
SKETCH PLAN

on 22/3/18 I veh A @ 01:45 hr I veh a was driving along grange rd twote Patterson Rd turning along the grange rd turning new orchard turn. I veh A stop @ the traffic lights suddenly veh B from rear hit veh A rear. at the point of accident I veh A ferry a male passenger he was ok.

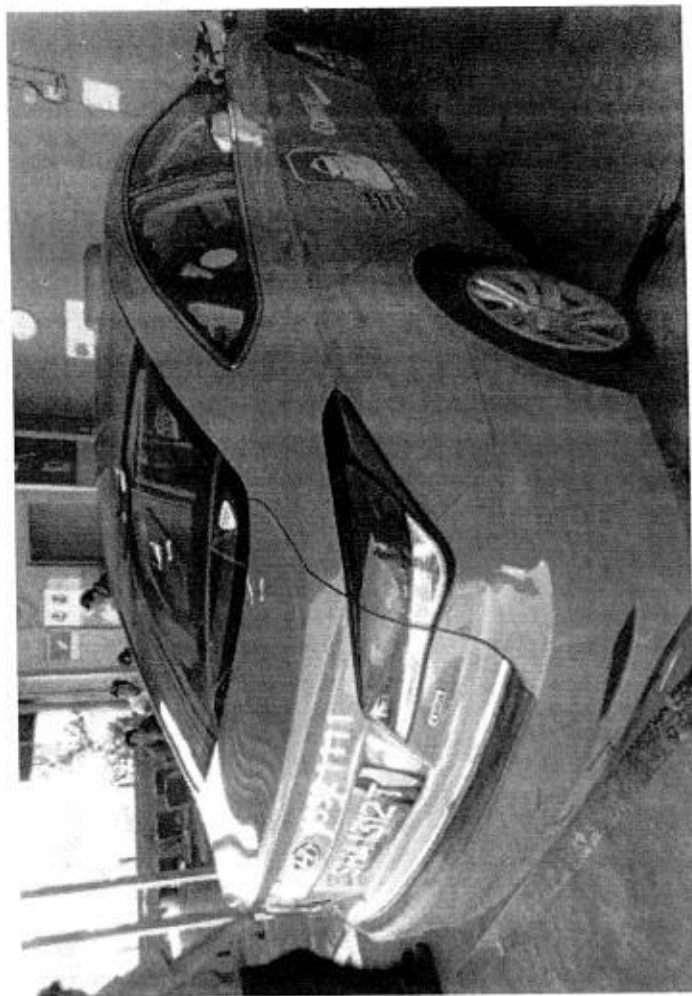
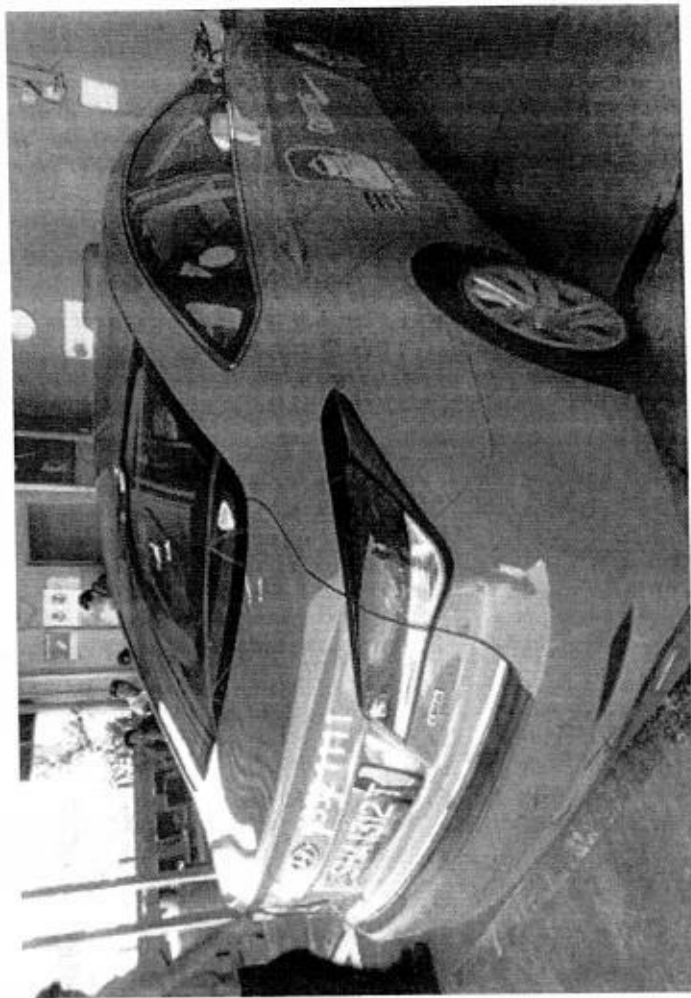
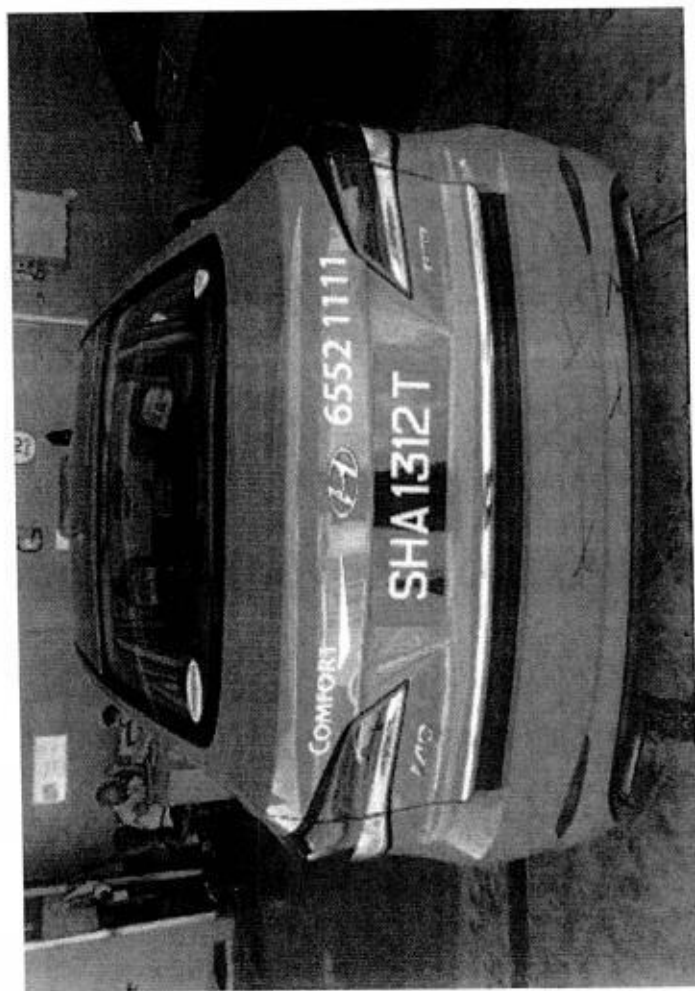
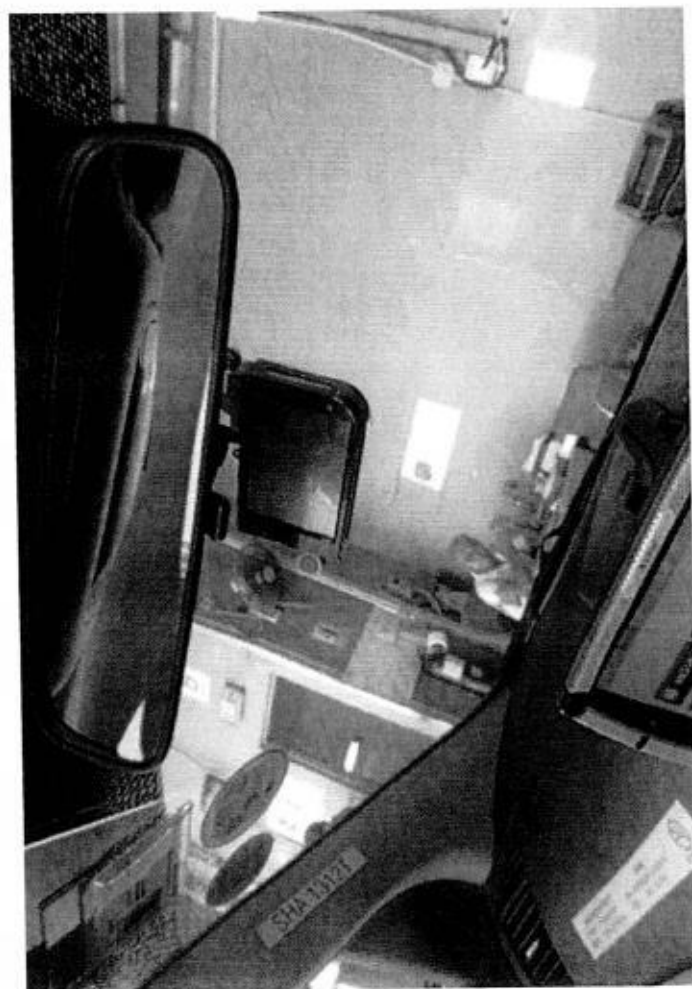
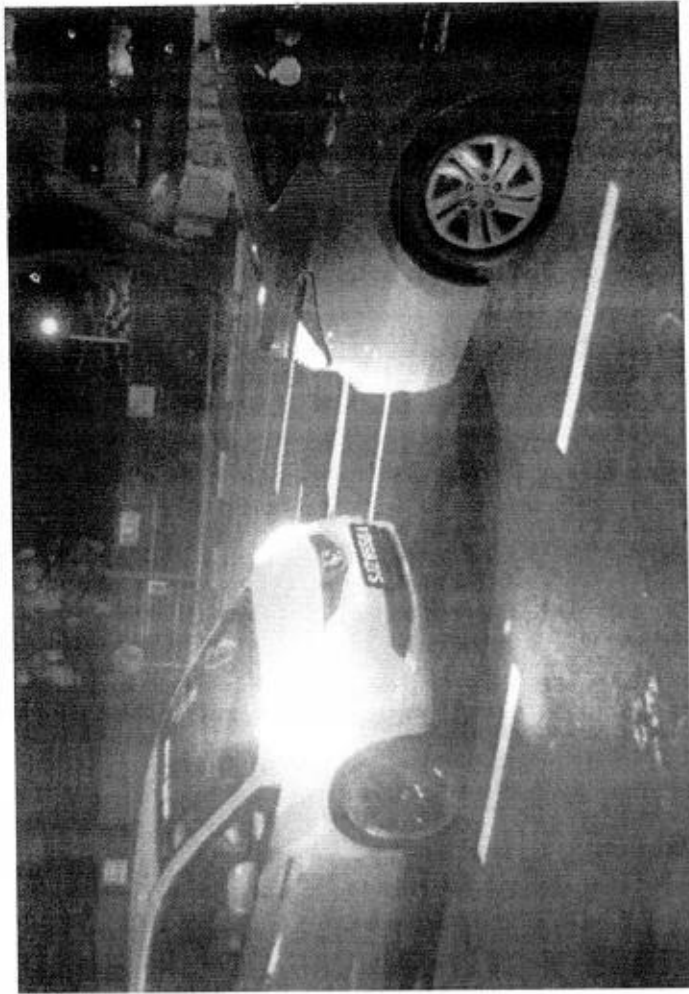
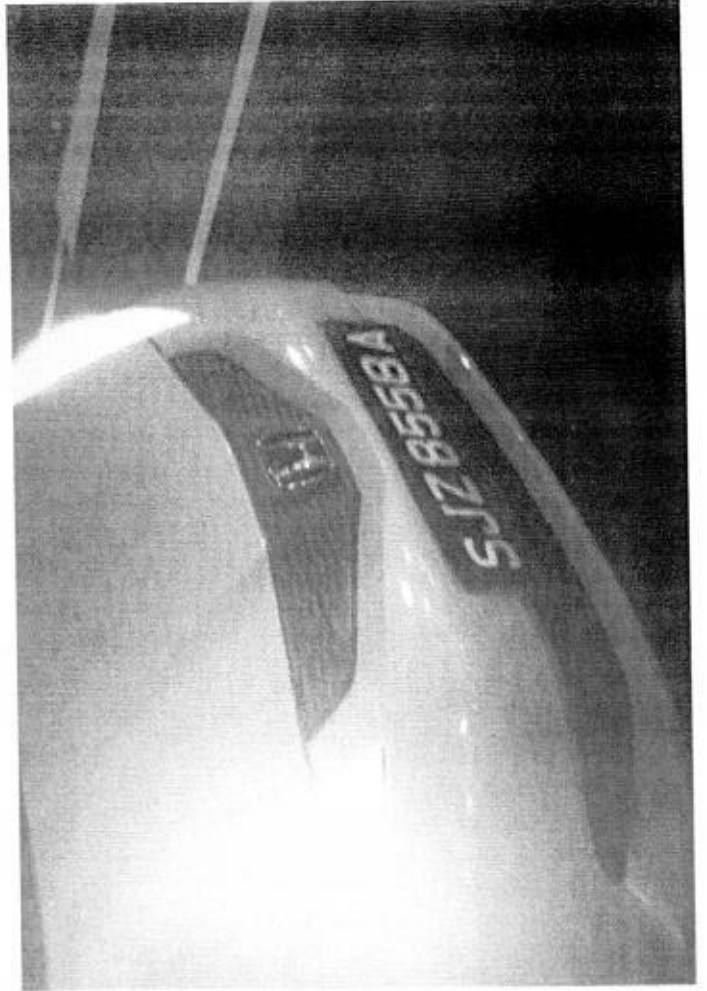
The U/C / Chassis frame / Body Structure affected due to collision.

No.	Qty	Part No. Particulars	Condition	Repairer's	Amount
1	1	*REAR BUMPER	Deformed	603.60 FL	*603.60 FL
2	1	*REAR BUMPER REINFORCEMENT	Serviceable	504.35 FL	*- FL
3	2	*REAR BUMPER REINFORCEMENT BRACKET (LH/RH)	Serviceable	360.00 FL	*- FL
4	1	*REAR BUMPER SPONGE	Serviceable	143.40 FL	*- FL
5	1	*REAR BUMPER UNDER COVER	Serviceable	225.00 FL	*- FL
6	10	*REAR BUMPER CLIPS	Not Necessary	22.00 FL	*- FL
7	1	*REAR BUMPER REVERSE SENSOR	Serviceable	135.70 FS	*- FS
8	1	*REAR BUMPER RUBBER MAT	Necessary	50.00 FS	*50.00 FS

(a) Spare Parts after List discount	\$532.88
(b) Labour Charges	\$440.00
<b>Total for Part-By-Part Repair Cost</b>	<b>\$972.88</b>
(c.) Lumpsum Repair (if applicable)	
Total for Lumpsum repair cost after Less: 20%	
<b>Final Lumpsum Repair cost</b>

No	Particulars	Lab.Type	Repairer's	Amount
<b>Labour Items</b>				
1	PANEL BEATING	New	250.00	200.00
2	SPRAY PAINTING CHARGE	New	250.00	180.00
3	WIRING CHARGE	New	30.00	-
4	REMOVE/REFIX REVERSE SENSOR	New	120.00	60.00
Gross Labour Cost (\$\$)			<b>650.00</b>	<b>440.00</b>
