VEHICLE DAMAGE INSPECTION REPORT

Our File No: CC3/MSG18006011/SRBN2

Handling Insurer:	MSIG Insurance (Singapore) Pte. Ltd.	Policy No:	B80264094SVP
Claimant Vehicle No :	SHC4314H	Insured Vehicle No :	SJY9251H
Date of Loss:	26/03/2018	Nature of Claim:	TP
		Claim No:	553908

Reg No:	SHC4314H	Engine No:	2ZR6007138
Make & Model:	TOYOTA PRIUS, 1.8 (A)	Chassis No:	JTDKN36U205741405
Reg. Date:	16/04/2014 (Man. Year: 2014)	Odometer:	316616 km
Colour:	Maroon		
Engine Capacity:	1798 cc		
Market Value/New Car Price:	N/A		
Sum Insured (S\$):	Market Value/New Car Price

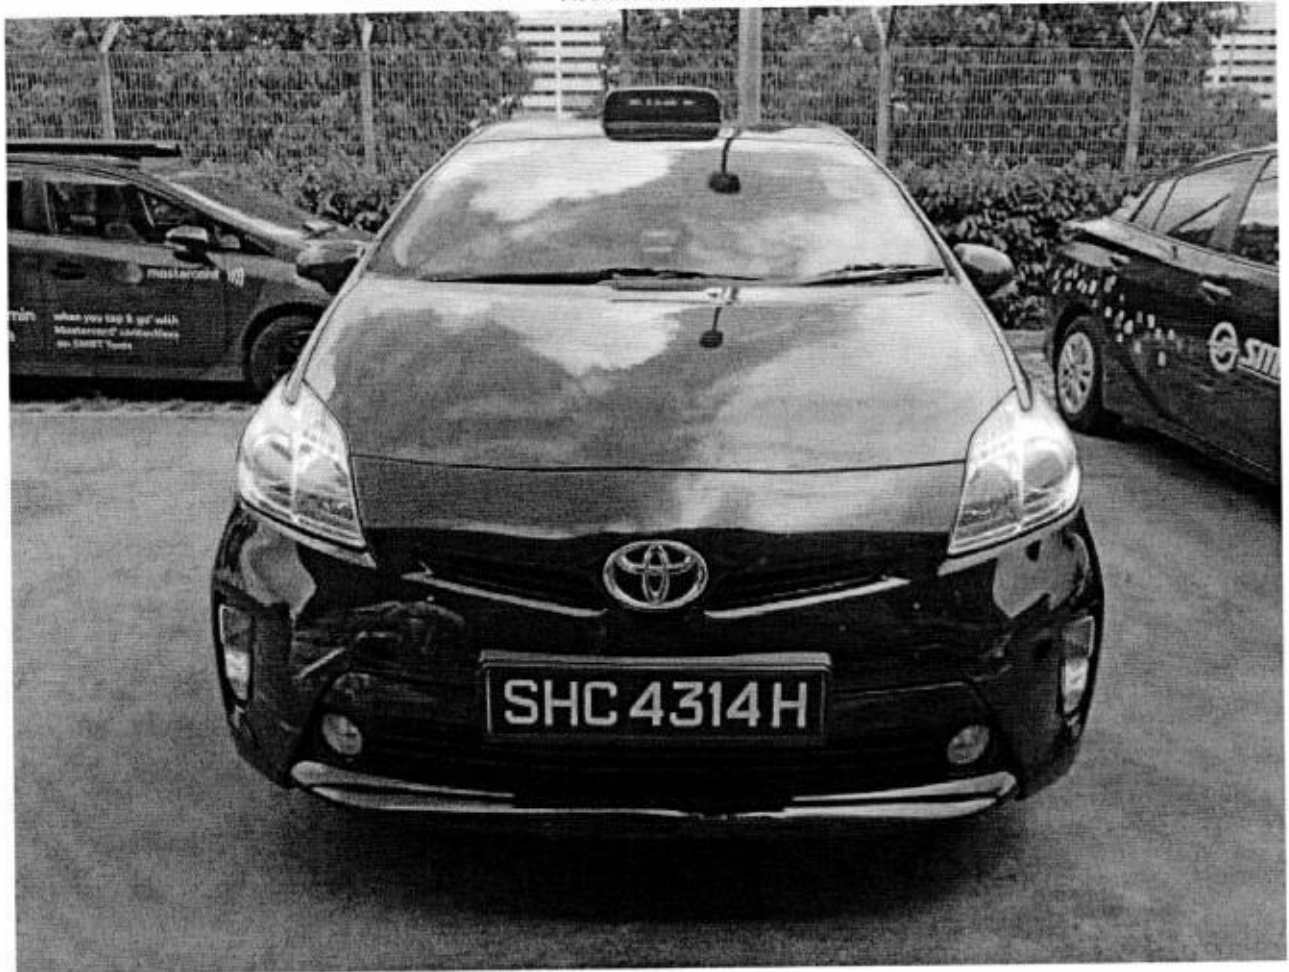
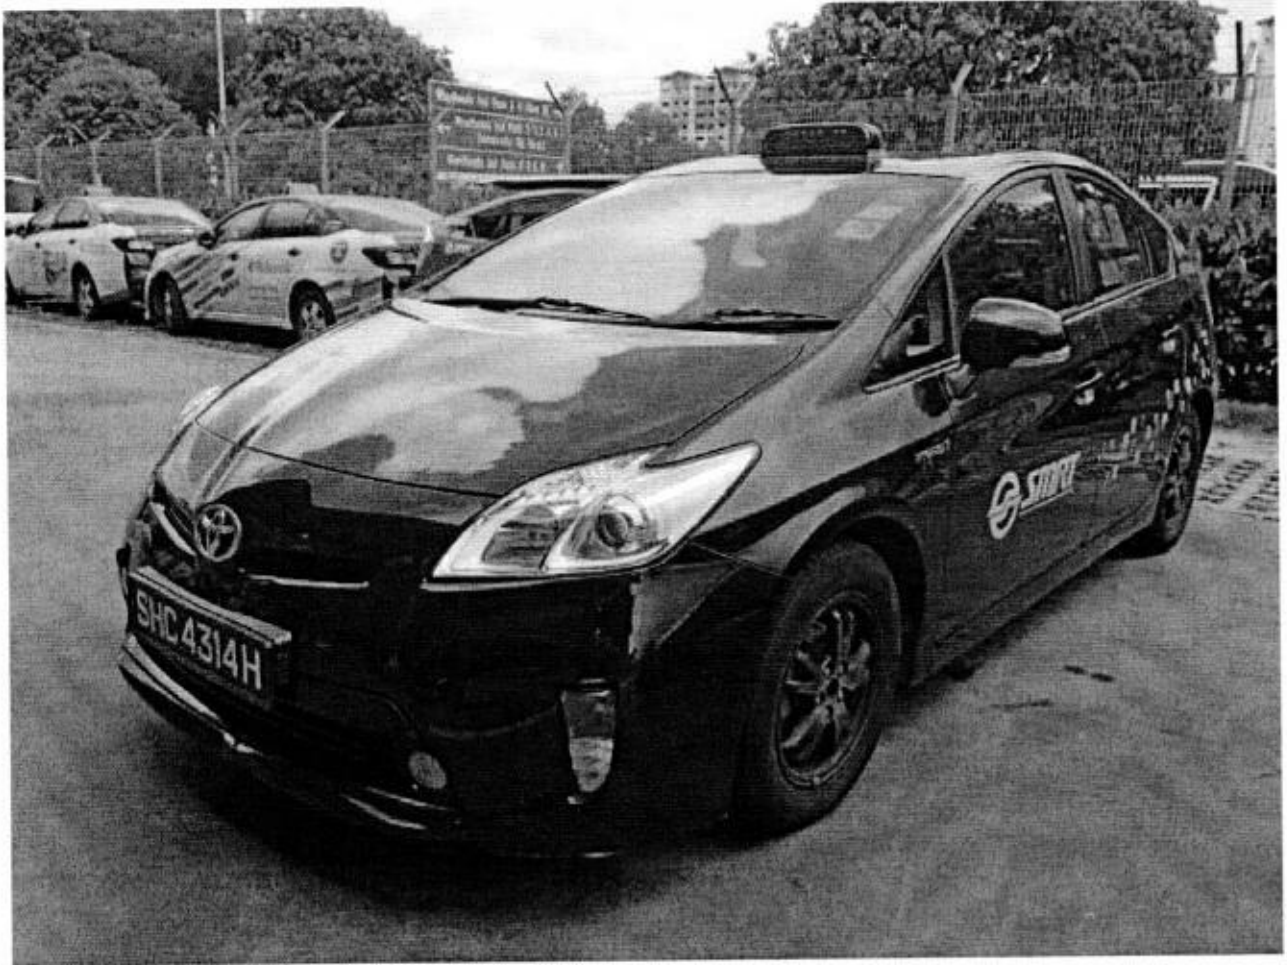
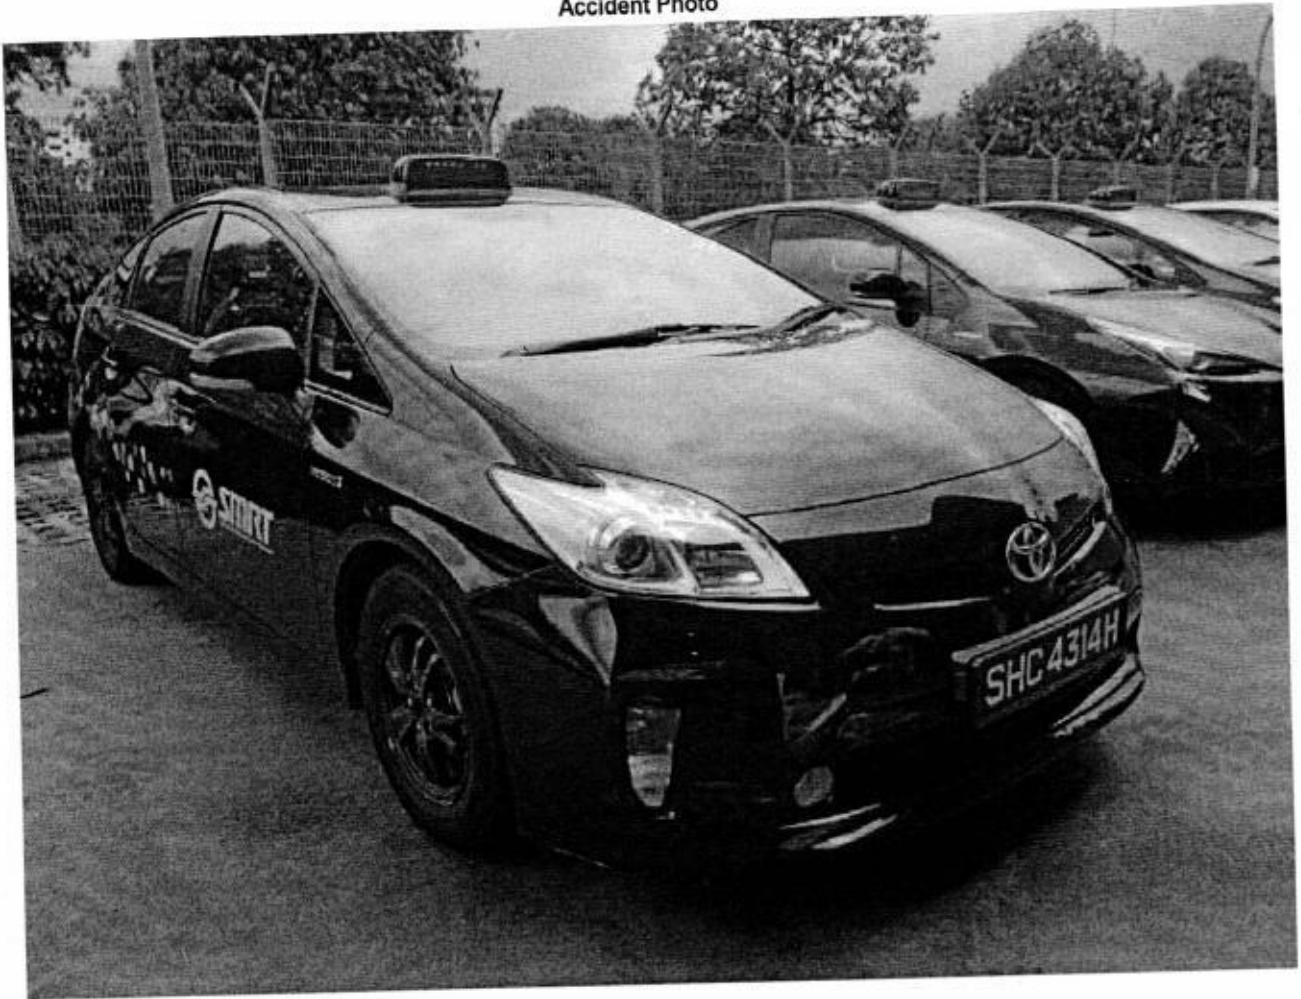
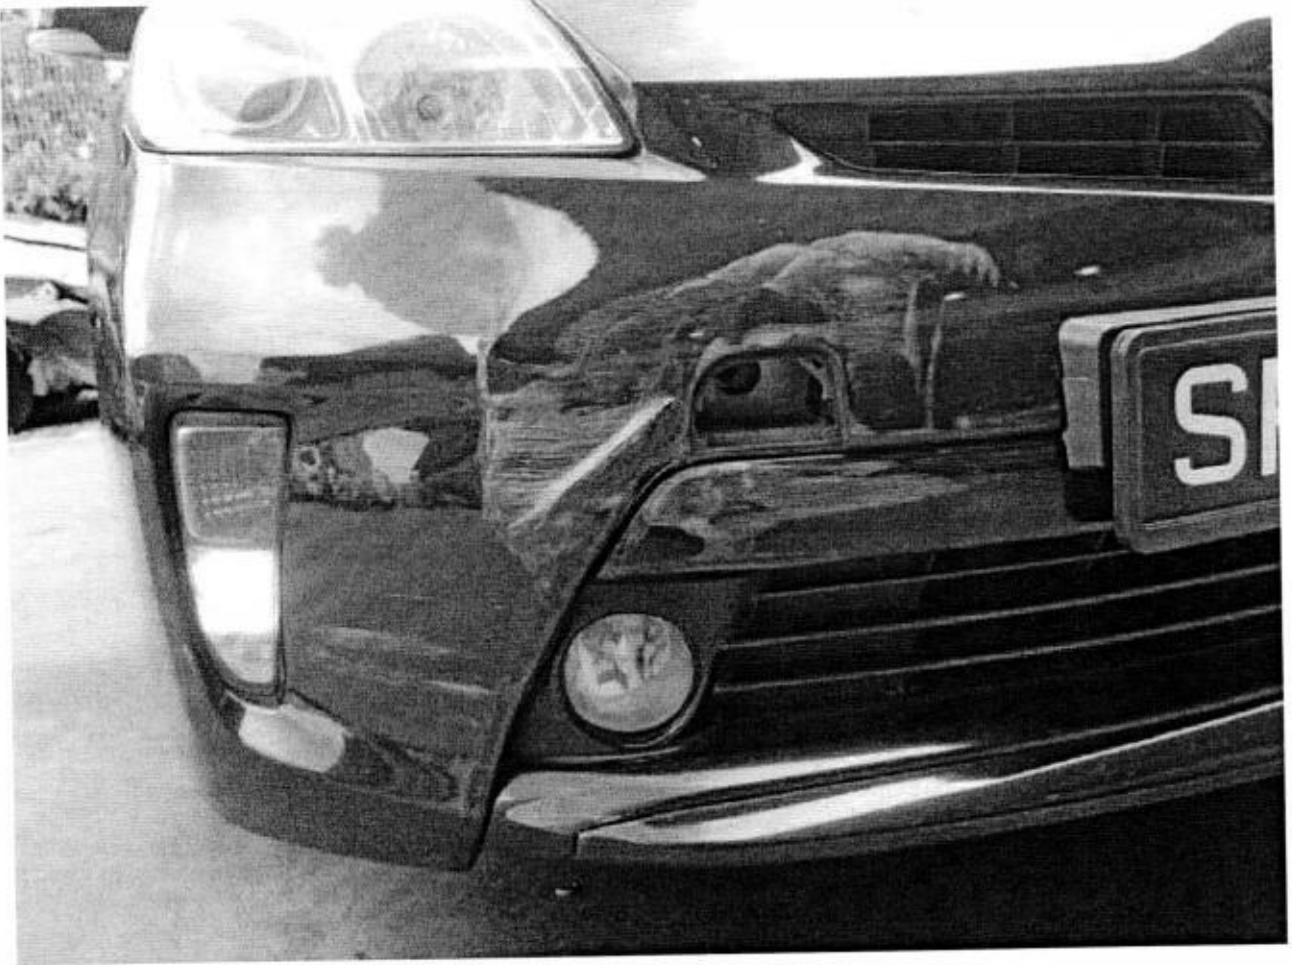
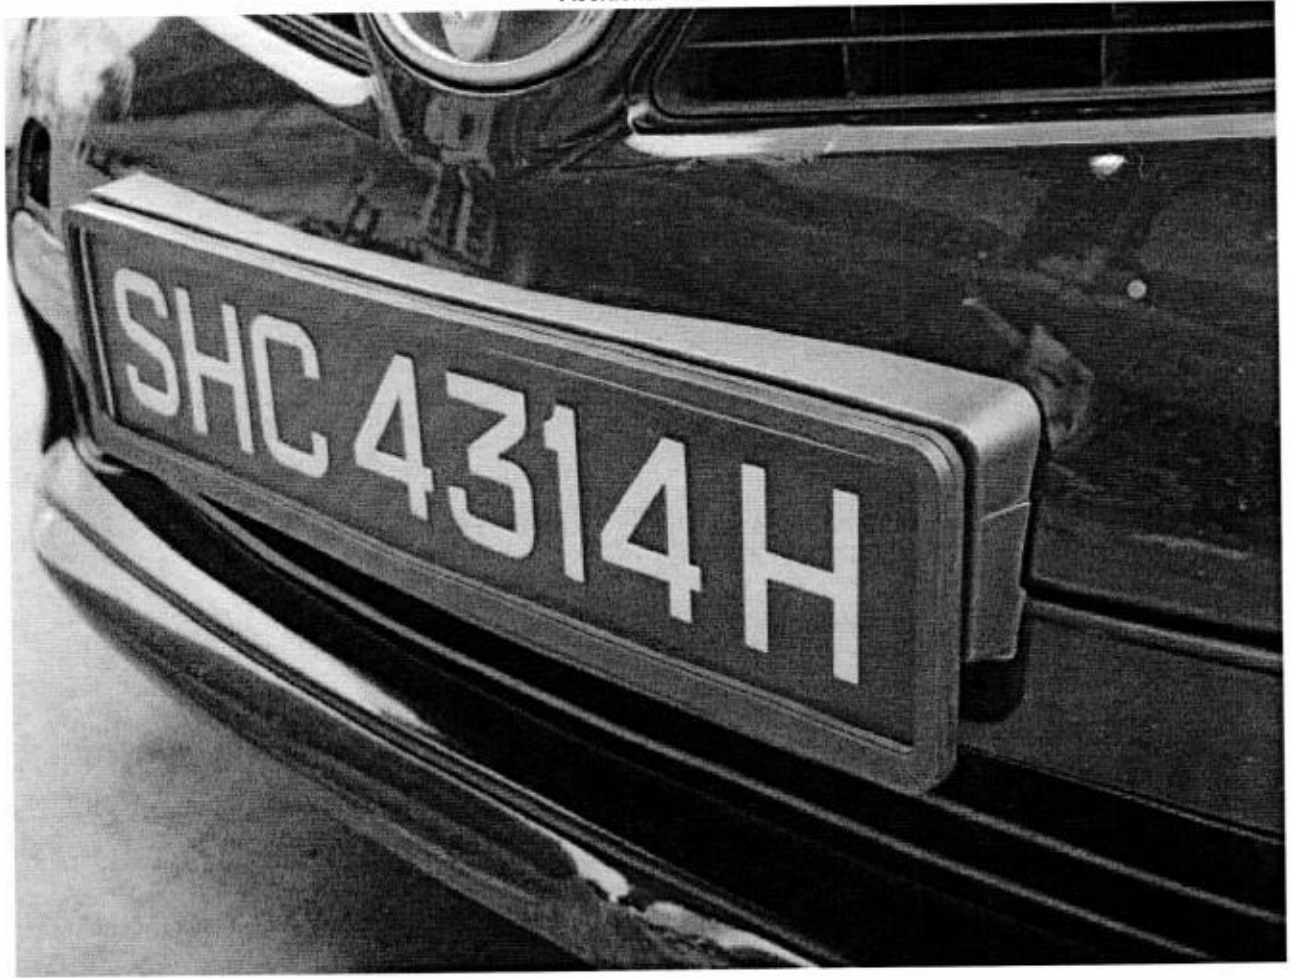
Accident Photo

The U/C / Chassis frame / Body Structure affected due to collision.

I WAS TRAVELLING STRAIGHT ALONG YISHUN RING ROAD AT THE RIGHT LANE WHEN THE VEHICLE SJY9251H SUDDENLY DASHED OUT FROM THE CAR PARK EXIT. THE OTHER PARTY ACTION DID NOT GAVE AMPLE TIME FOR ME TO STOP AND RESULTED IT'S RIGHT PORTION COLLIDED WITH THE FRONT PORTION OF MY TAXI.
