Accident Involving Vehicles SLH1223H & SLE2496X [Your Insured] on 06/03/2018 @
 1510Hrs along SINARAN DRIVE

Estimated Repair Costs For SLH1223H [Toyota Sienta]

VEHICLE DAMAGE INSPECTION REPORT

Our File No: CS/AIG18006047/KQD3Q2

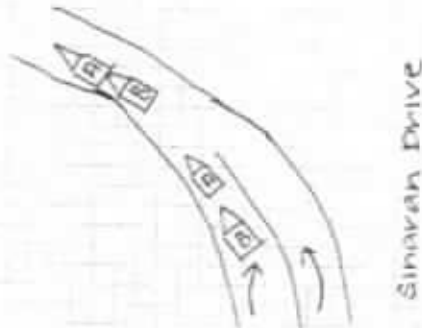
SKETCH PLAN

A : SLH1223H
B : SLE2496X

On 06/03/2018 at around 1510hrs, I WAS travelling along Sinaran Drive.

I came to a stop to give way to vehicles on the major road. After which, the vehicle SLE2496X collided onto the rear portion of my vehicle.
