VEHICLE DAMAGE INSPECTION REPORT

Our File No: CC3/TMI18006122/K1QBN2

Handling Insurer:	Tokio Marine Insurance Singapore Ltd	Policy No:	MI001519
Claimant Vehicle No :	SHD3346S	Insured Vehicle No :	SLG5866G
Date of Loss:	02/04/2018	Nature of Claim:	TP
		Claim No:	M1801735

Reg No:	SHD3346S	Engine No:	D4FDGU660005
Make & Model:	HYUNDAI I40, 1.7 D CRDi (A)	Chassis No:	KMHLB41UMGU092187
Reg. Date:	21/07/2016 (Man. Year: 2016)	Odometer:	178052 km
Colour:	Blue		
Engine Capacity:	1685 cc		
Market Value/New Car Price:	N/A		
Sum Insured (S\$):	Market Value/New Car Price

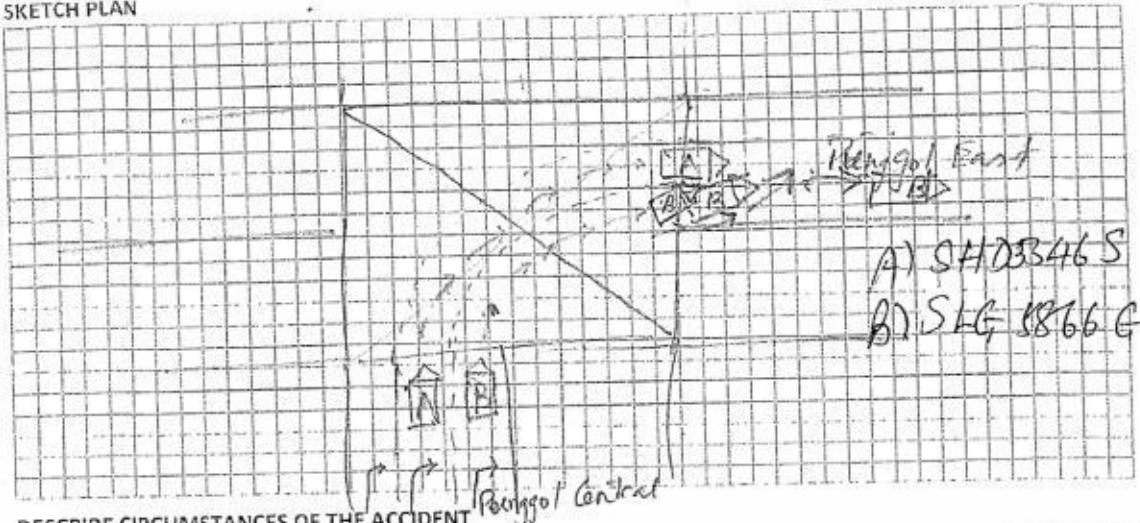
SKETCH PLAN

On 2/4/18 at about 2220hr while I Veh A was making a right turn onto Punggol East within my lane, Veh B from the lane on my right ^{side} lane intercepted into my lane abruptly causing a collision that damaged the right front portion of my vehicle. The ^{damage} stretched towards the whole right front side ^{door} of my vehicle.
