## VEHICLE DAMAGE INSPECTION REPORT

Our File No: CS/CT118006248/ACD3N2  
Date: 17/02/2020

Handling Insurer: China Taiping Insurance (Singapore) Pte. Ltd. Policy No: DMPCSN3043611705  
Claimant Vehicle No: SKA4647Y Insured Vehicle No: SJK8464R  
Date of Loss: 30/03/2018 Nature of Claim: TP Claim No: SNM18D01684C02

Reg No: SKA4647Y  
Make & Model: VOLKSWAGEN TOURAN, 2.0 TSI (A) Engine No: CAV258956  
Reg. Date: 02/03/2011 (Man. Year: 2010) Chassis No: WVGZZZ1TZBW053512  
Colour: Grey Odometer: 125326 km  
Engine Capacity: 1390 cc  
Market Value/New Car Price: N/A  
Sum Insured (S\$): Market Value/New Car Price

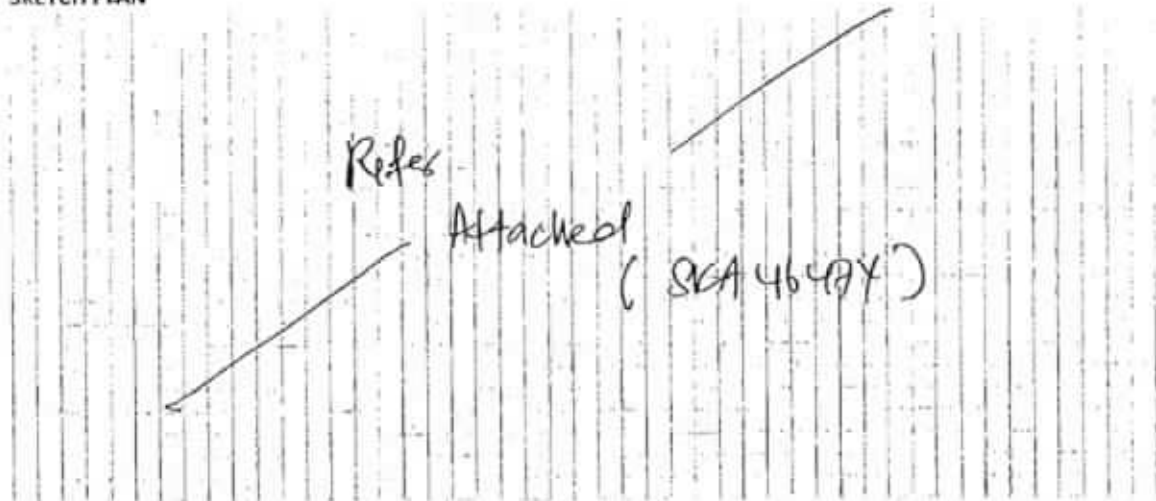
## SKETCH PLAN

At On 30/03/18, at about 1640hrs, I was travelling along the Malaysia's C1Q after exiting from the custom clearance counter. I was travelling straight when a car SJK 8964R (MITSUBISHI LANCER) exit from one of the custom counter and hit my <sup>front</sup> right fender, bumper.
