# LKK Auto Consultants Pte Ltd

## 1. Policy Particulars :- THIRD PARTY CLAIM

## VEHICLE DAMAGE INSPECTION REPORT

Claimant Vehicle No : SHD4000H

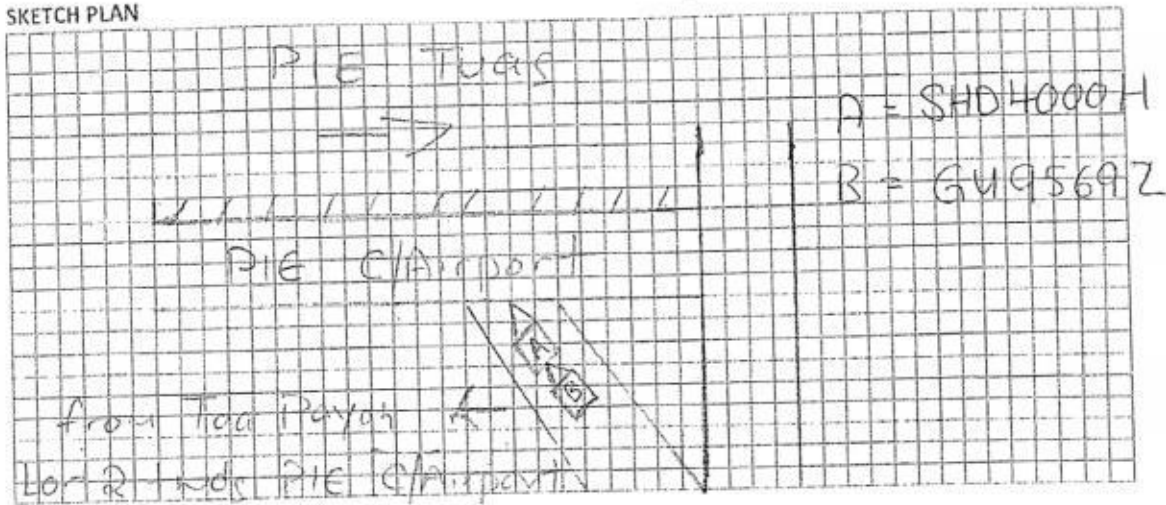
## SKETCH PLAN

On 4/4/18 at abt 1625hrs, I was driving from Slip Rd of Toa Payoh Lor 2 towards PIE Changi Airport. My Vehicle A was stationary at the give way line. Suddenly Vehicle B hit my rear portion. One female passenger was on board. No injury reported.
