## VEHICLE DAMAGE INSPECTION REPORT

Our File No: CS/CT118006313/UQD3N2

Handling Insurer:	China Taiping Insurance (Singapore) Pte. Ltd.	Policy No:	DMPCSN1650561701
Claimant Vehicle No :	SLN7832D	Insured Vehicle No :	SLE6124T
Date of Loss:	26/03/2018	Nature of Claim:	TP
		Claim No:	SNM18D01626C02

Reg No:	SLN7832D	Engine No:	2ZR8018767
Make & Model:	TOYOTA C-HR HYBRID, 1.8 S CVT (A)	Chassis No:	ZYX102007423
Reg. Date:	17/05/2017 (Man. Year: 2017)	Odometer:	17158 km
Colour:	Black		
Engine Capacity:	1797 cc		
Market Value/New Car Price:	N/A		
Sum Insured (S\$):	Market Value/New Car Price

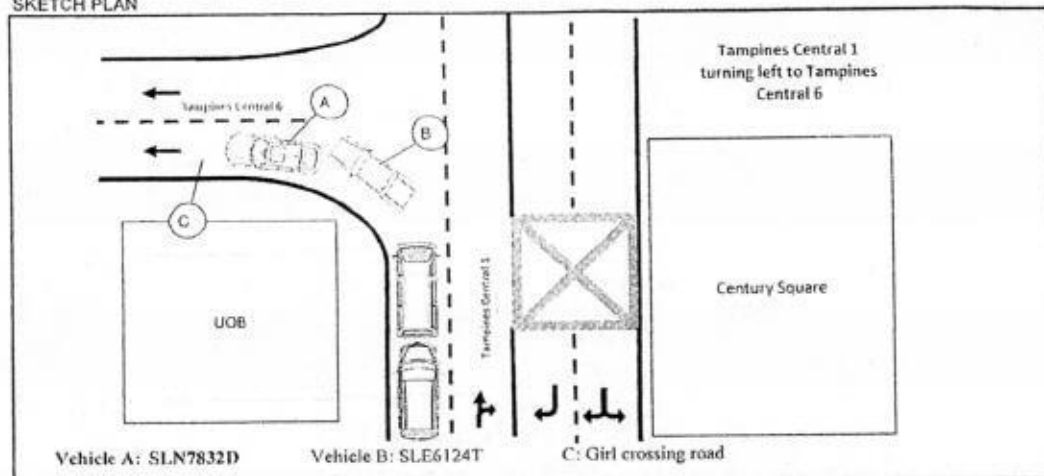
## SKETCH PLAN

I was making a left turn from Tampines Central 1 to Tampines Central 6. While making the left turn, I was slowing down and I got to stop my car as there was a girl crossing the road illegally disregarding oncoming traffic. Vehicle B which was behind me suddenly collided onto the right rear of my car.
