Affiliated to Federation Internationale Des Experts En Automobile				
BONNIE KWOK LLC		Ref : CS1/LAW18006384/Lvb		
101A UPPER CROSS ST #08-12 PEOPLE'S PARK CTRSINGAPORE 058357		Date : 06-04-2018		 
		Code : L094		
<b>1. Policy Particulars :- PAPER SURVEY</b>				
Insured Veh.	SJX 8533G	Veh. Inspected	PC 3229H	
Policy No.	DAI.17.0196.WT.lsm	Coverage (\$)	0.00	
Claim No.	BK.17784.17	Excess (\$)	0.00	
Assign From	ST	Assign Date	28/02/2018	
<b>2. Vehicle Particulars &amp; Condition</b>				
Make & Model		c.c	0	
Engine No.	HIDDEN	Year of Reg.		
Chassis No.		Colour		
Odometer	-	Steering		
Brakes		Modification		
General				
<b>3. Conditions of Tyres</b>				
	Size	Make	Balance	
R/H Front Tyre			mm	
L/H Front Tyre			mm	
R/H Rear Tyre			mm	
L/H Rear Tyre			mm	
<b>4. Description of Damages</b>				
<b>5. General Information</b>				
Accident Date	07/03/2017	Inspection Date	06/04/2018	
Survey held at	ENG SOON PAINTING SVC BLK 4 YEW TEE IND EST 393 - J WOODLANDS ROAD SINGAPORE 677969

## VEHICLE DAMAGE INSPECTION REPORT

## ADJUSTMENT ON REPAIR COST FOR VEHICLE NO. PC 3229H

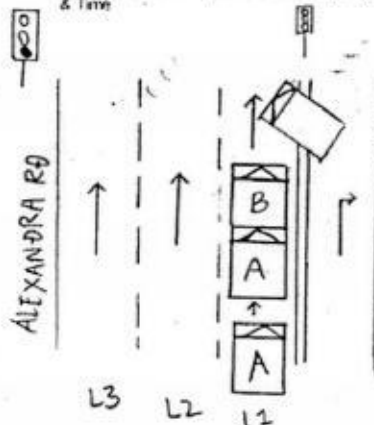
Sketch Plan

SJX 85336

After the accident, we alighted from our vehicles to check on the damages. We exchanged our particulars. I offered the driver of PC3229H private settlement and we agreed verbally. After I repaired my car, on 14.03.2017, the driver of PC3229H SMSed me that his boss wanted to report the accident. At the material time of the accident, nobody was injured.
