To Inspect Vehicle No. SLW 692P

LKK Auto Consultants Pte Ltd

1. Policy Particulars :- OWN DAMAGE

VEHICLE DAMAGE INSPECTION REPORT

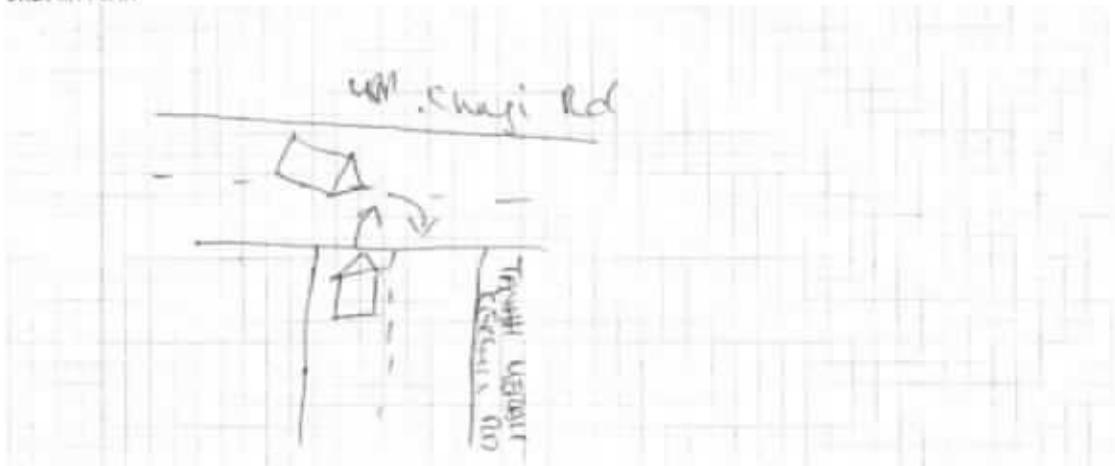
SKETCH PLAN

At 1910 hrs, I was travelling towards Upper Chayji Rd from Townh which Kachil rd. I turn right and a car SP# 86264 turn right at Upper Chayji rd, but my front right tyre stop & rolled left to inspect damages and exchange particulars
