VEHICLE INSPECTION REPORT

Reg No: GBC 8187 C

Make & Model: Isuzu NHR85 AUE4AC

VEHICLE DAMAGE INSPECTION REPORT**Our File No:** CS3/MSG18000313/GRBE2-1**Date:** 31/05/2018REFERENCE

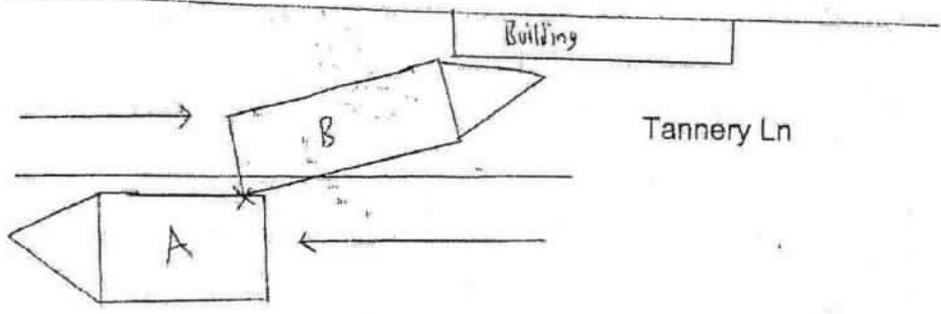
Sketch Plan

I WAS STATIONARY AT Tannery LN WHICH WAS A TWO WAY TRAFFIC WAITING FOR THE TRAFFIC TO BE CLEAR BEFORE MOVING OFF. SUDDENLY VEHICLE B YP741P FROM THE OPPOSITE LANE TURN INTO A WAREHOUSE BUILDING AND VEHICLE B REAR PORTION SIDE-SWIPE ONTO MY REAR RIGHT SIDE OF MY VEHICLE WHILE HE WAS TURNING IN.

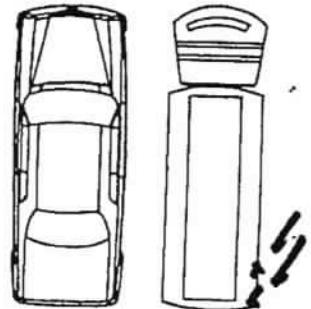
IMPACT: ARROW INDICATES
DIRECTION OF IMPACT.

The impact was confined to the rear o/s portion of the vehicle.

The above vehicle sustained damaged were rear o/s lower garnish - bent.
