### 1. Policy Particulars :- THIRD PARTY CLAIM

**Preliminary Advice**

REPAIR ESTIMATE FOR SGV8820Z

## VEHICLE DAMAGE INSPECTION REPORT

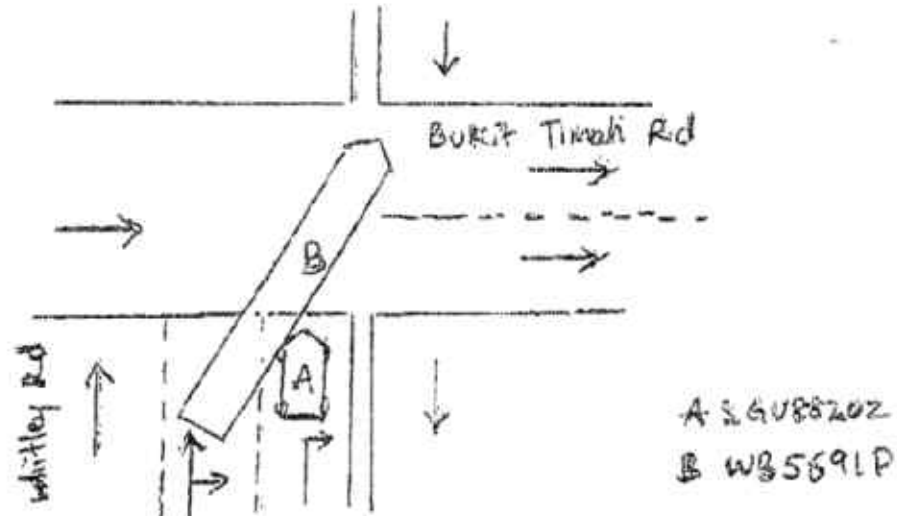
SKETCH PLAN

On the 10th April 2018 at 8.03 am, I Leong Zhenyong Kuei Rose was at Whitley Rd waiting to turn to Bursat Timah Rd. However vehicle B WB5691P (big and long crane) turn first and hit at the front left side of my vehicle A 2GUB8202 while it was stationary.
