REF: CS/UOL8006782 / Abnz

To Inspect Vehicle No: SLK 4785S Insured: XE 277A

ADJUSTMENT ON REPAIR COST FOR VEHICLE NO. SLK 4785S

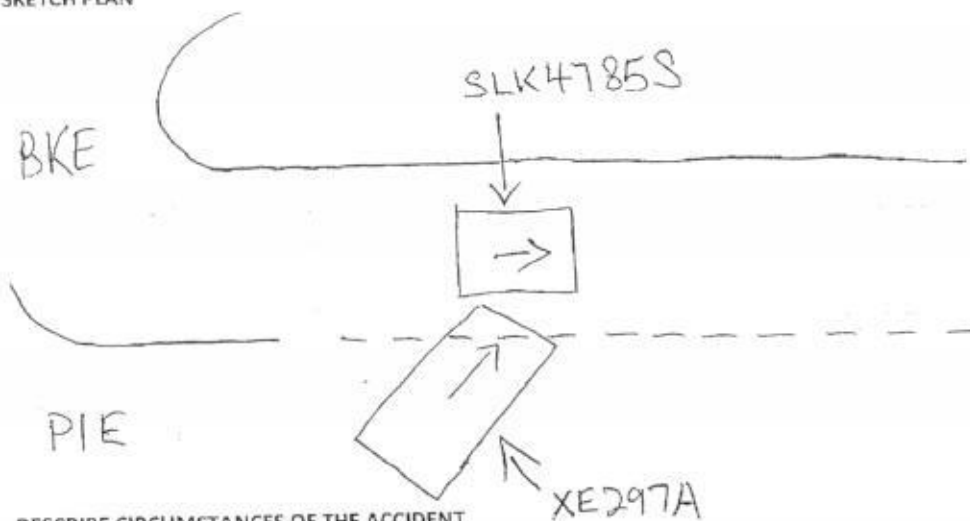
SKETCH PLAN

Out of sudden, a tipper truck, XE297A (green in colour), came from the right lane and side swipe my rear right portion of my car. Due to the collusion, my car was drag for a few distance. After the collusion, I came out of my car and discovered there are some damages on my car. The tipper driver, my passenger and I did not suffer any serious injury.
