Affiliated to Federation Internationale Des Experts En Automobile				
TRANS-CAB AUTO SERVICES PTE LTD		Ref : CS/TP18006938/Kvb		
NO.2 ANG MO KIO STREET 63 SINGAPORE 569111		Date : 16-04-2018	 	
		Code : TP378		
<b>1. Policy Particulars :- THIRD PARTY CLAIM</b>				
Insured Veh.	Veh. Inspected		SHF 628M	
Policy No.	Coverage (\$)		0.00	
Claim No.	Excess (\$)		0.00	
Assign From	Assign Date		13/04/2018	
<b>2. Vehicle Particulars &amp; Condition</b>				
Make & Model	c.c		0	
Engine No. HIDDEN	Year of Reg.			
Chassis No.	Colour			
Odometer -	Steering			
Brakes	Modification			
General				
<b>3. Conditions of Tyres</b>				
	Size	Make	Balance	
R/H Front Tyre			mm	
L/H Front Tyre			mm	
R/H Rear Tyre			mm	
L/H Rear Tyre			mm	
<b>4. Description of Damages</b>				
<b>5. General Information</b>				
Accident Date	01/04/2018	Inspection Date	13/04/2018	
Survey held at	TRANS-CAB AUTO SERVICES PTE LTD NO.2 ANG MO KIO ST 63 SINGAPORE 569111

Affiliated to Federation Internationale Des Experts En Automobile				
TRANS-CAB AUTO SERVICES PTE LTD			Ref : CS/TP18006938/Kvbn2	
NO.2 ANG MO KIO STREET 63SINGAPORE 569111			Date : 18-04-2018	
			Code : TP378	
<b>1. Policy Particulars :- THIRD PARTY CLAIM</b>				
I

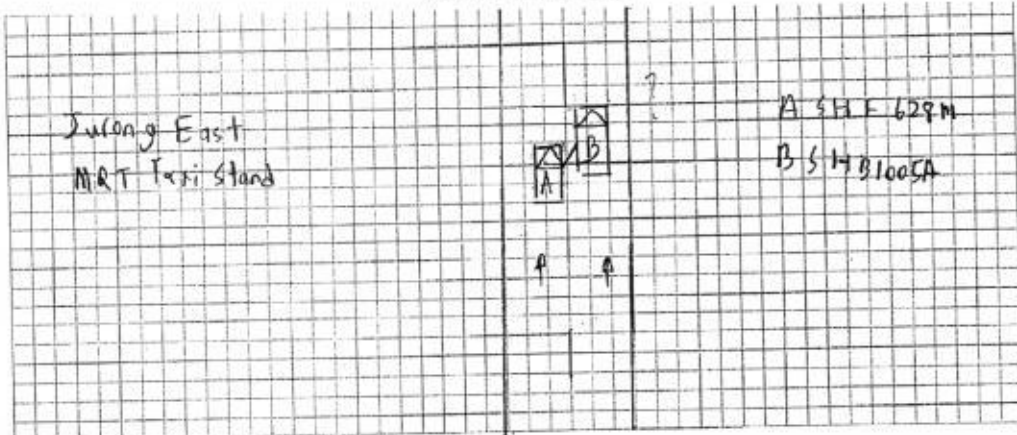
Sketch Plan #2 Pg. 1

ON 01.04.2018 AT AROUND 0851HRS, I WAS TRAVELLING STRAIGHT TOWARDS JURONG EAST MRT TAXI STAND. I WAS PICKING UP A PASSENGER. AS I WAS DRIVING OFF, VEHICLE B (SHB1005A) WHICH WAS STATIONARY ON MY RIGHT. HIS PASSENGER OPEN LEFT PASSENGER DOOR AND HIT ONTO MY TAXI RIGHT SIDE FRONT PORTION.
