National Assessment Centre Services

TP Claims against NTUC Income: Follow-Through Survey

THE VEHICLE SUSTAINED DAMAGES AT THE O/S FRONT PORTION. DAMAGES SEE DETAILS.

ADJUSTMENT ON REPAIR COST FOR VEHICLE NO. SHA 5005D

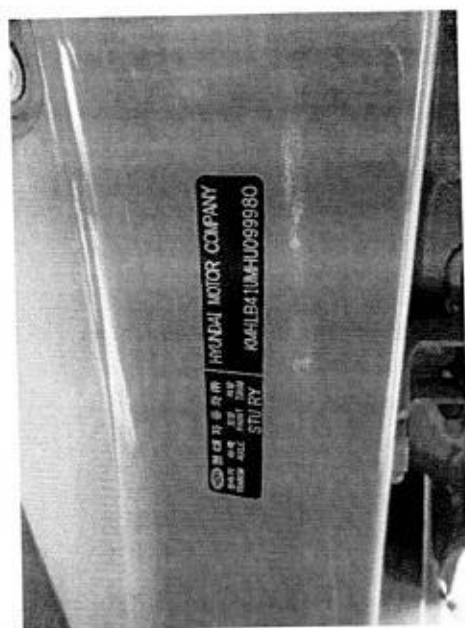
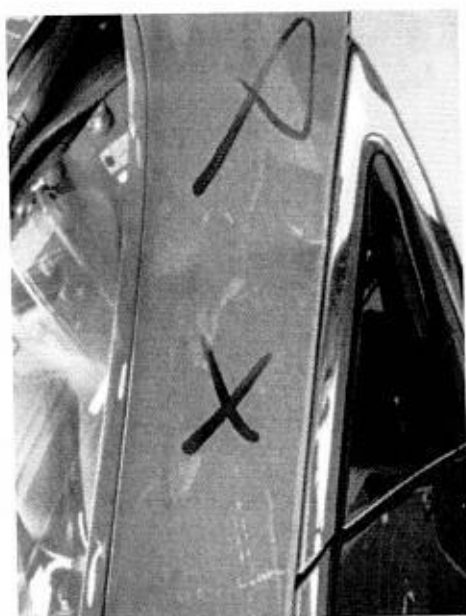
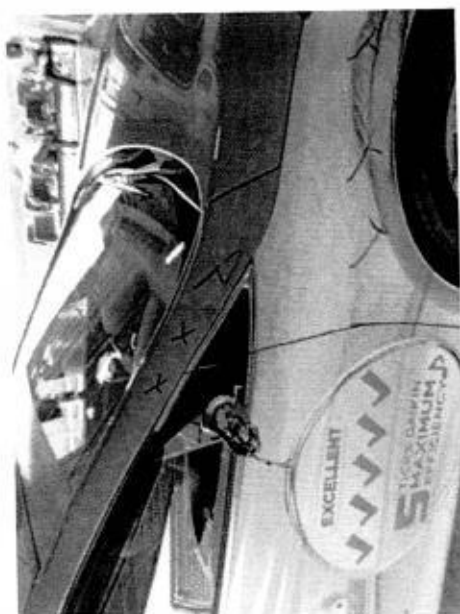
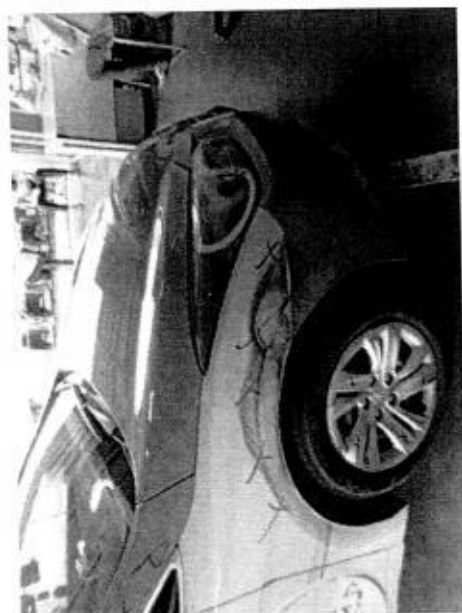
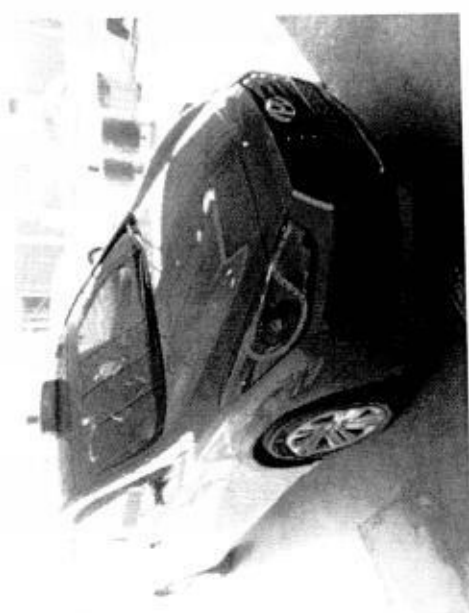
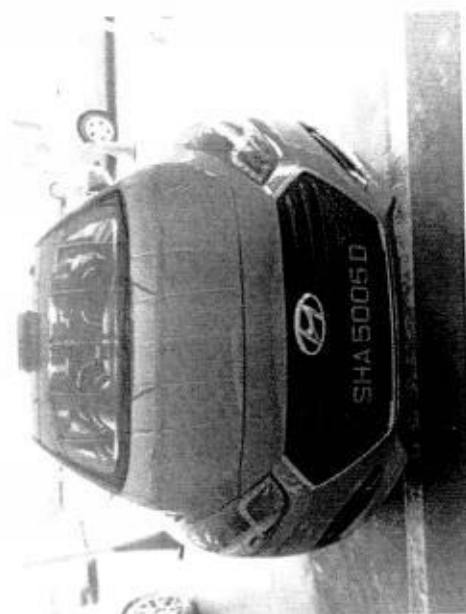
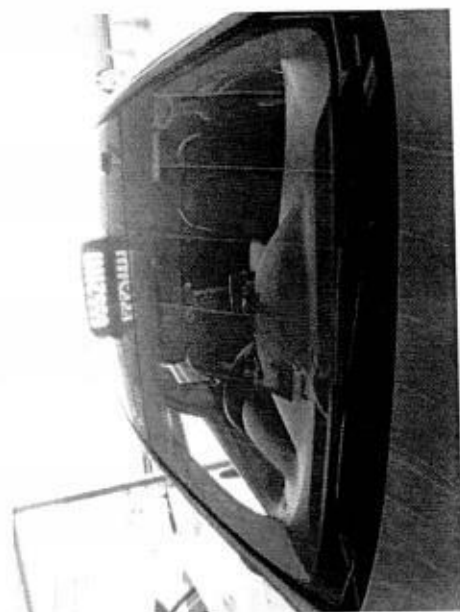
Qty	Description of Parts	Condition	Estimate By Workshop (\$)	Our Adjusted (\$)
<u>REPLACEMENT OF PARTS</u>				
1	FRONT BUMPER COVER	DEFORMED	1,052.20	1,052.20
1	FRONT BUMPER BRACKET (RH)	SERVICEABLE	24.60	-
1	FRONT DOOR MIRROR (RH)	BROKEN	980.50	980.50
1	FRT WHEEL HUB CAP (RH)	GRAZED	150.70	150.70
1	FRONT PILLAR (RH)(NPA)	TO REPAIR	-	-
1	FRONT RH FENDER (NPA)	TO REPAIR	-	-
	LESS 20% DISCOUNT		-441.60	-436.68
			1,766.40	1,746.72
<u>SPECIAL NETT ITEMS</u>				
1	FRT FENDER ADVERTISEMENT LOGO (RH)(SN)	NECESSARY	100.00	100.00
			100.00	100.00
<u>LABOUR</u>				
	THATCHAM STANDARD REPAIR TIME ON BODY WORKS.		630.00	420.00
	THATCHAM TTS STANDARD SPRAY PAINTING COST AND LABOUR.		950.00	650.00
			1,580.00	1,070.00
GRAND TOTAL			3,446.40	2,916.72
RECOMMENDED COST OF REPAIRS (CONFIRMED)				2,916.72
