TO	: AXA INSURANCE	DATE	: 17/04/2018
ATTENTION	: MOTOR CLAIMS DEPT	JOB TYPE	: T/P CLAIM
ESTIMATE REPORT :			
<u>VEHICLE DETAILS</u>			
VEHICLE NO	: SLR2230C	WDD2050402R285020	
MODEL	: MERCEDES BENZ C180	Denise	
CHASSIS NO			
<u>ACCIDENT DETAILS</u>		DATE	: 14-Apr-18
		TIME	: 21:50HRS
THIRD PARTY REQUESTOR / CONTACT : JACK LI

Affiliated to Federation Internationale Des Experts En Automobile				
MG SOLUTION PTE LTD		Ref : CS/TP18007183/Atbn2		
23 KAKI BUKIT AVE 4 (SOUTH WING) #02-03B VICOM INSPECTION CENTRESINGAPORE 415933		Date : 03-08-2018

## ADJUSTMENT ON REPAIR COST FOR VEHICLE NO. SLR 2230C

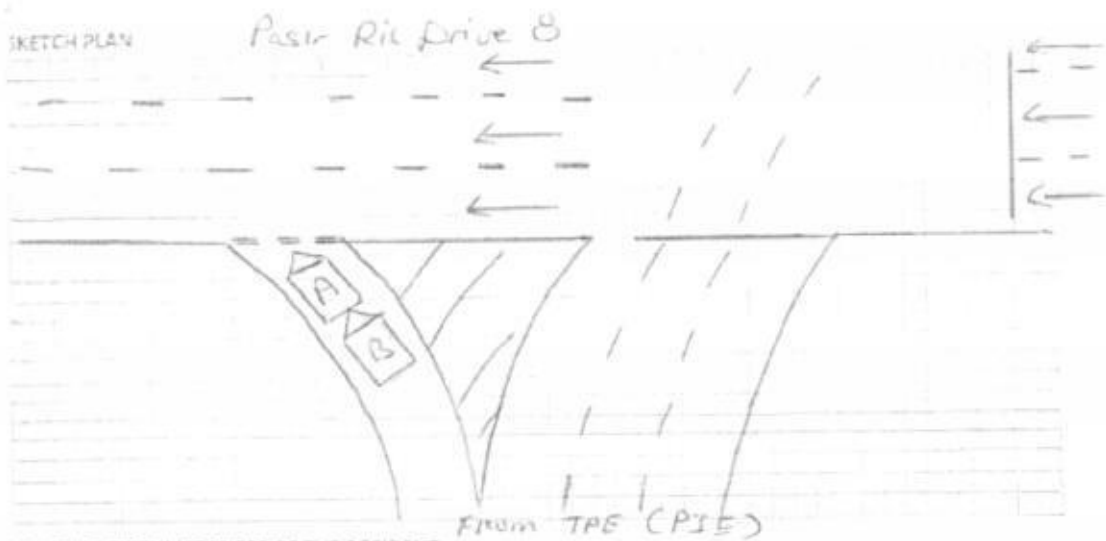
# Individual Statement

On 14/04/2018 at about 2150 hrs at Slip Road from TPE (PSE) towards Pasir Ris Drive 8. I was travelling on the above mentioned slip road and came to a stop while giving way to the main traffic along Pasir Ris Drive 8. Suddenly I heard a loud bang from behind and when I alighted, I realised that it was Vehicle (B) who hit onto my Rear Portion of my Vehicle (A) causing damages to my Vehicle.

(A) STR 2230 C

(B) SLT 8298 H
