# National Assessment Centre Services

## 1. Policy Particulars :- THIRD PARTY CLAIM

THE VEHICLE SUSTAINED DAMAGES AT THE N/S BODY. DAMAGES SEE DETAILS.
--

## ADJUSTMENT ON REPAIR COST FOR VEHICLE NO. SHD 3301X

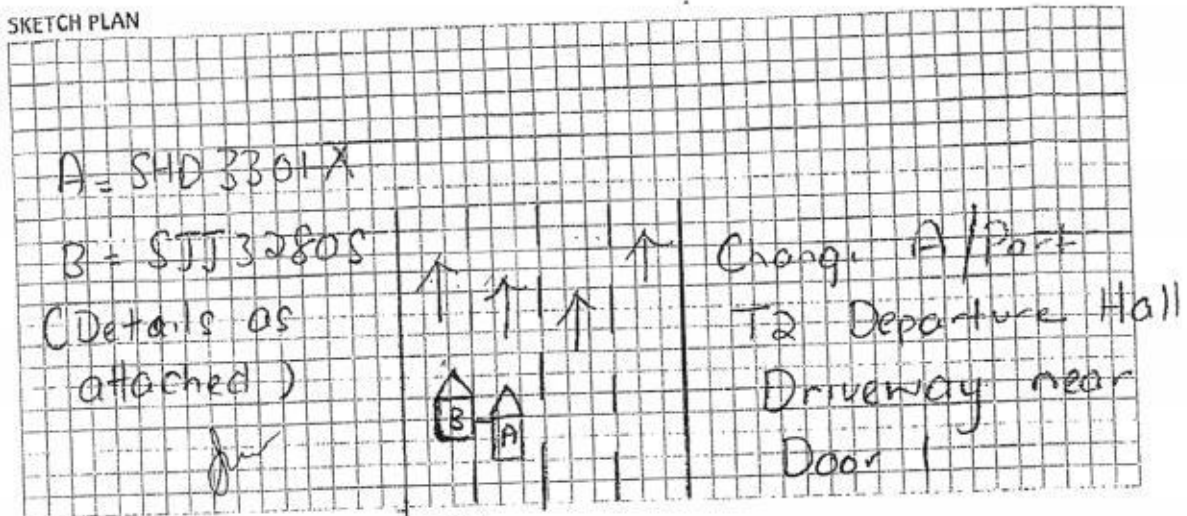
## SKETCH PLAN

On 20/4/18 @ 1730 hrs, I was driving along T2 Departure hall near Door 1 on the second lane from the left. Suddenly a Stationery Vehicle STJ3280S on my left, the passenger opened the right hand side rear door to alight. Due to this, the opened door hit the left hand front including left hand side wing mirror, left hand side front door glass and left hand side rear of my taxi thus damaging them in the process. 01 Male passenger on board my taxi. No injury reported at the point of accident.

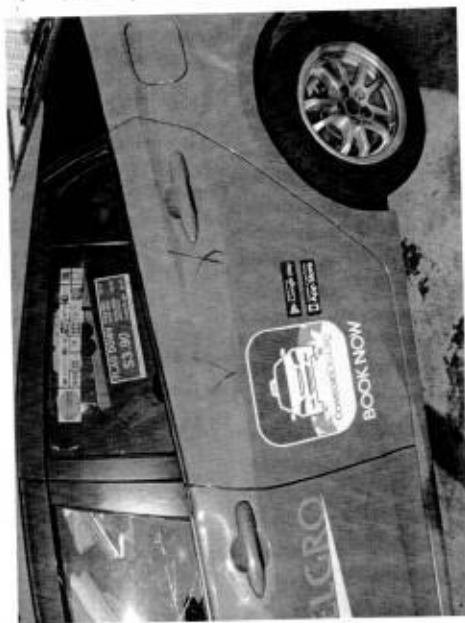
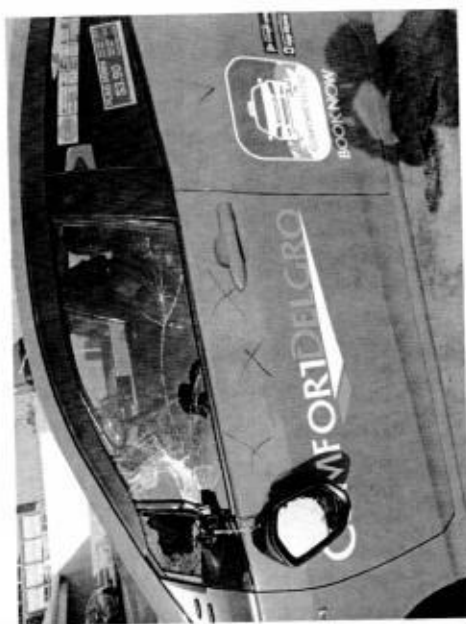
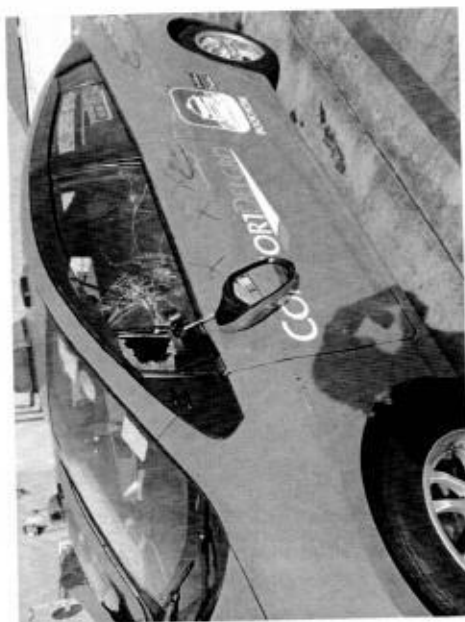
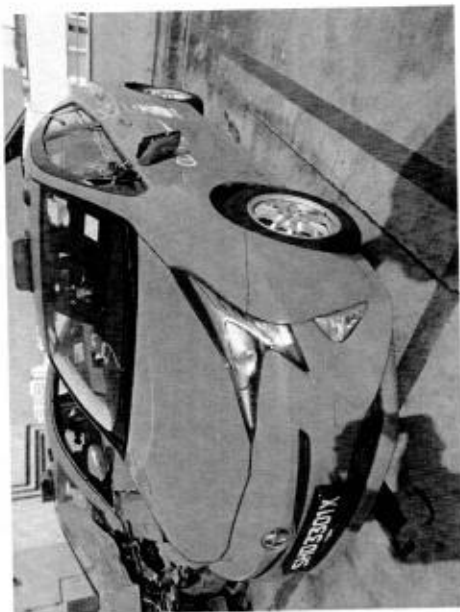
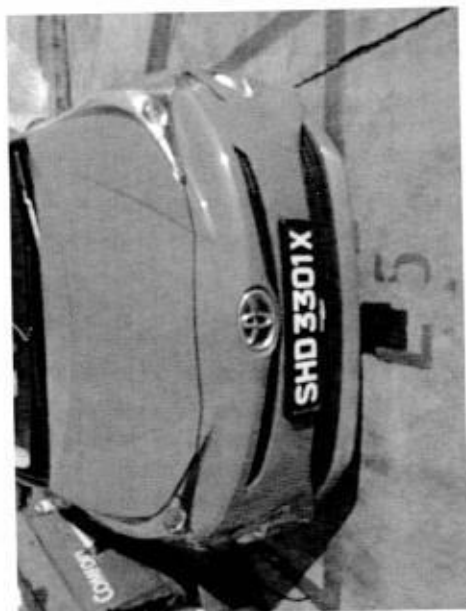
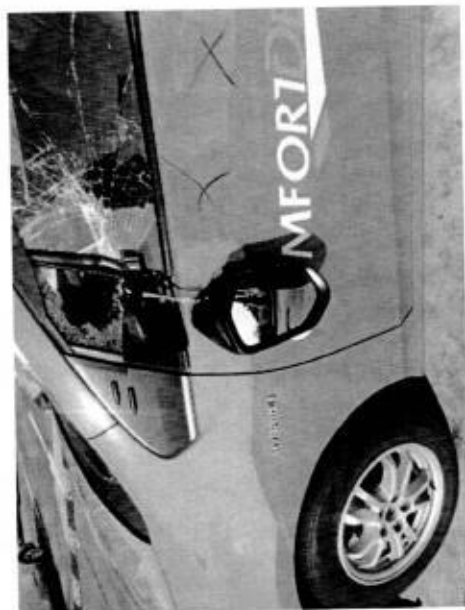
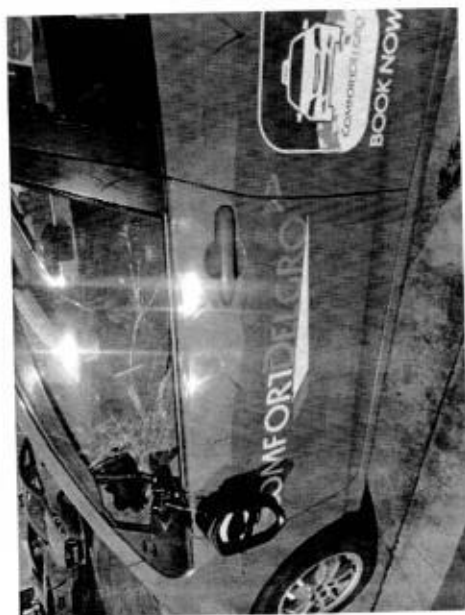
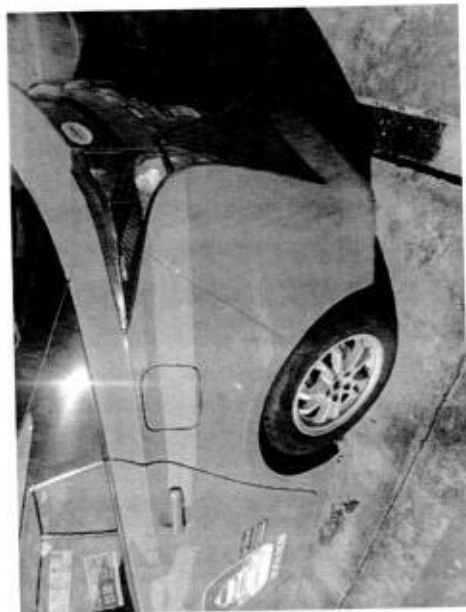
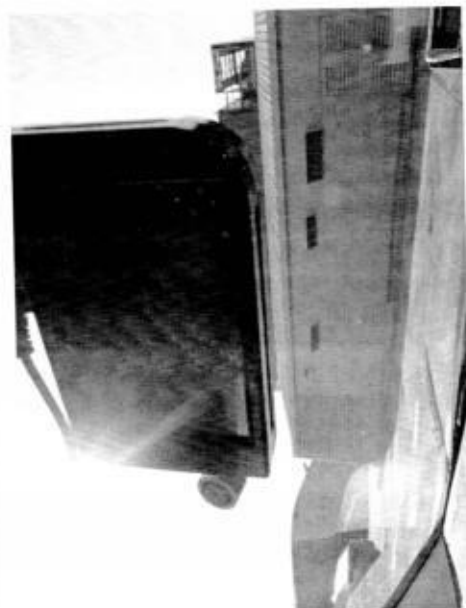
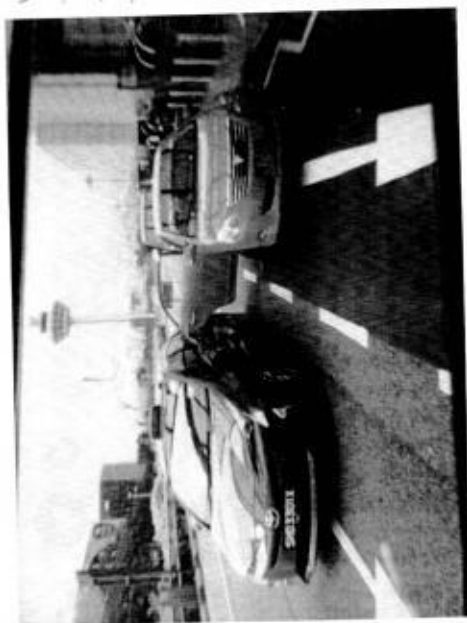
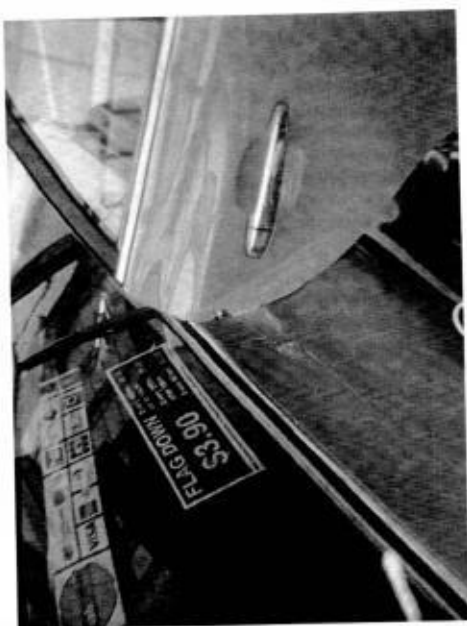
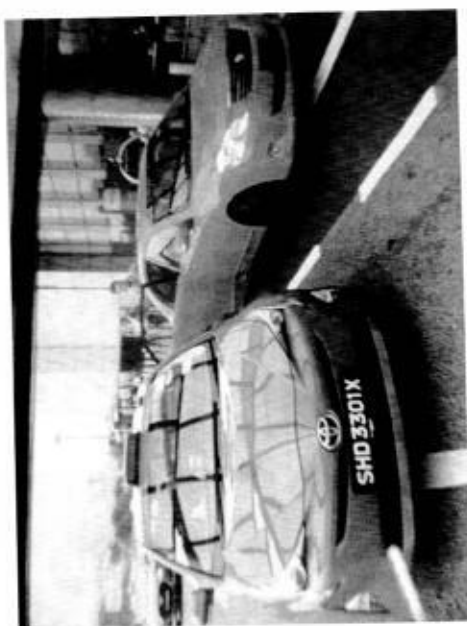
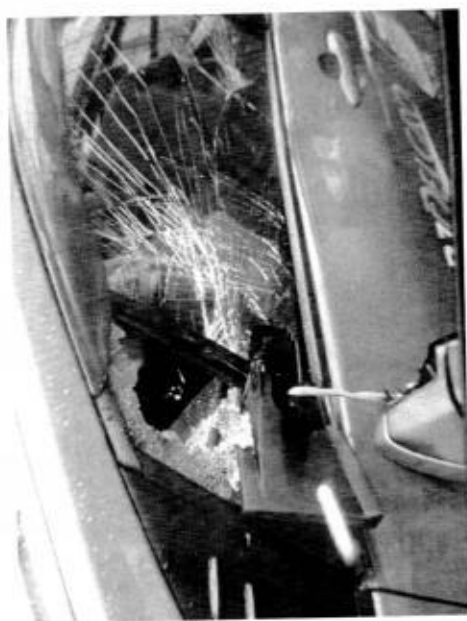
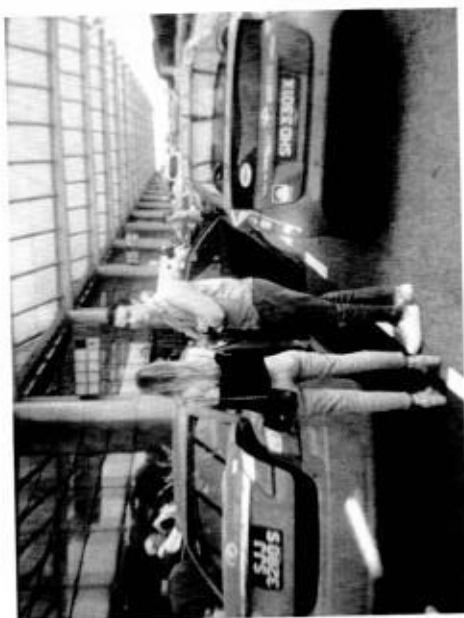
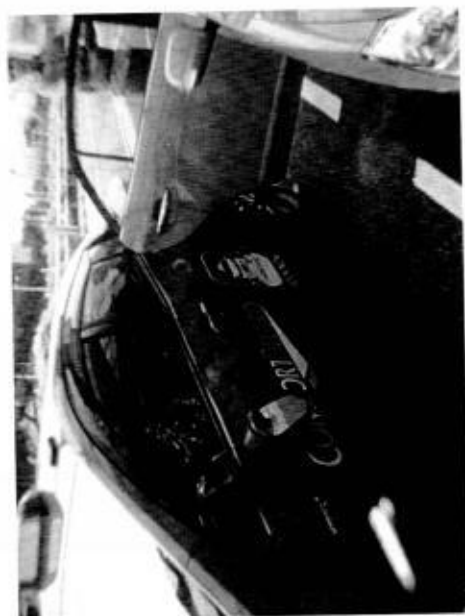
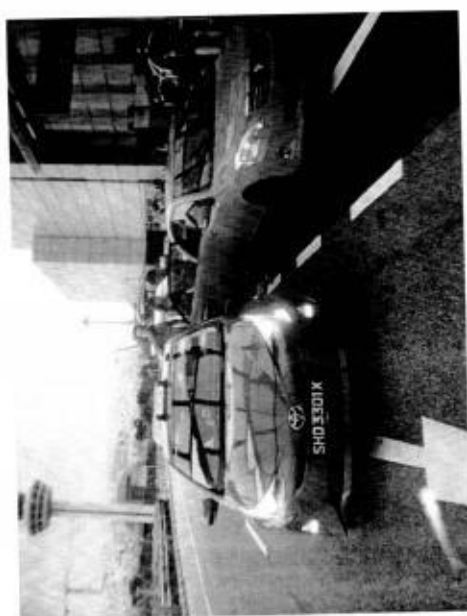
The U/C / Chassis frame / Body Structure affected due to collision.

Qty	Description of Parts	Condition	Estimate By Workshop (\$)	Our Adjusted (\$)
<b>REPLACEMENT OF PARTS</b>				
1	PANEL SUB-ASSY,FRONT DOOR LH	DENTED	1,227.00	1,227.00
1	FRONT DOOR OUTER MOULDING	CUT	188.60	188.60
1	REAR DOOR OUTER HANDLE,LH	TO REPAIR	93.90	-
1	GLASS,SUB-ASSY,FRONT DOOR,LH	SHATTERED	780.50	780.50
1	MIRROR ASSY,OUTER REAR VIEW,LH	BROKEN	1,374.00	1,374.00
1	COVER,OUTER MIRROR,LH	CRACKED	155.70	155.70
1	MIRROR OUTER,LH	CRACKED	212.80	212.80
1	MOULDING,FRONT DOOR WINDOW FRAME,LH	SERVICEABLE	53.70	-
1	REAR DOOR (LH)	DENTED	1,232.80	1,232.80
	LESS 25% DISCOUNT		-1,329.75	-1,292.85
			3,989.25	3,878.55
<b>NETT ITEMS</b>				
1	FRONT DOOR COMFORT LOGO (N)	NECESSARY	75.00	75.00
1	REAR DOOR COMFORT & APPS STICKER (N)	NECESSARY	80.00	80.00
	LESS 10% DISCOUNT		-	-15.50

155.00	139.50
<b>LABOUR</b>				
	THATCHAM STANDARD REPAIR TIME ON BODY WORKS.		520.00	320.00
	THATCHAM TTS STANDARD SPRAY PAINTING COST AND LABOUR.		700.00	470.00
			1,220.00	790.00
<b>GRAND TOTAL</b>			<b>5,364.25</b>	<b>4,808.05</b>
<b>RECOMMENDED COST OF REPAIRS (CONFIRMED)</b>				<b>4,808.05</b>
