REF: NS/INC18007474/KHbn2

# National Assessment Centre Services

Code: INC4			
<b>1. Policy Particulars :- THIRD PARTY CLAIM</b>			
Insured Veh.	GY 734B	Veh. Inspected	SHD 3440C
Policy No.	5047861571-07	Coverage (\$)	0.00
Claim No.	MT/0991206-002	Excess (\$)	0.00
Assign From		Assign Date	23/04/2018
<b>2. Vehicle Particulars &amp; Condition</b>			
Make & Model	TOYOTA PRIUS	c.c	1798
Engine No.	HIDDEN	Year of Reg.	2017
Chassis No.	JTDKB3FUX03557611	Colour	BLUE
Odometer	162638	Steering	IN ORDER
Brakes	IN ORDER	Modification	STANDARD ALLOY RIM
General	GOOD		
<b>3. Conditions of Tyres</b>			
	Size	Make	Balance
R/H Front Tyre	195/65 R15	BRIDGESTONE	7 mm
L/H Front Tyre	195/65 R15	BRIDGESTONE	7 mm
R/H Rear Tyre	195/65 R15	BRIDGESTONE	7 mm
L/H Rear Tyre	195/65 R15	BRIDGESTONE	7 mm
<b>4. Description of Damages</b>			
THE VEHICLE SUSTAINED DAMAGES AT THE O/S REAR PORTION. DAMAGES SEE DETAILS.

## ADJUSTMENT ON REPAIR COST FOR VEHICLE NO. SHD 3440C

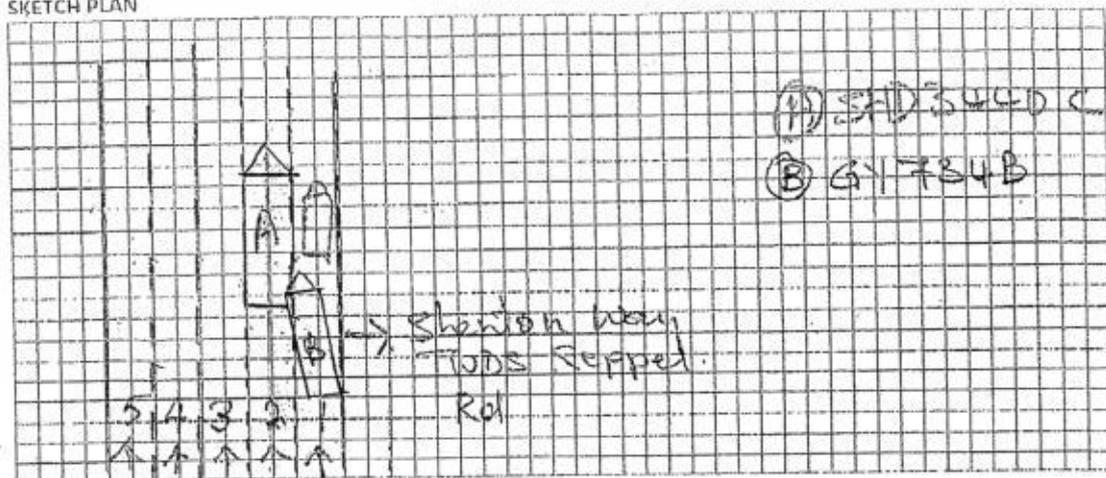
SKETCH PLAN

On 20/4/2018 at about 1320 hrs, I vehicle A was driving along Shenton way toward Keppel road. While I was on the second a-d going straight following a bus behind, suddenly vehicle B came from my right and sway into my lane brushes against my taxi right rear portion. No one was injured at that time.

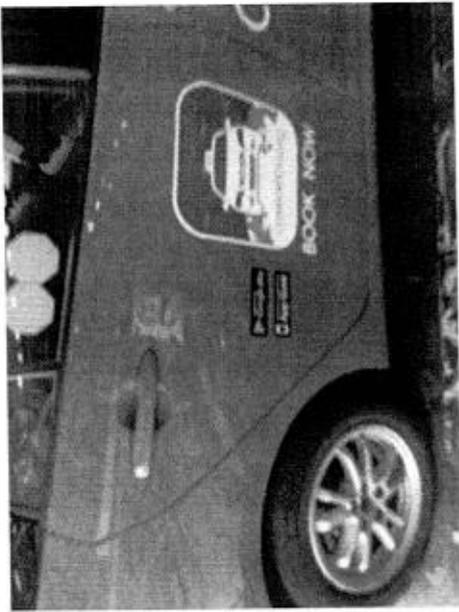
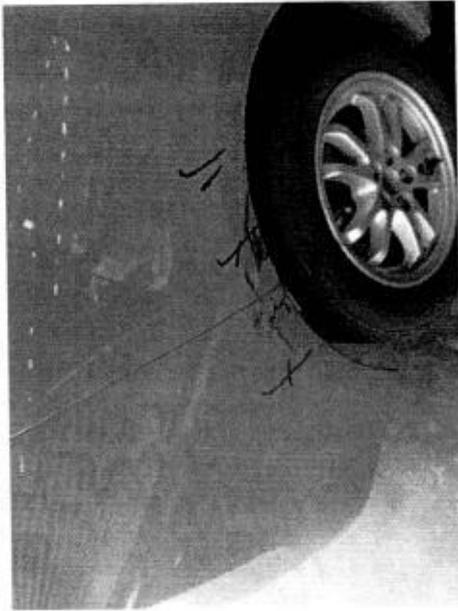
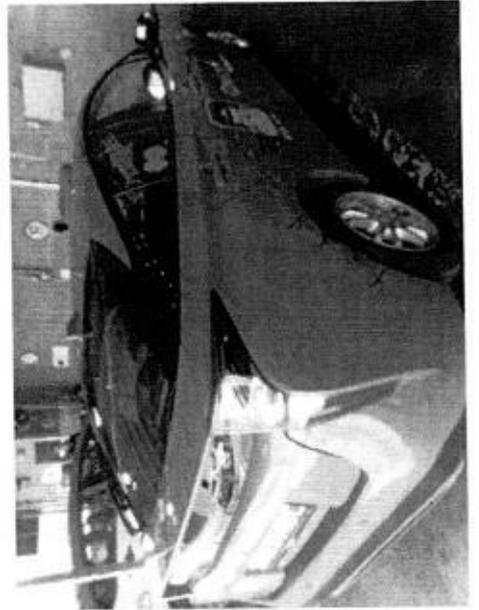
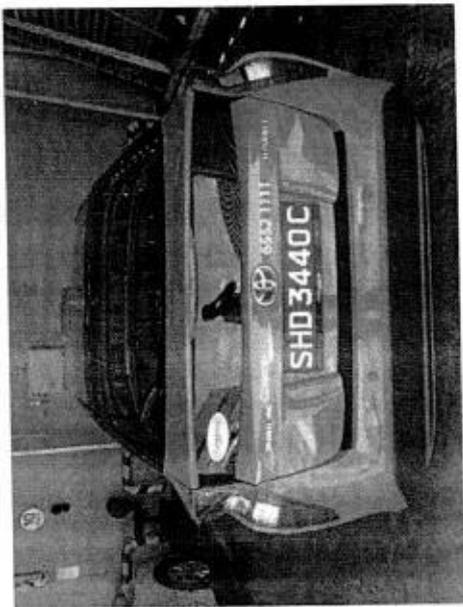
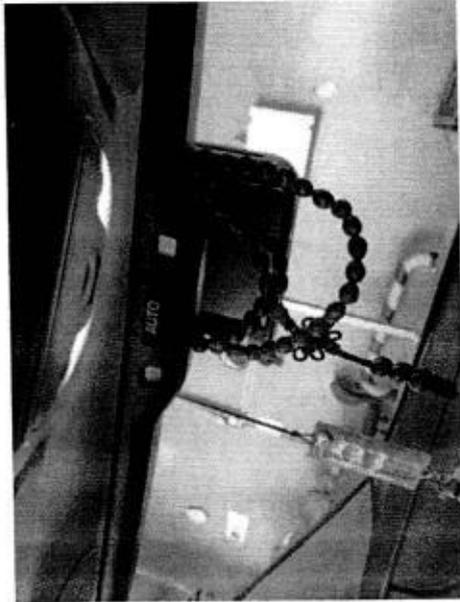
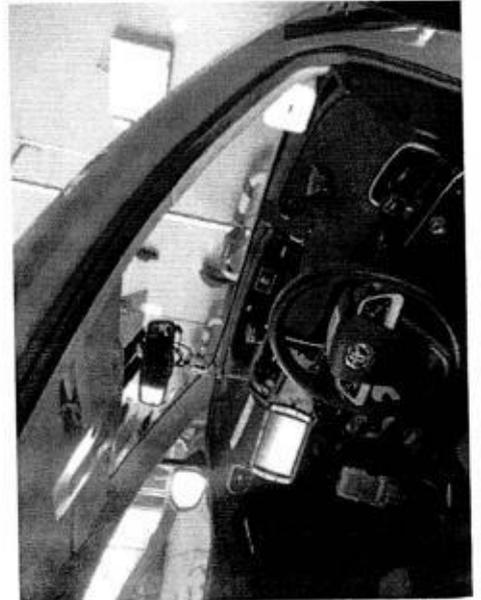
o/s Rear

The U/C / Chassis frame / Body Structure affected due to collision.

Qty	Description of Parts	Condition	Estimate By Workshop (\$)	Our Adjusted (\$)
<b>REPLACEMENT OF PARTS</b>				
1	REAR BUMPER	TO REPAIR	458.60	-
1	REAR BUMPER SIDE RETAINER	SERVICEABLE	112.70	-
1	RETAINER,REAR BUMPER,SIDE,RH	SERVICEABLE	94.80	-
1	SEAL,REAR BUMPER SIDE,RH	SERVICEABLE	148.40	-
1	REAR RH FENDER (NPA)	TO REPAIR	-	-
	LESS 25% DISCOUNT		-203.62	-
			610.88	-
<b>SPECIAL NETT ITEMS</b>				
1	REAR BUMPER RUBBER MAT (SN)	NOT NECESSARY	50.00	-
			50.00	-
<b>LABOUR</b>				
	THATCHAM STANDARD REPAIR TIME ON BODY WORKS.		420.00	100.00
	THATCHAM TTS STANDARD SPRAY PAINTING COST AND LABOUR.		550.00	400.00
			970.00	500.00
<b>GRAND TOTAL</b>			<b>1,630.88</b>	<b>500.00</b>
<b>RECOMMENDED COST OF REPAIRS (CONFIRMED)</b>				<b>500.00</b>
