SJE 1398B

| Adj Asg. Remarks: | DEAR MARCUS, PLEASE CONDUCT THIRD PARTY SURVEY, CHECK CONSISTENCY OF THE DAMAGES AND DO A DIRECT SETTLEMENT. | | |

## REPAIR ESTIMATE FOR SJE1398B

## VEHICLE DAMAGE INSPECTION REPORT

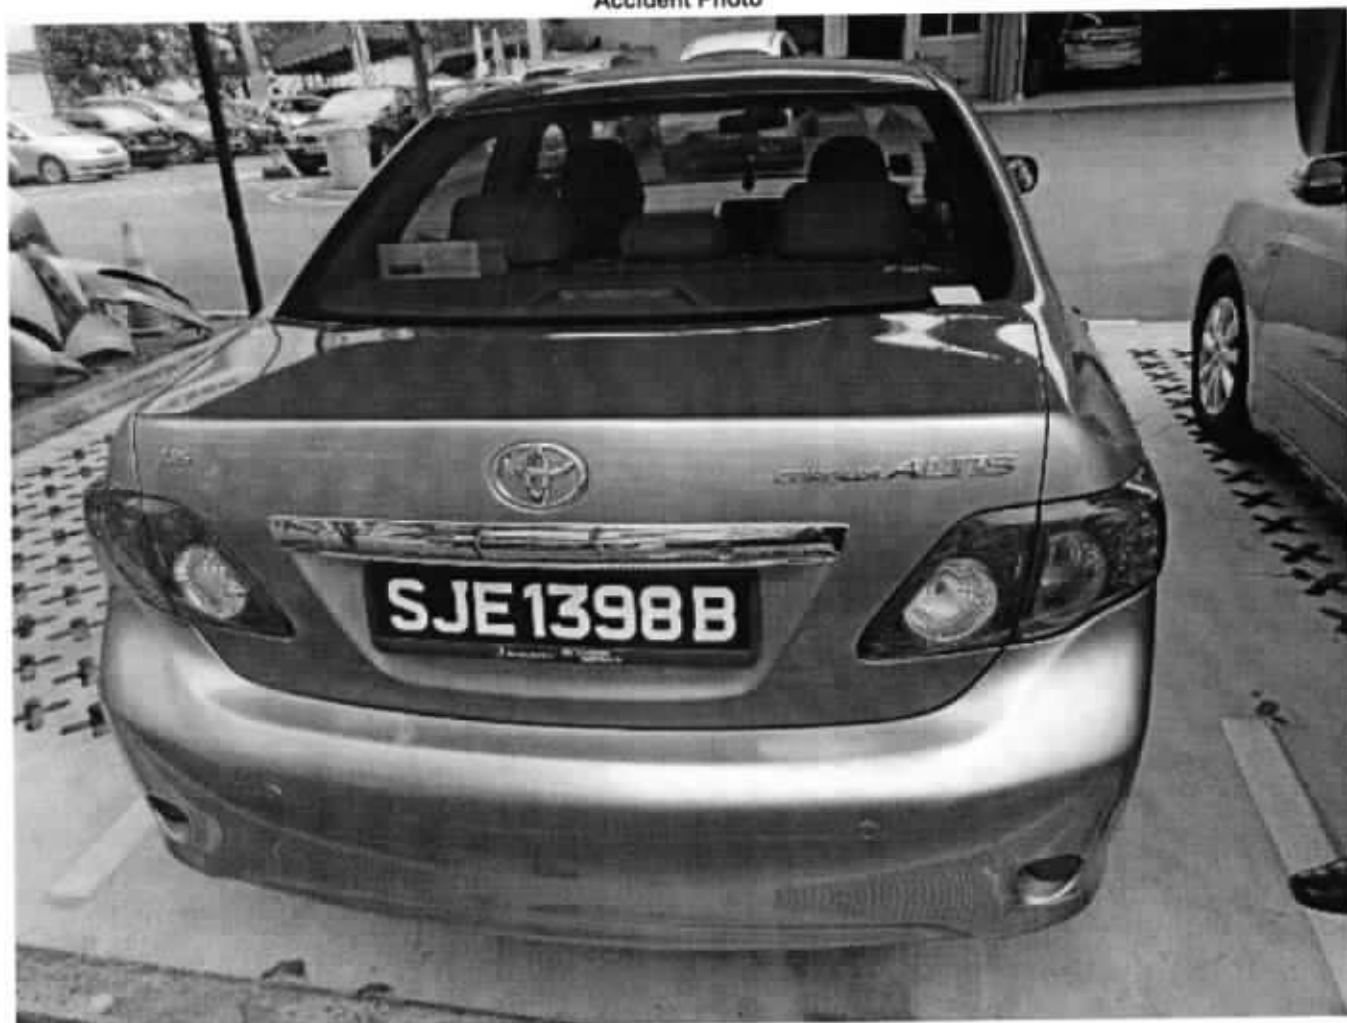
Accident Photo

Rear O/S

suddenly I noticed a HONDA Civic 'Black colour' SJJ1763D tried to switch lane as a result the car hit my rear right side bumper.
