1. Policy Particulars :- THIRD PARTY CLAIM			
Insured Veh.	SJJ 2862U	Veh. Inspected	SHB 340M
Policy No.		Coverage (\$)	0.00
Claim No.		Excess (\$)	0.00
Assign From		Assign Date	25/04/2018

SMRT Accident Vehicle Repair Estimates

ACCIDENT INVOLVING SJJ 2862U & SHB 340M ON 23/04/2018

VEHICLE DAMAGE INSPECTION REPORT

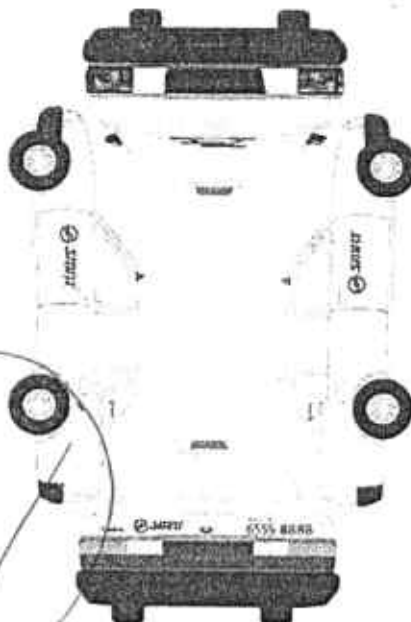
Recording Camera

Radio Antenna

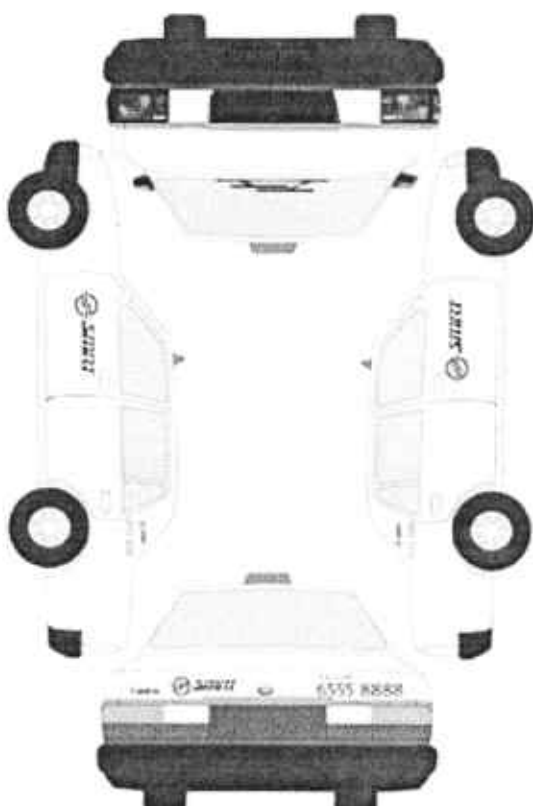
Job Scope	Quotation from ARC	Adjusted by Surveyor, if applicable
TO REPAIR RH REAR PORTION	845.00	0.00 300
Total Labour	845.00	0.00

Job Scope	Quotation from ARC	Adjusted by Surveyor, if applicable
TO REPSRAY REAR BUMPER	378.00	0.00 200
TO RESPRAY REAR FENDER RH	378.00	0.00 X
TO RESPRAY REAR PANEL	180.00	0.00 100
Total Spray Painting & Panel Beating	936.00	0.00

- Lump Sum Repair
- Question Mark Insurance Photo
- Photo After Paint
