REF: CS/CTU8007620/RHB 52

To Inspect Vehicle No: SLH 8901T Insured: GT 547B

Make: *TOYOTA COROLLA ALTIS 1.6 c.c 1598*

VEHICLE DAMAGE INSPECTION REPORT

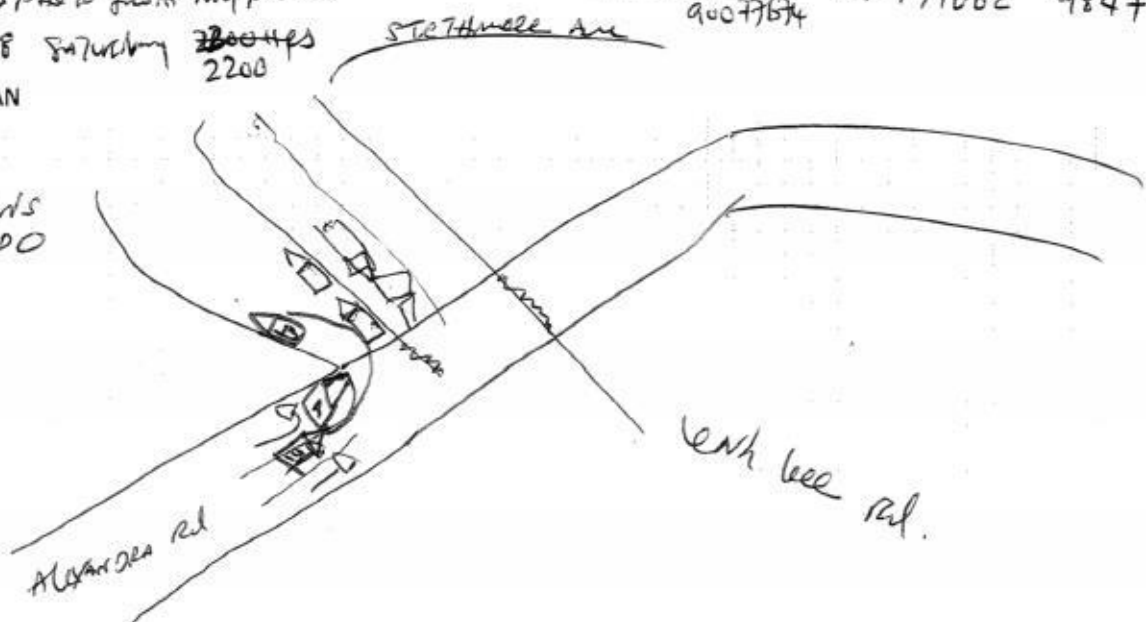
SKETCH PLAN

DESCRIBE CIRCUMSTANCES OF THE ACCIDENT

B HIT A VEHICLE

- AS A UBER DRIVER @ 2149 HRS ON 21/04/18 SATURDAY I GOT A REQUESTED BY UBER RIDER FROM: 10 STIRLING RD S'148954 (QUEEN'S CONDO) GOING TO 20 UPPER CIRCULAR RD S'058416
- WHILE TRAVELLING TOWARDS QUEEN'S CONDO, AT 352 ALEXANDRA RD TURN RIGHT TO COMMERWEALTH AVE, BUT THERE WAS 3-4 CAR MOVING IN-TURN, SO I GOT TO WAIT FOR THE U-TURN CAR CLEAR BEFORE I CAN TURN OUT, BUT SUDDENLY A VAN ~~BE~~ TURN OUT FROM ^{THE} REAR OF MY CAR & HIT MY R-H-R BUMPER AREA! BUT DIDN'T STOP & ^{DRIVER} OFF & SUDDENLY STOP AT THE ROAD SIDE OF COMMERWEALTH AVE! (INITIAL INTENTION- HIT & RUN) WHEN I CAME OUT OF MY CAR HE HAD TURNED & STOP ONE SIDE
