**Preliminary Advice**

Vehicle No	: SLX7951R	Accident Date	: 18/04/2018
Make	: AUDI A3	Policy No.	: 1800037501
Assignment Date	: 26/04/2018	Excess	: S\$3,300.00
Date of Inspection	: 26/04/2018	Est. Duration of Repair	: 0.00
Inspection At	: PREMIUM AUTOMOBILES PTE LTD (UBI) 55 UBI ROAD 1 SINGAPORE 408699

## VEHICLE DAMAGE INSPECTION REPORT

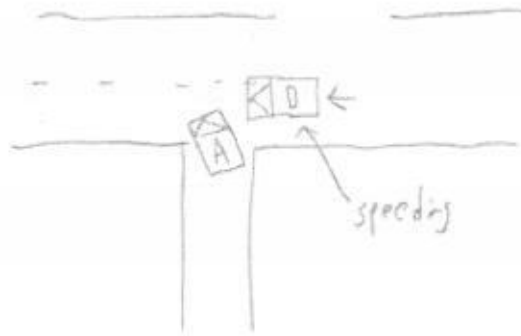
### SKETCH PLAN

A = SLX7951R

B = SJW9125A

I waited to turn left from Cairnhill Circle to Bideford Road around 10 pm on Apr 18, 2018.

The red light was on however there was a sign "Left Turn on Red". I checked the upcoming traffic - cars seemed far and slow.

I started to turn out and was hit by a speeding car coming out of nowhere.

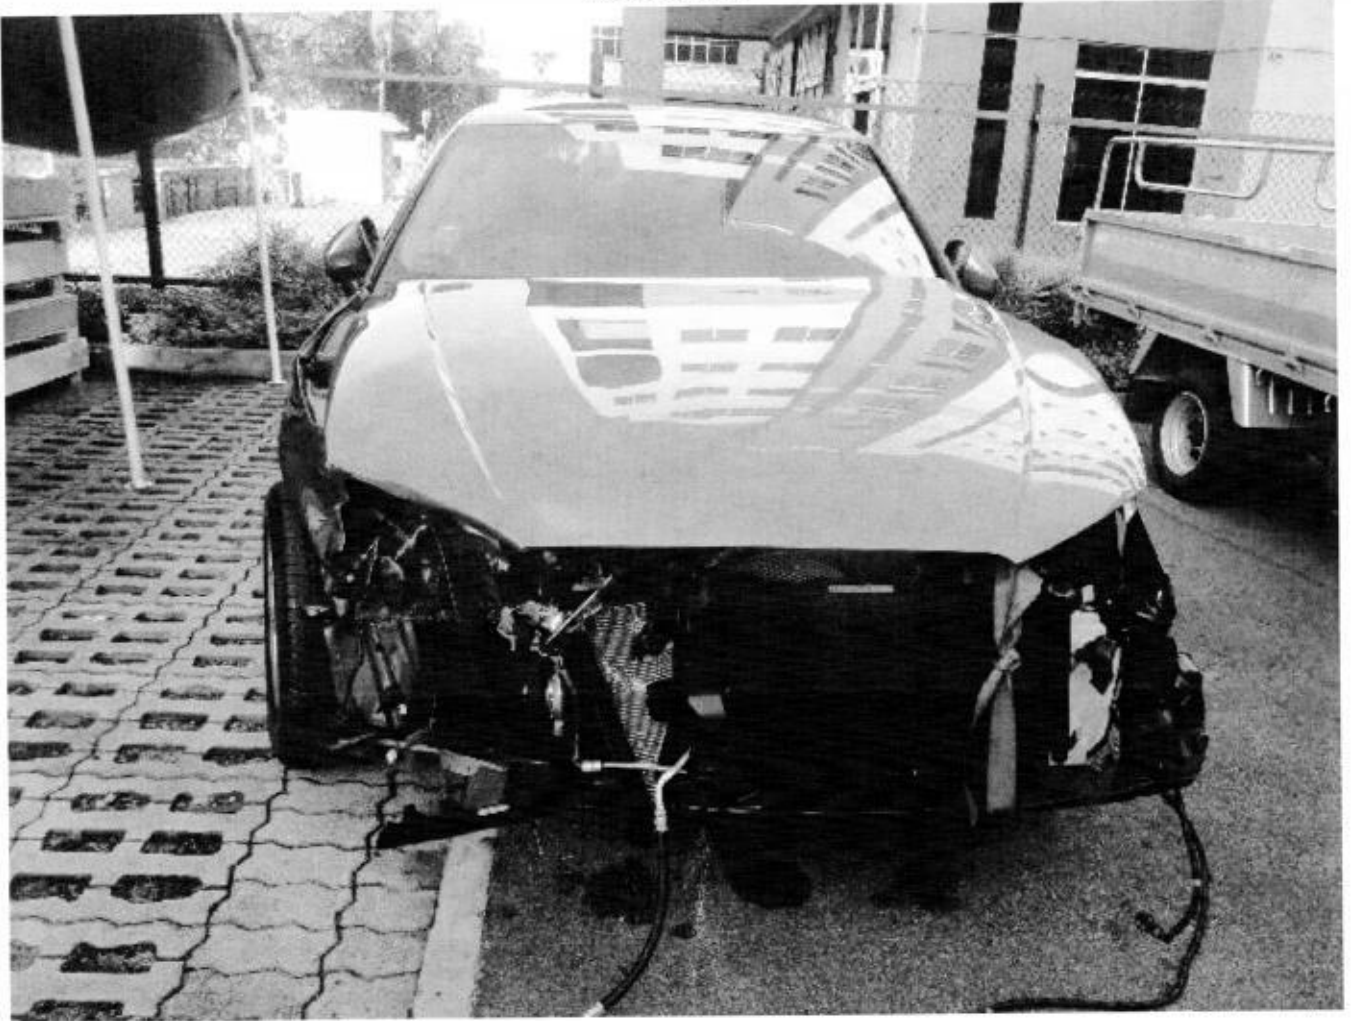
Accident Photo

The vehicle sustained impact / damages front portion and parts claimed are consistent to the accident.

The accident has caused intensive damages including unconfirmed items. The damages incur onto the frontal, chassis, SRS system, engine, gearbox and undercarriage which estimated to be \$84,700. We estimated labour cost to be \$45,000 before any supplementary.

As such, we conclude that we are not able to repair the vehicle and we have informed the customer of such. We propose for a Total Loss on the vehicle.

In view of the above, the vehicle is uneconomical to be repaired, you are advised to invite tender for the wreck.
