# LKK Auto Consultants Pte Ltd

Ref : CS/TP18007732/Uvb

## 1. Policy Particulars :- THIRD PARTY CLAIM

## ADJUSTMENT ON REPAIR COST FOR VEHICLE NO. GBH 2718J

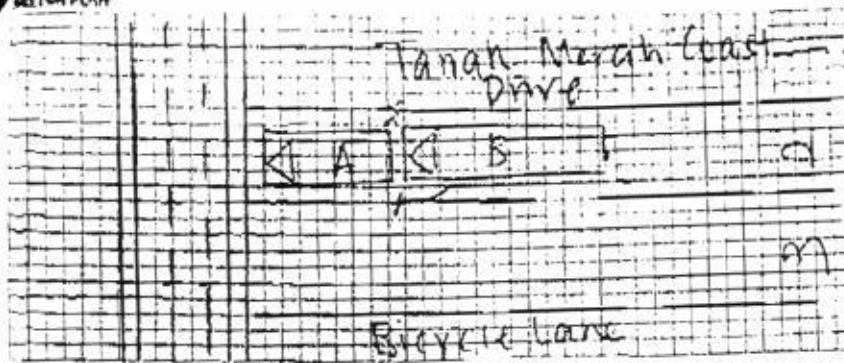
SKETCH PLAN

Type Of Accident COLLISION - HEAD TO REAR  
 Weather Conditions CLEAR  
 Road Surface DRY

On 24 April 2018 at or about 12:15pm, my company van (GBH2718J) with driver, Muhammad Fadzil Bin Ismail, S8606461H and passenger Kyaw Naing Oo, G2545603W, was hit from behind by a tipper truck, XB6732L, driven by Ulaganathan Annamalai, G8231090N, an Indian national, while my van was stationary at the traffic light junction along Tanah Merah Coast Road, outside Changi Lodge.

The impact totally smashed the back of my van and caused the van to move 10 meters ahead.
