PRE-REPAIR INSPECTION REPORT				
ERGO INSURANCE PTE LTD		Ref: CS3/EG18007735/T1z4be2		
5 TEMASEK BOULEVARD #04-01 SUNTEC TOWER		Date: 09-07-2018		
FIVE SINGAPORE 038985

Code: EGI				
<b>1. Policy Particulars :- (THIRD PARTY CLAIM)</b>				
Insured Veh.	XD 7009A	Veh. Inspected	GT 2359P	
Policy No.		Coverage (\$)	0.00	
Claim No.	DSMCV1800819/SA	Excess (\$)	0.00	
Assign From	YEE PEI LI	Assign Date	26/04/2018	
<b>2. Vehicle Particulars &amp; Condition</b>				
Make & Model	NISSAN CABSTAR	c.c	3153	
Engine No.	HIDDEN	Year of Reg.	2000	
Chassis No.	JN1SF4F23Z0841703	Colour	BLUE	
Odometer	-	Steering	IN ORDER	
Brakes	IN ORDER	Modification	NIL	
General	GOOD			
<b>3. Conditions of Tyres</b>				
	Size	Make	Balance	
R/H Front Tyre	185 R14	YOKOHAMA	6 mm	
L/H Front Tyre	185 R14	YOKOHAMA	6 mm	
R/H Rear Tyre	165 R13 (D)	YOKOHAMA	6/6 mm	
L/H Rear Tyre	165 R13 (D)	YOKOHAMA	6/6 mm	
<b>4. Description of Damages</b>				
THE VEHICLE SUSTAINED DAMAGES AT THE FRONT N/S PORTION.

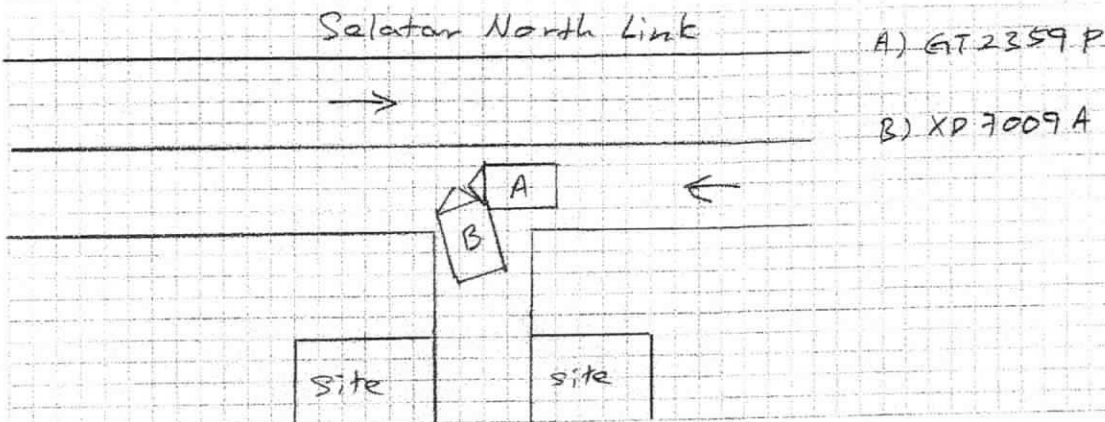
SKETCH PLAN

On 24/04/2018 @ 18:30. I was driving straight along Selatan North Link. The vehicle B (XD 7009 A) came out from the site gate without stop. I tried to stop, but could not stop in time and collided on my ~~side~~ from left side. Nobody injured and we both exchange particulars.
