## 1. Policy Particulars :- THIRD PARTY CLAIM

VEHICLE NO : SHD 3491E

THE VEHICLE SUSTAINED DAMAGES AT THE O/S REAR PORTION.
DAMAGES SEE DETAILS.

## ADJUSTMENT ON REPAIR COST FOR VEHICLE NO. SHD 3491E

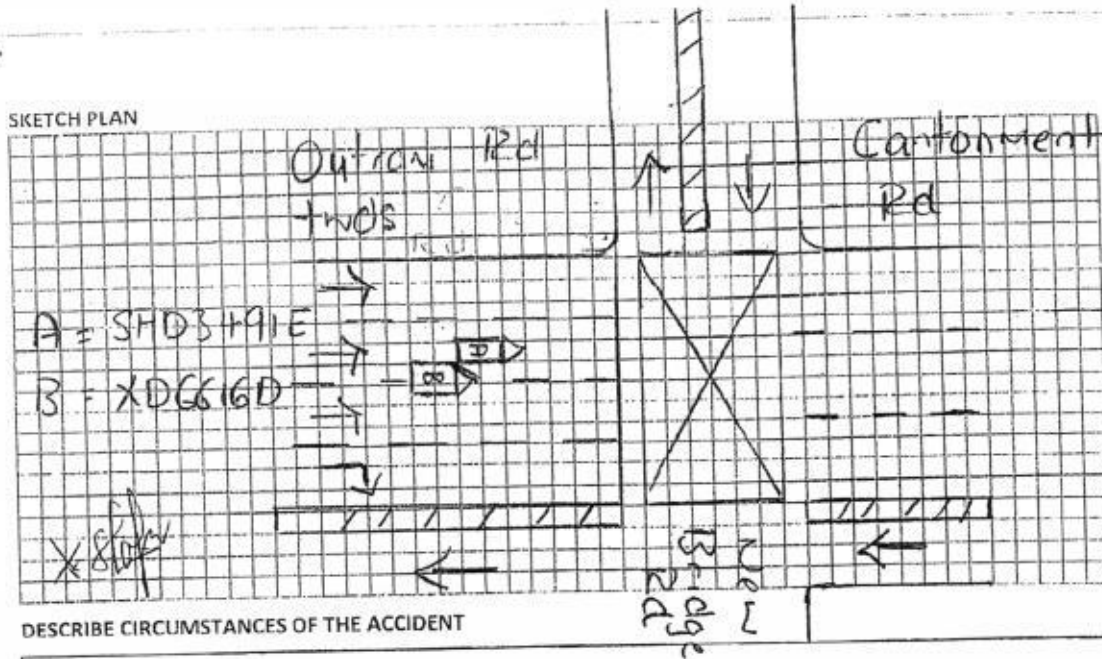
## SKETCH PLAN

On 26/04/2018 at about 08:25hrs, I was driving on the second lane from the left along Outram Road towards Cantonment Road before junction of New Bridge Road. The traffic was heavy and slow moving.

Shortly, my passenger informed that he felt a slight jerk from behind. Thus I drove on further down in order not to obstruct the traffic. Thereafter, I stepped out and checked. Found a truck XD6616D have grazed onto the right rear of my taxi & the driver told me to file a report for claim purposes.

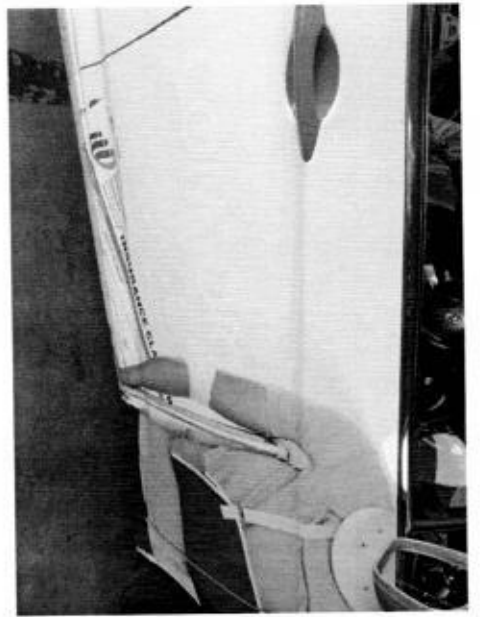
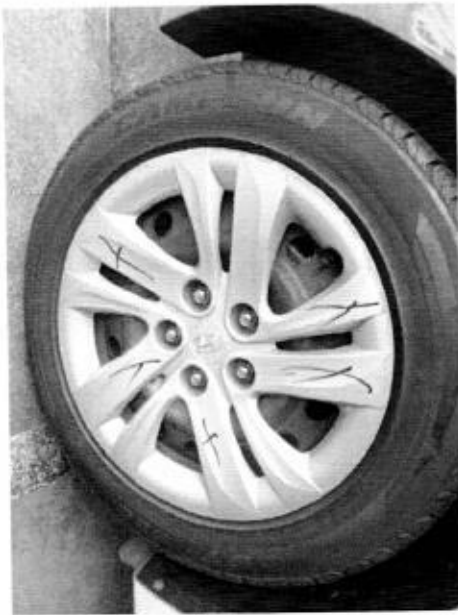
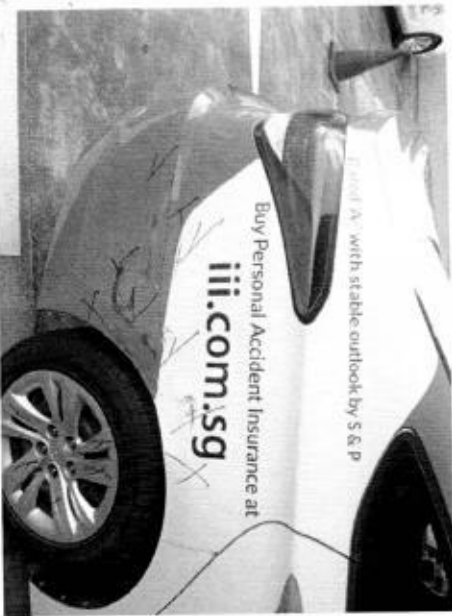
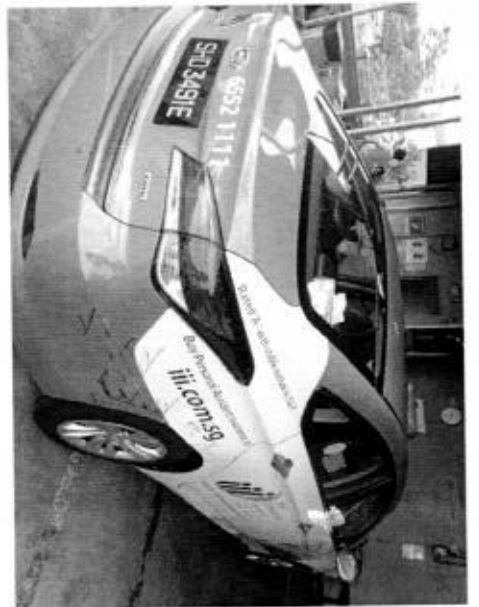
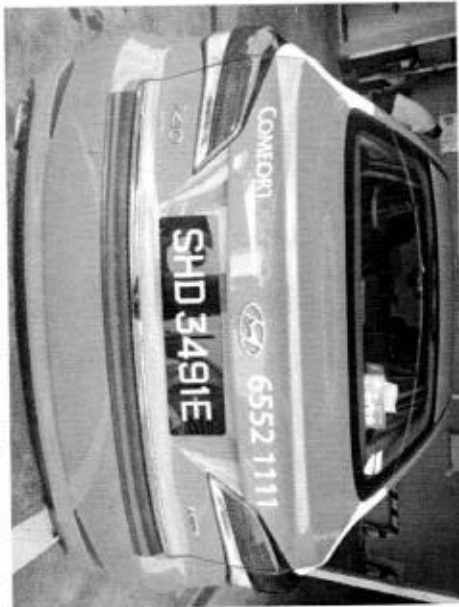
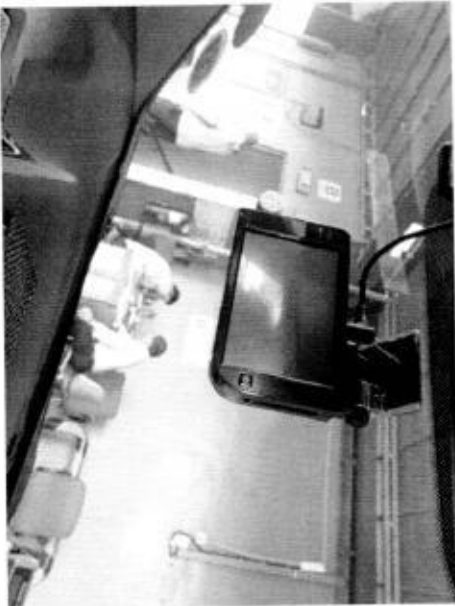
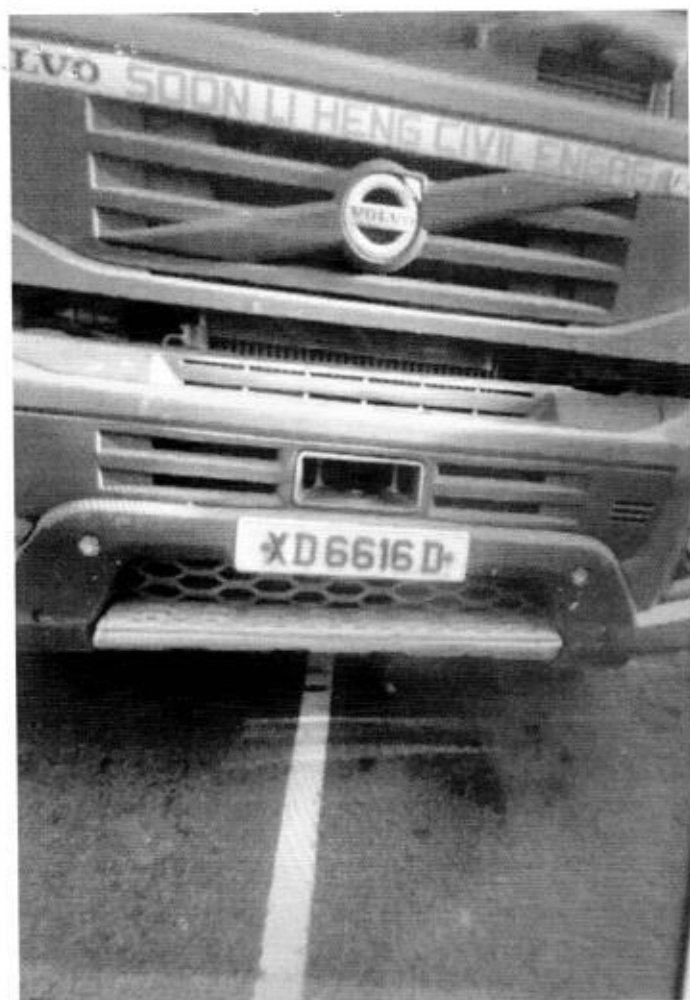
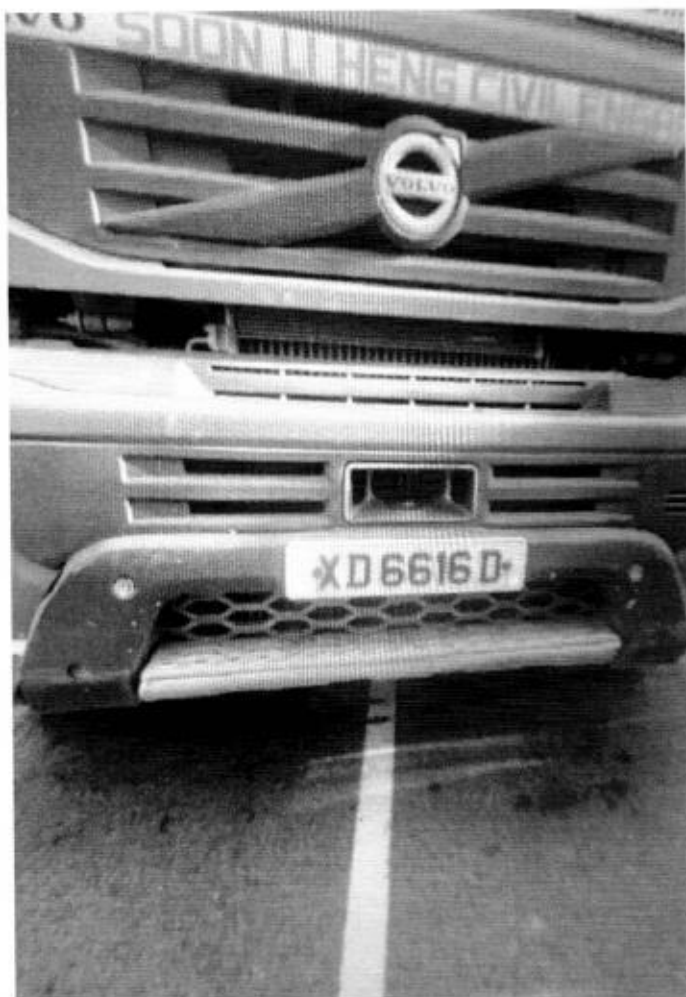
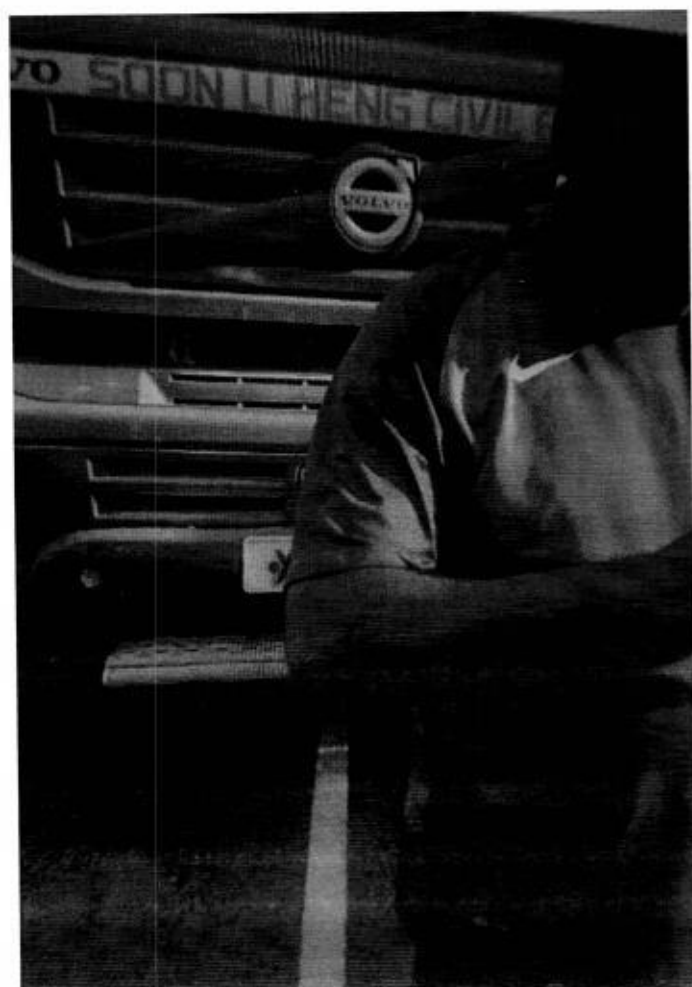
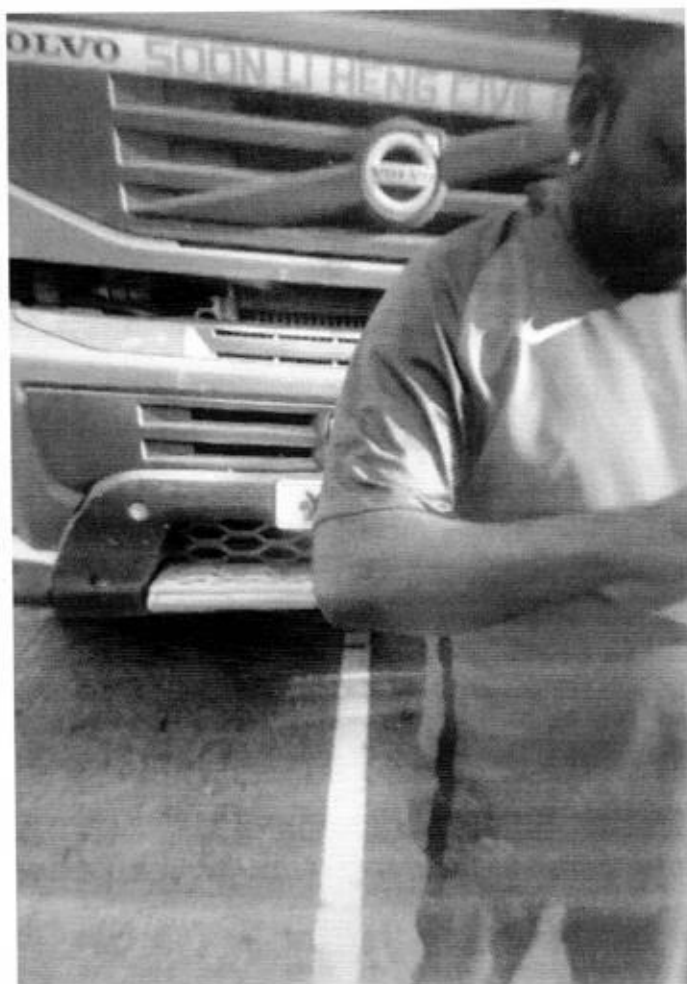
o/s Rear

The U/C / Chassis frame / Body Structure affected due to collision.

Qty	Description of Parts	Condition	Estimate By Workshop (\$)	Our Adjusted (\$)
<b><u>REPLACEMENT OF PARTS</u></b>				
1	REAR BUMPER	CUT	603.60	603.60
10	REAR BUMPER CLIPS	NECESSARY	22.00	22.00
1	REAR FENDER (RH)	TO REPAIR	2,020.10	-
1	REAR FENDER INNER LINING (RH)	SERVICEABLE	164.40	-
1	REAR WINDSCREEN MOULDING	NOT NECESSARY	60.00	-
1	REAR WHEEL HUB CAP,RH	GRAZED	150.70	150.70
1	REAR BUMPER SIDE BRACKET (RH)	CRACKED	49.00	49.00
	LESS 20% DISCOUNT		-613.96	-165.06
			2,455.84	660.24
<b><u>SPECIAL NETT ITEMS</u></b>				
1	REAR BUMPER RUBBER MAT (SN)	NECESSARY	50.00	50.00
2	REAR FENDER ADVERTISEMENT LOGO (LH/RH) @\$100.00 (SN)	NOT NECESSARY	200.00	-

250.00	50.00
<b><u>LABOUR</u></b>				
	THATCHAM STANDARD REPAIR TIME ON BODY WORKS.		1,370.00	370.00
	THATCHAM TTS STANDARD SPRAY PAINTING COST AND LABOUR.		450.00	360.00
			1,820.00	730.00
<b>GRAND TOTAL</b>			<b>4,525.84</b>	<b>1,440.24</b>
<b>RECOMMENDED COST OF REPAIRS (CONFIRMED)</b>				<b>1,440.24</b>
