GREAT AMERICAN INSURANCE COMPANY Ref : CS/GAI18007794/Utbn2

1. Policy Particulars :- THIRD PARTY CLAIM

4. Description of Damages

ADJUSTMENT ON REPAIR COST FOR VEHICLE NO. GBA 8511K

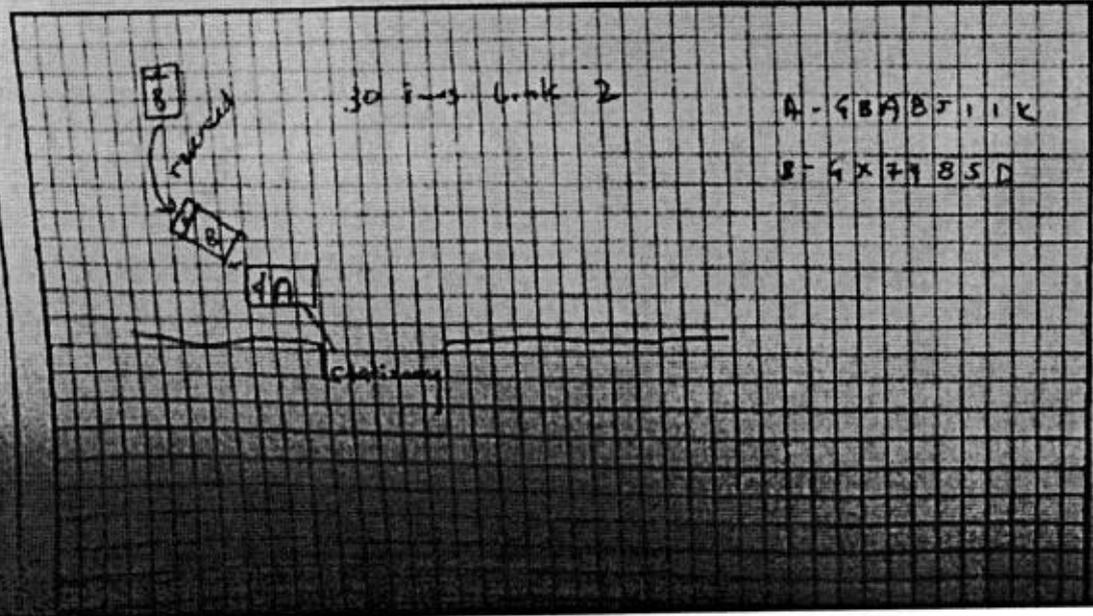
Sketch Plan

My vehicle was stationary at the said location when vehicle B GX7485D reversed. I sounded my horn but the said vehicle did not slow down. As such, vehicle collided into the front right portion of my vehicle.
