Insured Vehicle No	: SJJ7195D		
TP Vehicle No	: SJN3333C	Accident Date	: 26/04/2018
Make	: MERCEDES-BENZ E250	Assignment Date	: 30/04/2018
Date of Inspection	: 02/05/2018	Est. Duration of Repair	: 5 days
Inspection At	: Serve You Motor Service (HQ) BLOCK 5033 ANG MO KIO INDUSTRIAL PARK 2 #01-265 Singapore 569536

VEHICLE DAMAGE INSPECTION REPORT

Our File No: CS/MSG18007882/KS3BE2

Handling Insurer: MSIG Insurance (Singapore) Pte. Ltd. Policy No: A28813365MCY
 Claimant Vehicle No: SJN3333C Insured Vehicle No: SJJ7195D
 Date of Loss: 26/04/2018 Nature of Claim: TP Claim No: 556941

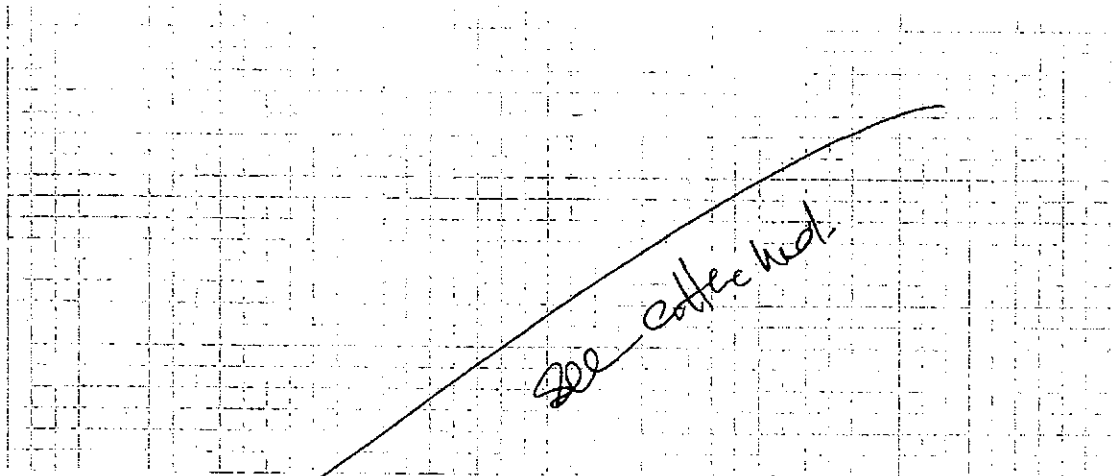
SKETCH PLAN

I WAS TRAVELLING ALONG BUKIT BATOK WEST AVE 8 (INFRONT OF BT BATOK SEC SCHOOL) AFTER ALIGHTNING MY GRANDCHILDREN TO SCHOOL. ALL OF A SUDDEN, A VEHICLE WHICH WAS PARK ON THE LEFT SIDE OF THE LANE MOVE OUT WITHOUT CHECKING. AS A RESULT, THE SAID VEHICLE HIT ONTO THE REAR LEFT PASSENGER DOOR OF MY VEHICLE. ATTENDED BY : SUSAN
