VEHICLE DAMAGE INSPECTION REPORT

Our File No: CS/III18007994/ARBS2
Date: 21/06/2018

Handling Insurer: India International Insurance Pte Ltd Policy No: MCOM0016
Claimant Vehicle No : SLT4027A **Insured Vehicle No :** SH8061D
 Date of Loss: 25/04/2018 Nature of Claim: TP Claim No: MCT18040717

Reg No: **SLT4027A**
 Make & Model: TOYOTA COROLLA ALTIS, 1.6 (A) Engine No: 3ZZ4761866
 Reg. Date: 08/05/2008 (Man. Year: 2008) Chassis No: MR053ZEE106107523
 Colour: Blue Odometer: 152636 km
 Engine Capacity: 1598 cc
 Market Value/New Car Price: N/A
 Sum Insured (S\$): **Market Value/New Car Price**

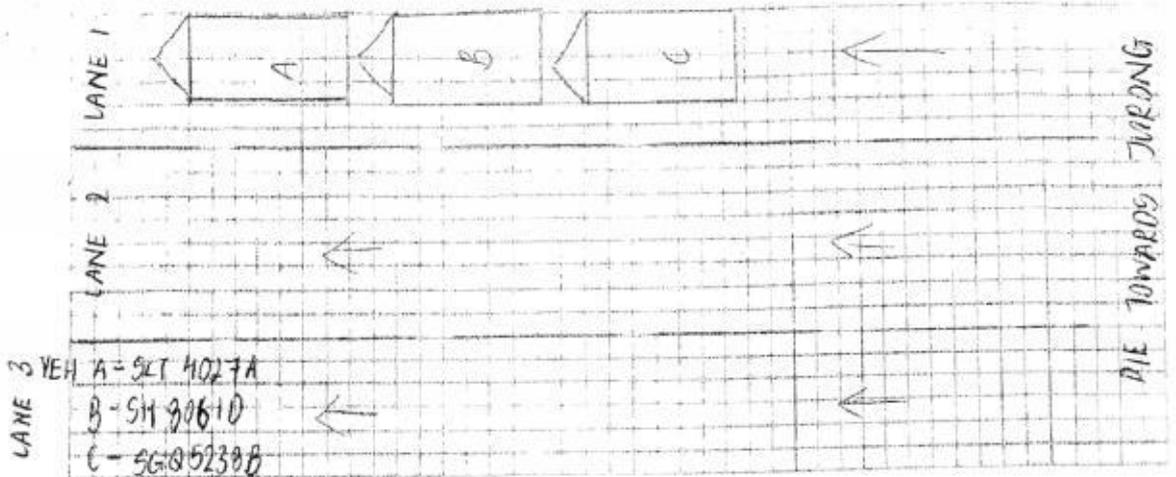
SKETCH PLAN

ON 25/04/2018 @ 5:14PM I WAS DRIVING ALONG PIE TOWARDS JURONG. I WAS ON STATIONARY ON THE EXTREME RIGHT LANE AND SUDDENLY VEH C - SG 5238B BEHIND OF VEH B - SH 8061D WHICH WAS ALSO STATIONARY AT THE TIME HIT VEH B - SH 8061D AND CAUSES A CHAIN COLLISION. VEH B - SH 8061D COLLIDED ONTO MY REAR PORTION. SG 5238B COULD NOT STOP IN TIME AND HIT SH 8061D. SH 8061D HIT MY REAR PORTION COLLIDED INTO MY CAR AND HIT MY REAR PORTION
