Insured Vehicle No	: SDZ6188T	Accident Date	: 01/05/2018
TP Vehicle No	: SKH6858E	Assignment Date	: 02/05/2018
Make	: BMW 135I	Est. Duration of Repair	: 3.00
Date of Inspection	: 14/05/2018		
Inspection At	: PERFORMANCE MOTORS LIMITED (ALEXANDRA) 303 ALEXANDRA ROAD, SIME DARBY PERFORMANCE CENTRE SINGAPORE 159941

The vehicle sustained impact / damages front n/s portion and parts claimed are consistent to the accident.

## VEHICLE DAMAGE INSPECTION REPORT

Reg No:	SKH6858E	Engine No:	11348309N55B30A
Make & Model:	BMW 135i, 3.0 (A)	Chassis No:	WBAUN72000VM22858
Reg. Date:	04/01/2013 (Man. Year: 2012)	Odometer:	19283 km
Colour:	Black		
Engine Capacity:	2979 cc		
Market Value/New Car Price:	N/A		
Sum Insured (S\$):	Market Value/New Car Price

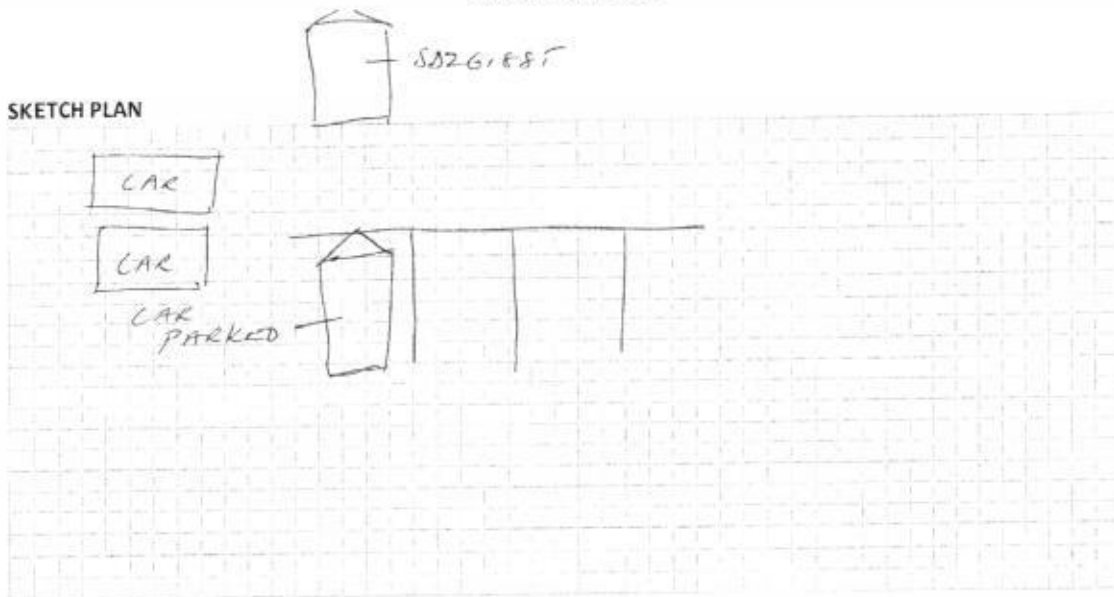
## SKETCH PLAN

MY CAR WAS PARKED IN THE UNDERGROUND CAR PARK AT HOLLAND VILLAGE SHOPPING CENTRE. LEFT WHEN I RETURNED THE REAR BUMPER + HEADLIGHT WAS SCRAPPED + DAMAGED.
