## Preliminary Advice

| Vehicle No | : SKA1849B | Accident Date | : 28/04/2018 |
| Make | : MERCEDES-BENZ C200 | Policy No. | : DMPCSN3000211801 |

## Point of Impact / General Description of Damages

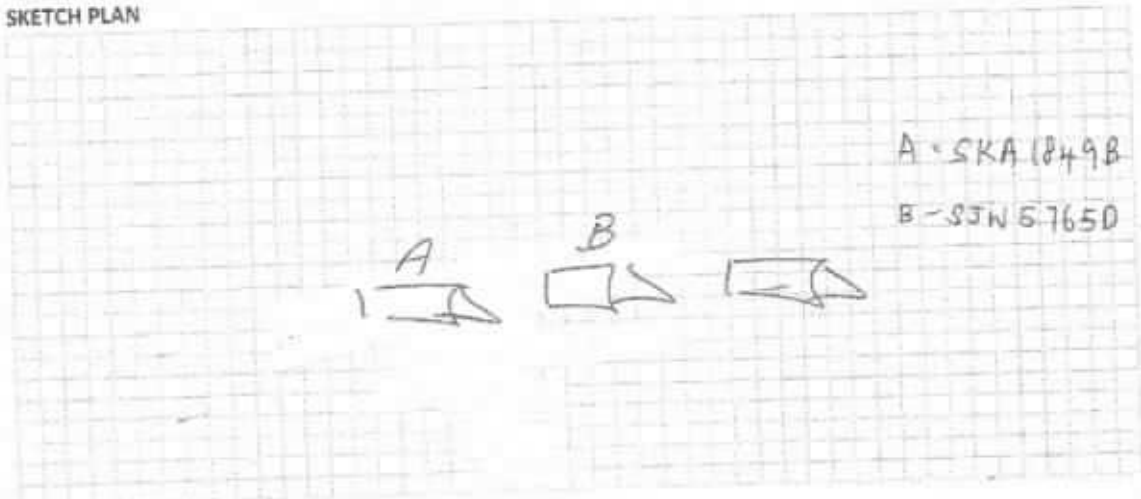
SKETCH PLAN

I was driving along T junction of Marymount Lane heading towards Upper Thomson Rd. The front vehicle B stopped abruptly but I could not stop in time and accidentally hit onto his car's rear portion. Fortunately no injury to both parties.
