Ref : CS/AGI18008139/Atbn2

## 1. Policy Particulars :- THIRD PARTY CLAIM

## ADJUSTMENT ON REPAIR COST FOR VEHICLE NO. SLT 9881S

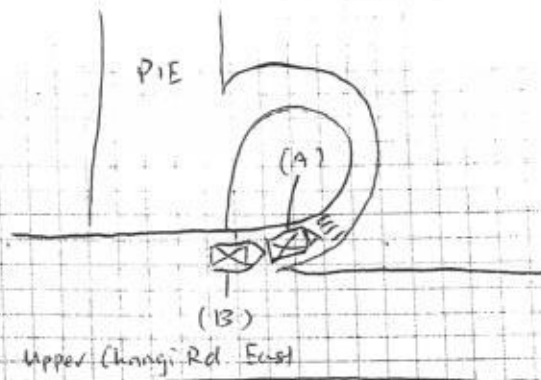
# SKETCH PLAN

(A) SLT9881S  
(B) SGV3112S

I stopped my car (SLT9881S) at the slip road towards PIE at Upper Changi Road East as there is a pedestrian waiting at pedestrian crossing. (SGV3112S) car cannot stop on time and knock onto the bumper of my car.
