Due Date	Priority	Type	Task Group	Subject	Handler	Assigned By	Completed On	Created On	Done?
No results.

Preliminary Advice

Vehicle No	: SKL7677H	Accident Date	: 30/04/2018
Make	: MERCEDES-BENZ 200	Policy No.	: DMPCSN3045341702
Assignment Date	: 04/05/2018	Excess	: S\$500.00
Date of Inspection	: 04/05/2018	Est. Duration of Repair	: 6.00
Inspection At	: CYCLE & CARRIAGE INDUSTRIES PTE LTD (PANDAN LOOP) 188 PANDAN LOOP SINGAPORE 128378

VEHICLE DAMAGE INSPECTION REPORT

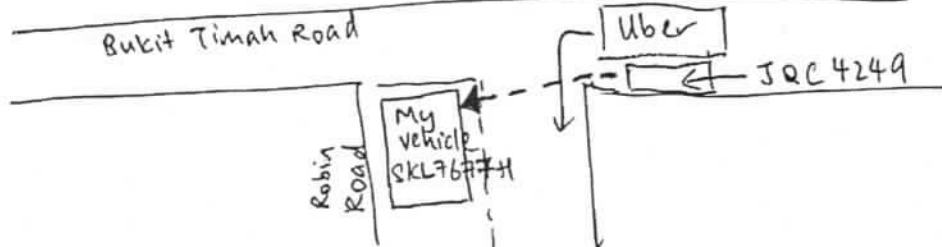
SKETCH:

My vehicle (SKL7677^H) was stationary along Robin Road, at the T-junction, waiting to turn left into Bukit Timah Road. An Uber car turning left into Robin Road hit a motorcycle (JQC 4249). The motorcycle lost balance and came towards my car. It hit the front right ^{bumper} ~~bumper~~ of my car. (Evidence: Car dash cam video, photos)
(TP called in; police report lodged)
