To: MSIG Insurance (Singapore) Pte. Ltd. 4 Shenton Way #21-01 SGX Centre 2 Singapore 068807	From: LKK Auto Consultants Pte Ltd 51 Ubi Ave 1 #01-25 Paya Ubi Industrial Park Singapore 408933
Attn: Katherine Wong Chew Shong	Date: 07 May 2018
Preliminary Advice

VEHICLE DAMAGE INSPECTION REPORT

Our File No: CS/MSG18008186/KVBN2

Handling Insurer:	MSIG Insurance (Singapore) Pte. Ltd.	Policy No:	A29043861QMX
Claimant Vehicle No :	SKZ8649J	Insured Vehicle No :	SLK3783D
Date of Loss:	02/05/2018	Nature of Claim:	TP
		Claim No:	557378

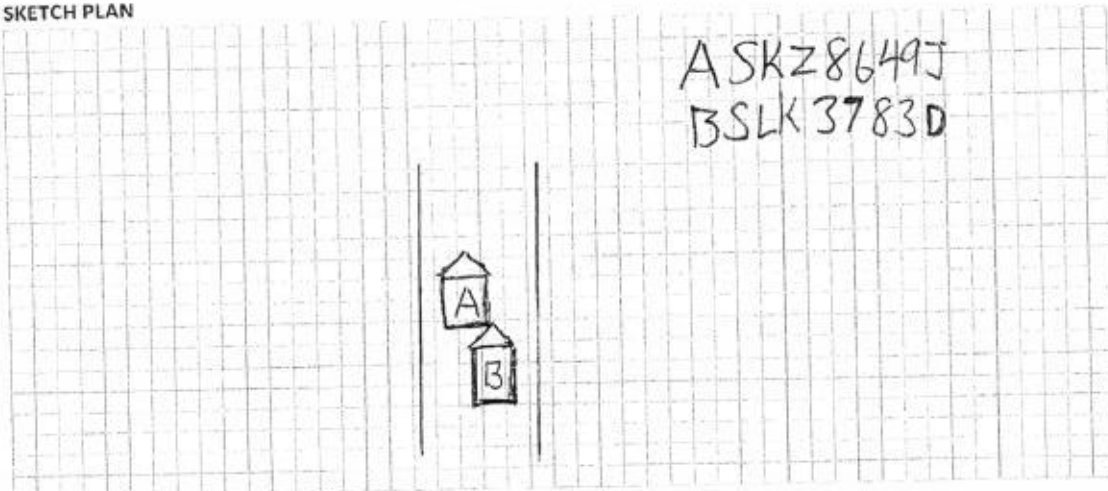
SKETCH PLAN

I was driving along the minor road near Blk 14 Sin Ming lane at Midview City. The car No. SLK3783P driven by Tan Hwee Leng hit me from behind.
