Preliminary Advice

VEHICLE DAMAGE INSPECTION REPORT

Handling Insurer:	MSIG Insurance (Singapore) Pte. Ltd.	Policy No:	29029800QMX
Claimant Vehicle No :	SKQ7624J	Insured Vehicle No :	SKW8186T
Date of Loss:	04/05/2018	Nature of Claim:	TP
		Claim No:	557536

Reg No:	SKQ7624J	Engine No:	B5750878N20B20A
Make & Model:	BMW 428I, 2.0 Gran Coupe (F36) (A)	Chassis No:	WBA4A52090D571968
Reg. Date:	26/12/2014 (Man. Year: 2014)	Odometer:	52750 km
Colour:	Grey		
Engine Capacity:	1997 cc		
Market Value/New Car Price:	N/A		
Sum Insured (S\$):	Market Value/New Car Price

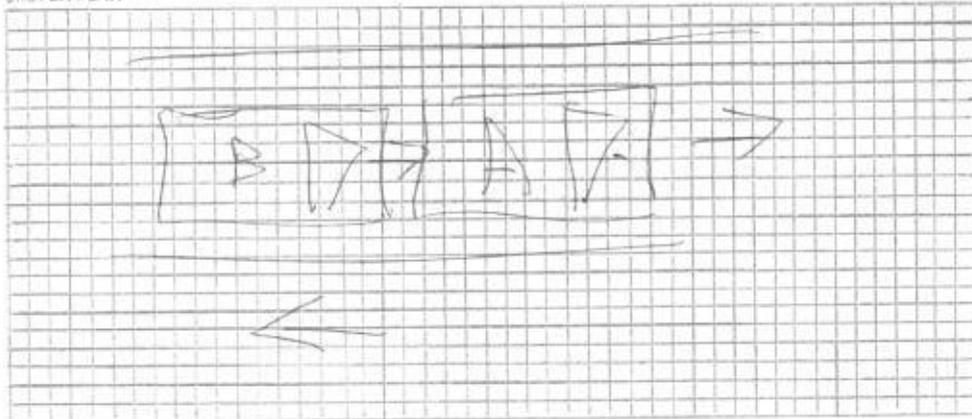
SKETCH PLAN

While waiting to turn into Whitley Road (at the junction of Dyson Road and Whitley Road), my car was stationary when suddenly a car hit my car in the rear.
