REF: CS/MSG18008445/R/Hb 91

Preliminary Advice

Vehicle No	: SLP8434C	Accident Date	: 04/05/2018
Make	: TOYOTA C-HR	Policy No.	: MSD/VPCP/17-001639
Assignment Date	: 08/05/2018	Excess	: S\$1,500.00
Date of Inspection	: 08/05/2018	Est. Duration of Repair	: 5.00
Inspection At	: AUTOFRANCE (HQ) 305 ALEXANDRA ROAD, #02-01 SINGAPORE 159942

VEHICLE DAMAGE INSPECTION REPORT

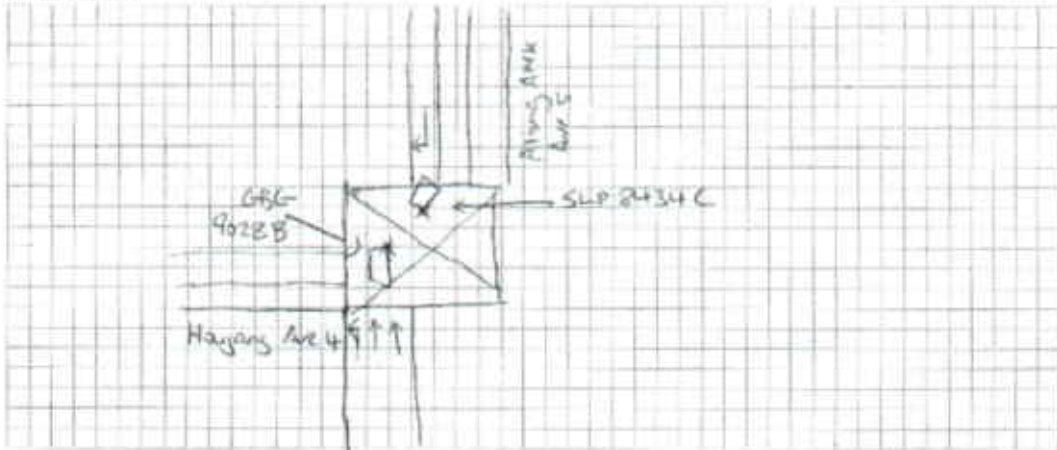
SKETCH PLAN

I was travelling along Ayrk Ave 5 approaching the junction towards Haydon Ave 4. The light was green and as I was approaching the junction, I stopped for incoming traffic. When the traffic was cleared, I proceeded to turn right to Haydon Ave 4. Then I realise that there is an incoming lorry GBG 9028B approaching from opposite side & both vehicle collided.
